## TIME ANALYSIS OF KING MATTHIAS THE 1<sup>ST</sup> SCULPTURAL GROUP

Julieta Daniela CHELARU\*, Vasile Filip SOPORAN, Ovidiu NEMEȘ

*The paper presents a study on the degradation of the King Matthias I sculptural group, caused by environment factors and influenced by the casting technology and by the assembling method. During this study, samples from inside the statue were used and analyzed, using microscopy and X ray diffraction.*

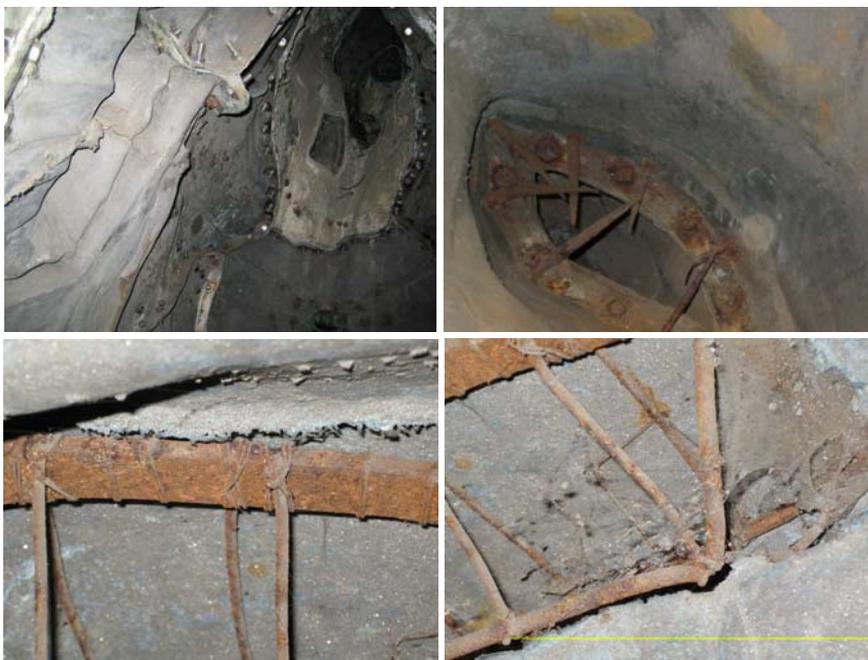
Each component of the group is made of several pieces assembled together with steel screws (Fig.2). The molding was made using the classic casting technology in sand and for more complex details the wax method was used.

**Fig. 2.** Images depicting the inside of the sculpture

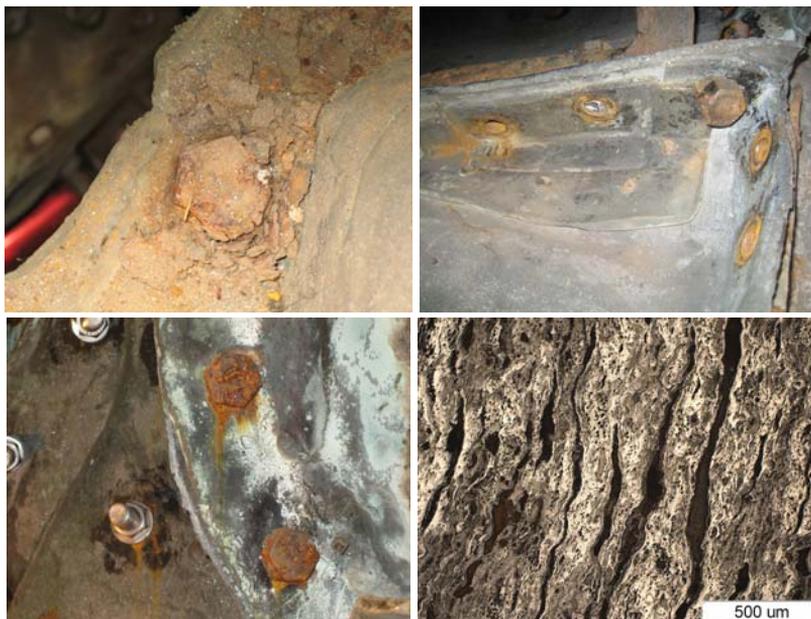
Studies have shown that the corrosion agents on a copper alloy surface are oxides, sulfides, carbonates, chlorides, sulfates of copper. Degradation caused by atmospheric corrosion depends on the chemical composition of the metallic material, on the pollutants and on the exposure time needed for the development of corrosion products [4-7]. Degradation appears mainly because of the interaction between water and corrosive substances on the surface of the materials. In the case of King Matthias the I<sup>st</sup> sculptural group, the degradation occurred not only because of environmental exposure, but also because of the steel screws used to assemble the component parts, which caused galvanic corrosion (Fig.3).

Fig. 3. Images representing the inside of the sculpture

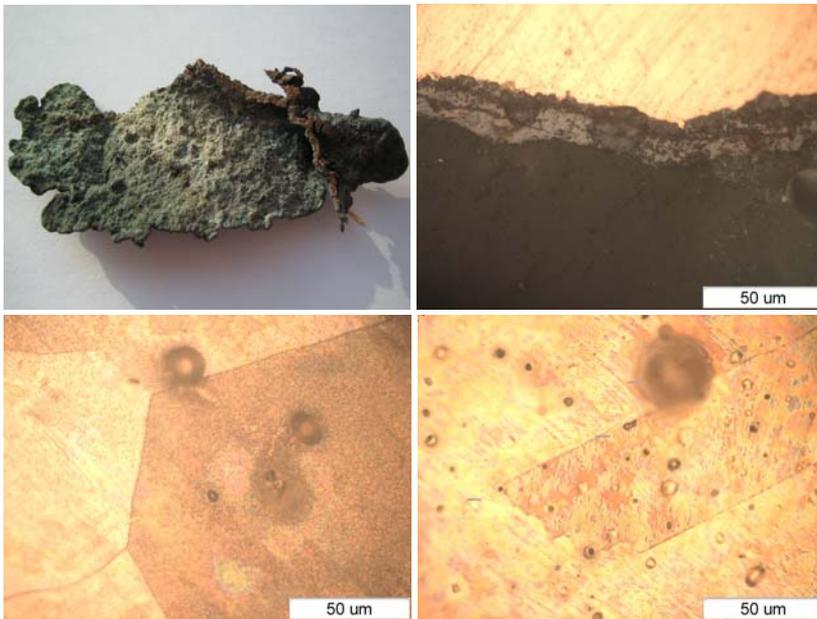
The structure of the alloy used is homogeneous, the crystals have polyhedral appearance with macles (Fig 4), leading to high anti-corrosive properties [8]. We can observe that in figure 4b, the oxide layer is 10-50 µm thick.

**Fig. 4** Samples of the alloy used in the casting of King Matthias I sculptural group: a) raw sample; b) oxide layer; c) macroscopic structure; d) microscopic structure

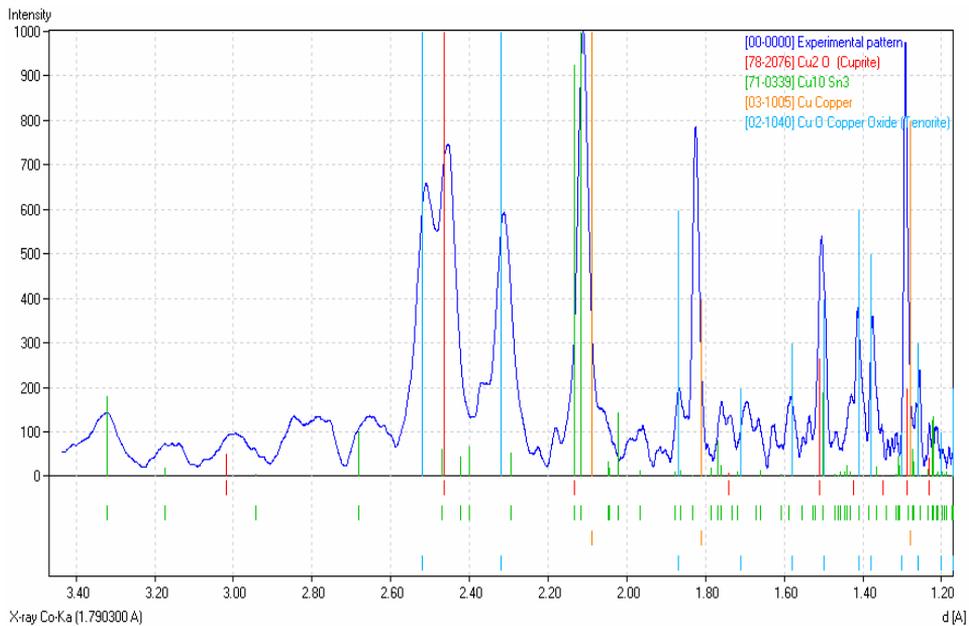
The main compounds identified after the X ray diffraction analysis in the bronze used to cast the King Matthias I sculptural group are cuprite and tenorite. These are the most common

corrosion products and they are usually found on metal surfaces. Alongside copper oxides, copper was identified in small quantities, probably as a result of cuprite decomposition.

**Fig. 5.** X ray diffraction analysis of the oxide layer formed on the inner walls of the statue

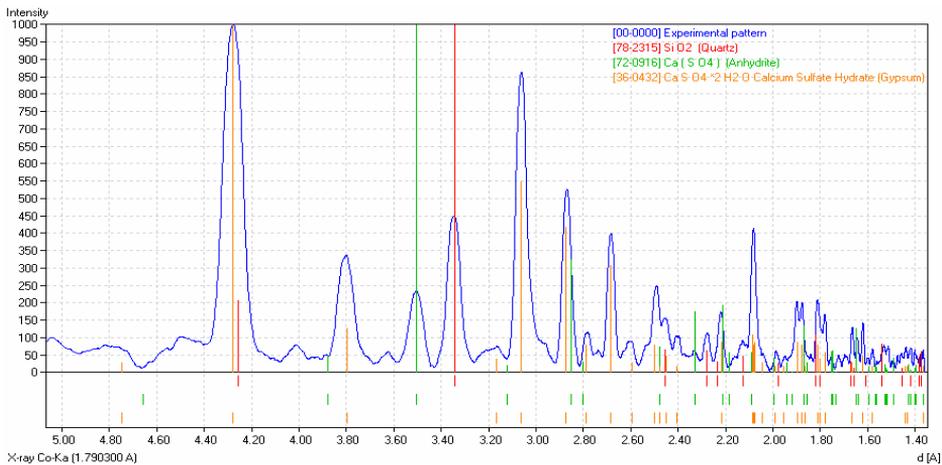
On the inner walls of the statue large quantities of material sediments were found. After X ray diffraction analysis the sediment was identified as a residual mixture of compounds resulting from contamination: gypsum or calcium sulfate hydrate ( $\text{CaSO}_4 \cdot 2\text{H}_2\text{O}$ ), sulphate calcium ( $\text{CaSO}_4$ ) and quartz ( $\text{SiO}_2$ ). Silicates may have resulted from the molding mixture or from the accumulation of airborne particles. Hydrated calcium sulfate probably resulted from calcium carbonate reaction with sulfate ions.

Fig. 7. X ray diffraction analysis of the sediments deposited on the inner walls of the statue
