THE STUDY OF CONSERVATION STATE OF A WOODEN CHURCH FROM BOZ VILLAGE, HUNEDOARA COUNTY, ROMANIA

Abstract

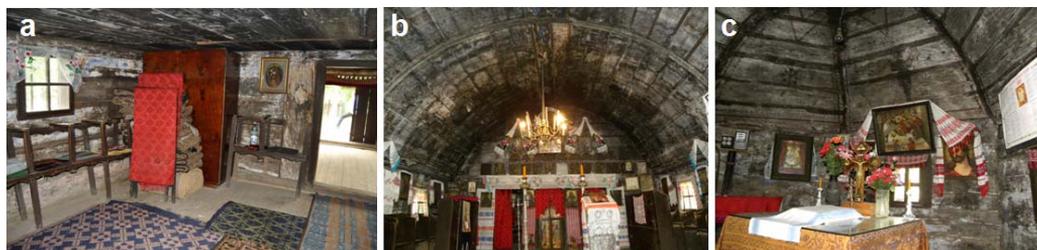
In the narthex may be found only traces of ground and colour on the walls and fragments from the decoration of the ceiling (Fig. 2a). Inside the nave we can admire a symmetric

painting, organized on registers, but it is difficult to recognize the scenes and the saints, because of their highly degraded and deteriorated state. The icon support inside the nave is remarkable since it was painted in the same period with the walls and represented Saint Simeon Stâlplnicul (Fig. 2b).

Fig. 2. Interior of the church – a) Narthex, b) Nave, c) Altar

In the altar, the paintings on the walls are highly deteriorated and few saints may be identified, while the symbolic representations on the arch are better preserved (Fig. 2c). In the church are also preserved some icons on wood dating from the 20th century and icons on glass.

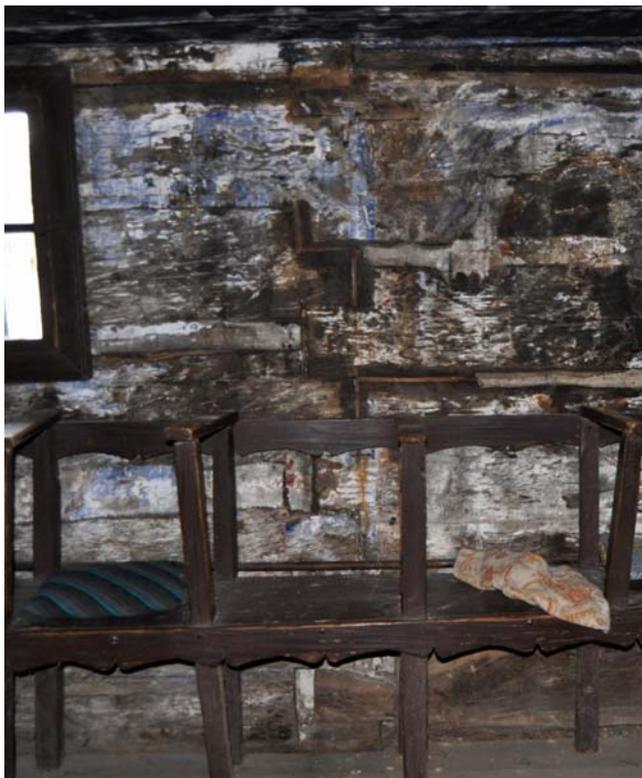
This wooden church was enlarged to the western part. At the northern wall was fixed a vertical pillar and on the south side, tow pillars (one corresponding to the Northern part – in the middle of nave and the second one to the western one). Horizontal beams are jointed on these pillars by tongue and groove joints (this technique was used for the extension of the walls, because the length of the beams was not enough). In the narthex we may observe the extension of the wall, because the old dovetail joint was preserved here (on the west wall of the church)

and the new wall was jointed to it (Fig. 3.). This extension was made before painting the interior spaces.

Fig. 3. Old joint, from where was enlarged the North wall of narthex

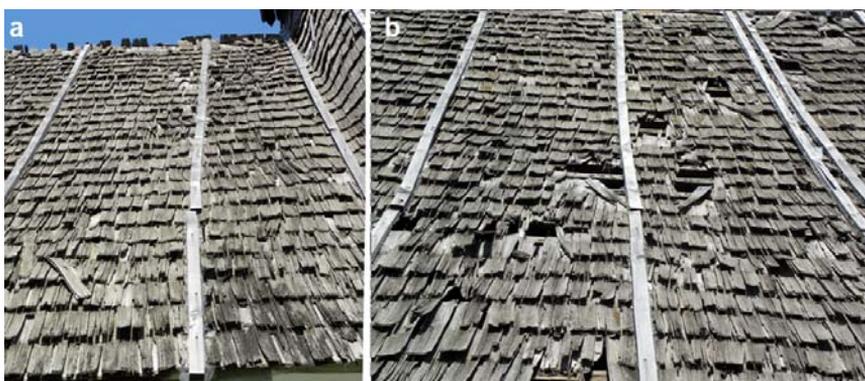
The main cause for this deteriorations and degradations is the losses of tightness of shingles cover. The roof suffered biodegradation and mechanic damages (Fig. 4.). The shingles, exposed to weathering and direct sun light were degraded, and cannot provide protection to the monument, if they are not changed in time, in 30 – 40 years [17]. We noticed the existence of lichens and fungi over the whole surface of shingles cover, especially on the north side, at the base of the bell tower, at the intersection of the porch with the narthex roof and at the level of changing of the tower roof's inclination.

Fig. 4. Damages at shingle roof from 2011: a - North side, b - South side

Emergency interventions are necessary outside for renewing the shingle roof cover. The shingle changing must be carried out with other handmade shingles from high quality wood (spruce) and respecting the traditional techniques. The outside plaster must be carried, consolidated, completed and blanched. The basement has to be rebuilt with stone, above the ground without filler.

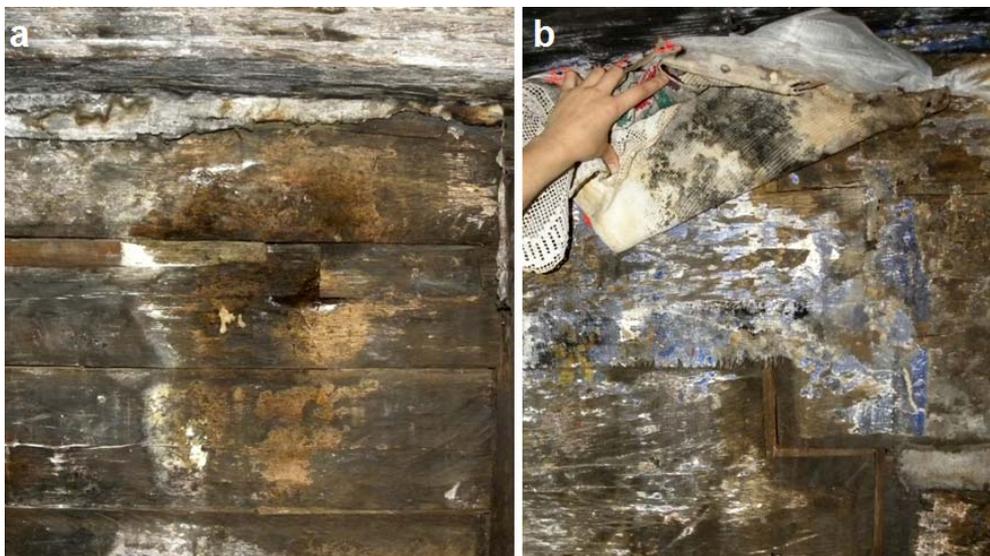
We can observe from these averages that the humidity from the infiltration and upward water are present inside the monument especially in the covered areas, where the low ventilation cannot dry it enough. Where the humidity was bigger than 14%, we found fungi attack under covered areas (Fig. 5a). Where the humidity was bigger than 18%, we found rot (Fig. 5b).

Fig. 5. Biodegradation of beams: a - North wall in narthex, under a towel, b - South wall in nave, under an icon

Inside, at the boards' floor insecticide treatments, water isolation between the ground and the boards by free spaces or with aggregate are required. The wall beams need insecticide and fungicides treatments, but we must be careful with the effects on the mechanical and chemical properties and their visual appearance on the wood and the painting [7].

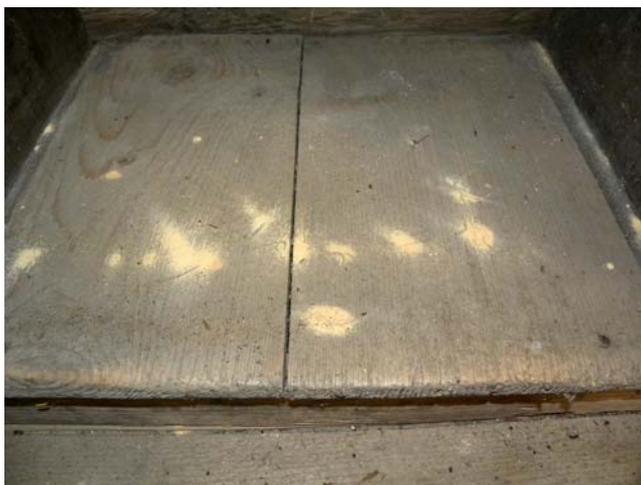
Advanced attacks of *Anobium punctatum* are very frequent at boarded floors, ceilings, arches, furniture and elements of iconostas all over the church. At wooden churches they appear also on the painted walls and they prefer the areas under the interstitial cloths with glue residues [18]. We observed at Boz wooden church an active attack of beetles, *Anobium Punctatum* at the boards' floor (which is partially covered with carpets) (Fig. 6.). The oak wood present fewer insects attacks than the fir boards (this attack is also active).

Fig. 6. – *Anobium punctatum* attack on boards' floor

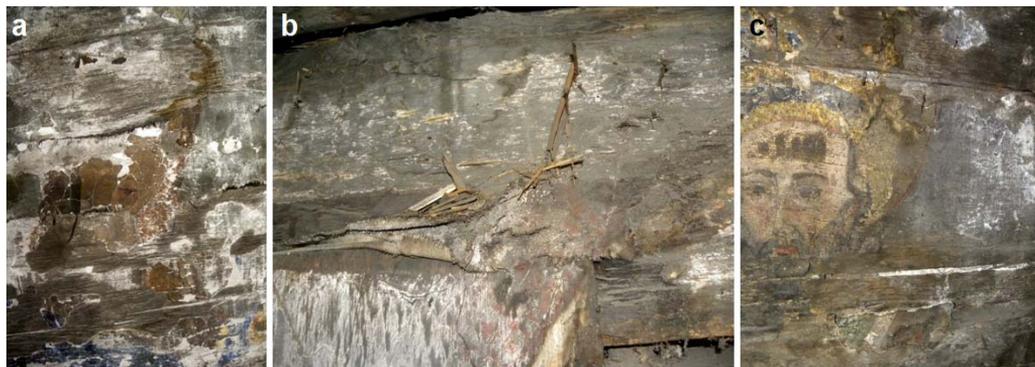
The interior paint is in an advanced state of degradation and deterioration, with considerable losses. All painting layers have washed part and dirt stains on preserved painting. On the narthex ceiling, on the nave and altar arches, on all walls there is moisture halos and stains, washing, losses, flaking, cracks, breakings out, attenuation and very fragile paint layers of a considerable surfaces, the main cause being the infiltrations (Fig. 7.). The most exposed parts are the upper areas of the walls and the bases of the arches (Fig. 7b). Another major cause with negative influence on the paintings is the insufficient ventilation of the entire space.

The entire painting is covered with smoke, dust, dirt, spider cloths, deposits of plants and insects scraps, sand, etc. Most of the interstitial canvases are lost. Those that have been preserved are fragile, rigid and present rot, breakings and rags.

Fig. 7. Degradation of paintings layers and interstitial canvases: a - Narthex, b - nave, c - altar

Regarding the interior painting, emergency interventions for the consolidation and preservation of the painting layers, wooden support and interstitial canvases (insect and fungi treatments, prophylactic consolidation of painting layers, consolidation of wood, gluing of interstitial canvases, removing of all unconstitutional objects) are prescribed and in the near future the restoration of entire painting. We want to point out the fact that all intervention has to start after the preventive conservation of the painting layers. The icons, tetrapodes, rush holders and other valuable objects must be soon included in a conservation, preservation and restoration process.

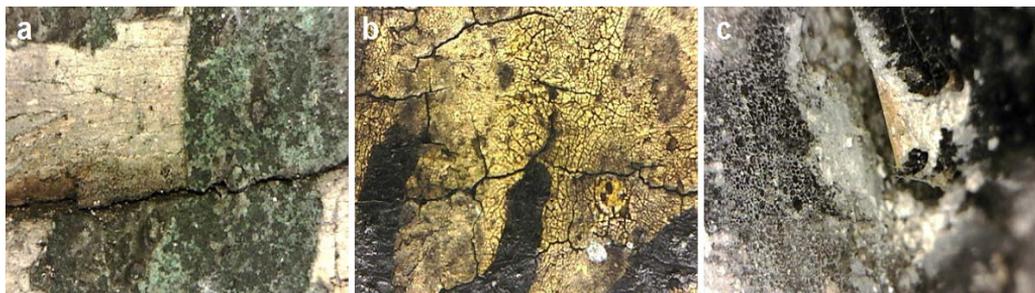
The wood panels of the icons and icon supports are deteriorated as a result of beetles attack, functional used, covering with towels and rugs. These present flaking, breakings, wears, losses, dirt, smoke, oil varnish crusts (Fig. 8.). On the front of the icons we observed many interventions with repainting of the faces of saints and of the lost parts (Fig. 9.).

Fig. 8. Macro photos at painting layers: a - wall painting, b - icon, c - icon support

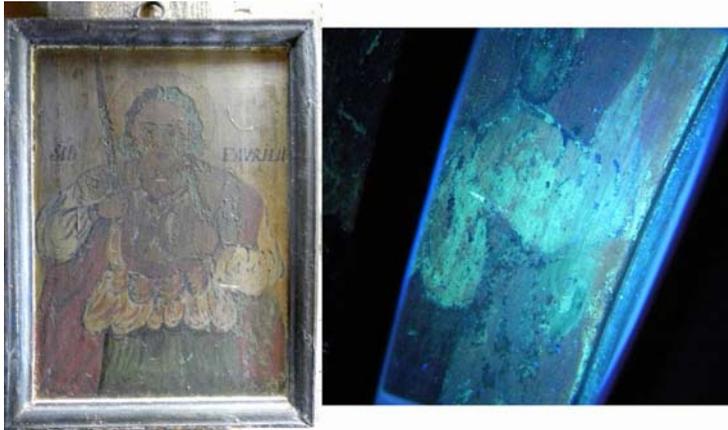
Fig 9. Detail of repaint area on St. Mikhail icon – using a UV lamp
