RESTORATION AND PRESERVATION OF ARTISTIC ELEMENTS APPLIED ON ISLAMIC ARCHITECTURAL FAÇADE OF SHAHIN AGHA SEBIL, CAIRO, EGYPT

Nabil A. Abd El-Tawab BADER^{1*}, ANWER F. MAHRAN²

¹ Conservation Department, Faculty of Archaeology, South Valley University, Qena, Egypt.

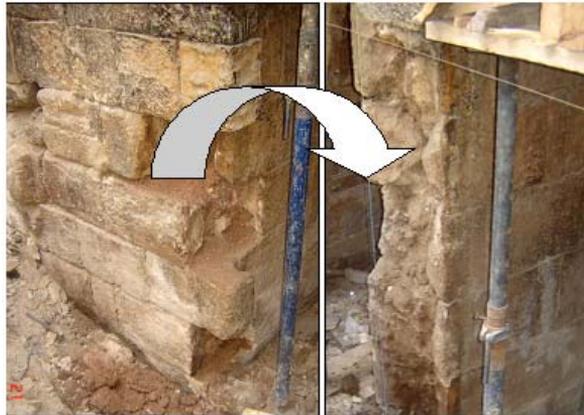
external stone block leaves with a void of varying thickness between them. The space between the two external leaves was filled with a loose low strength materials made of pieces of stone and mortar (Fig. 3). The thickness of the wall varies in the range of 450–600 mm. The artistic elements (Fig. 2) on the façade of Shahin Agha Sebil have suffered severe effects, some of them being collapsed (totally or partially) and several damage patterns were observed. The aim of this current work is to study and evaluate the current state of the stone façade of Shahin Agha Sebil, and to study the façade materials in order to identify its components and introduce a scientific study for its architectural and fine treatment.

Fig. 3. The facade wall assembly consists of a bearing limestone wall (Multiple-leaf walls)

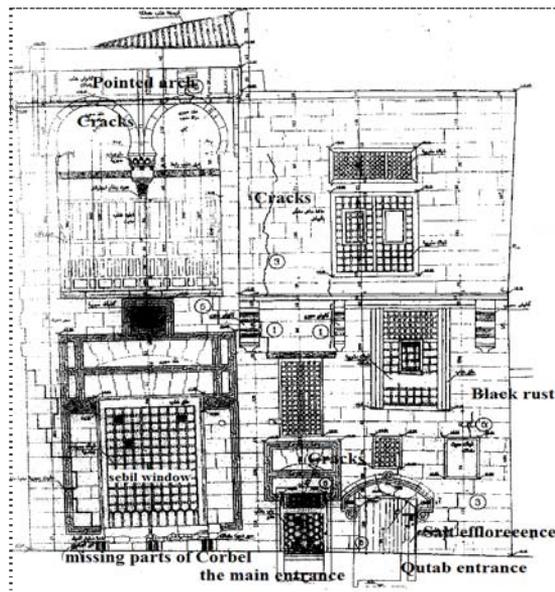
Detailed survey of stone decay phenomena was carried out on the façade of Sebil in order to establish the typology, causes and processes of the major weathering forms observed. Several weathering forms were identified and recorded at the plane of the façade (fig.4).

Fig. 4. The plan of the façade of Shahin Agha Sebil shows the missing parts and cracks.

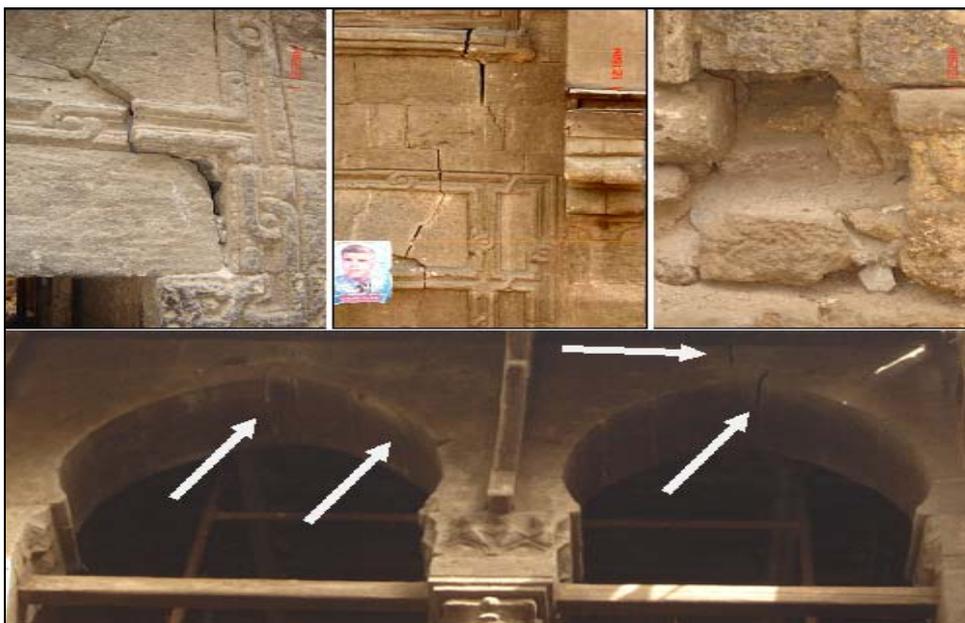
The façade of Sebil shows some clear indications of yielding cracks and partial collapse at several locations as a result of the physiochemical and architectural effects of deterioration factors. The structural damage is represented by walls cracking, stone surface decay, partial collapse of some parts of the wall and rock disintegration especially noted at lowest parts and mass wasting from architecture elements of the façade. Most of current damage conditions of the facade are mainly due to the earthquake, which occurred on October 1992. Almost all the causes of damage and deterioration appeared on the facade are related to the problems that affect the multiple leaf masonry walls. Also, Age of the building, it had survived for nearly 350 years' time-stresses effect on construction materials, lack of maintenance during its service life, loss of mechanical characteristics of the walls at foundation level due to moderate aggressive environment (ground water and soil) [2]. So, many vertical, diagonal and fine cracks in the walls were noticed as shown in Fig.5, which led to dangerous deterioration in the architectural elements like arches, gifts and threshold. More cracks were found at top of the façade. The cracks at top of facade and at the end of facade are indicating thermal movements. Vertical cracks generally indicate poorly bonded material or material that has lost its cohesion and is therefore weak. Diagonal cracks indicate failure of shear, due to ground settlement or subsidence, shear cracks may combine with thermal cracks. Crack wider at bottom-ground may be sliding horizontally as well. Fine cracks also appeared due to wind and salt crystallization [3].

Fig. 5. Examples of cracks, deformation of architectural and artistic elements at the facade of Shahin Agha Sebil.

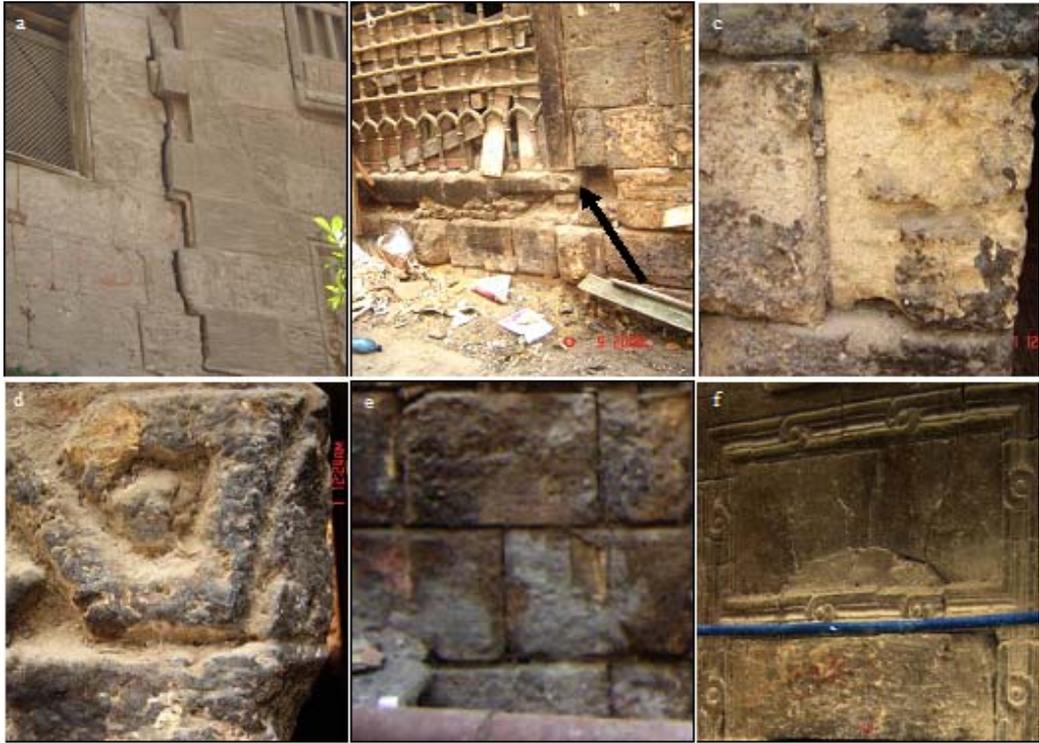
Sebil façade has deformation, buckling, leaning and brittle with loss of stiffness in the structure elements (Fig.6). Serious internal stress and vertical loads are the main cause of damage or collapse of structure (cracking, deformations, leaning, crushing, etc.). Also, the movement of core material may also be a source of new stresses, thus making the faces unstable, according to Drysdale et al [4]. Deformations may not only result from taking uploads, but from seasonal changes in temperature or internal heating, from changes in moisture content of materials and from differential settlements, movements of the ground or alterations to the structure that introduce a new pattern of equilibrium [3].

Fig. 6. Photograph of decay features common at Sebil facade **a** - buckling and leaning, **b** - deformation, brittle failure with loss of stiffness in the structure elements of the façade (lost cantilever (Corbel), **c** - Scars of flaking, **d** - hard crust and scars of flaking **e**-Efflorescence's to light-colored crust tracing the surface, **f** - soiling by particles from the pollution.

Rising contaminated ground water table caused many problems for the foundations of the Sebil walls, leading to uneven settlements of the foundations and structure. Cracks in a facade allow water to penetrate into the assembly thereby increasing its moisture stress and deterioration. The groundwater provides a constant source of moisture that seeps into Sebil site by capillary action up into the façade wall. Cairo City has been constructed on hills and low-lying areas frequently affected by flooding sewage water, which then degrades the Islamic Historical buildings. Also, they have been flooded by lakes and canal water; e.g., the former Egyptian canal. This water has had varying effects on the foundations and walls of the Islamic monuments [5]. The main of stone deterioration of the Sebil façade results from combination of raised groundwater level and the capillary transport of salt laden water due to the actual level of humidity and its continuous mechanism. Sewage water plays a major role in the formation of halite, either on the stone surface or in its pore system. The pressure of salt crystallization enhances the growth and development of micro and macro fractures and consequently leads to granular disintegration, scales, spalling, flaking prevail inside and breaks up stone surface and also decrease the overall strength of the stone especially in the lower parts of the walls. White salt efflorescence and yellowish brown iron staining can be noted in many points (Fig. 6d-e). The precipitation and growth of halite (NaCl) on stone surfaces and in pore systems is due to the seepage of underground water and it is widely observed in our study of the artistic elements of Shain Agha façade. NaCl is able, by a process of hydration and dehydration, to promote the disintegration of surfaces by its action on other salts. So a lot of stone blocks have seriously lost their internal cohesion and resistance and a big percentage of these stone become powdered,

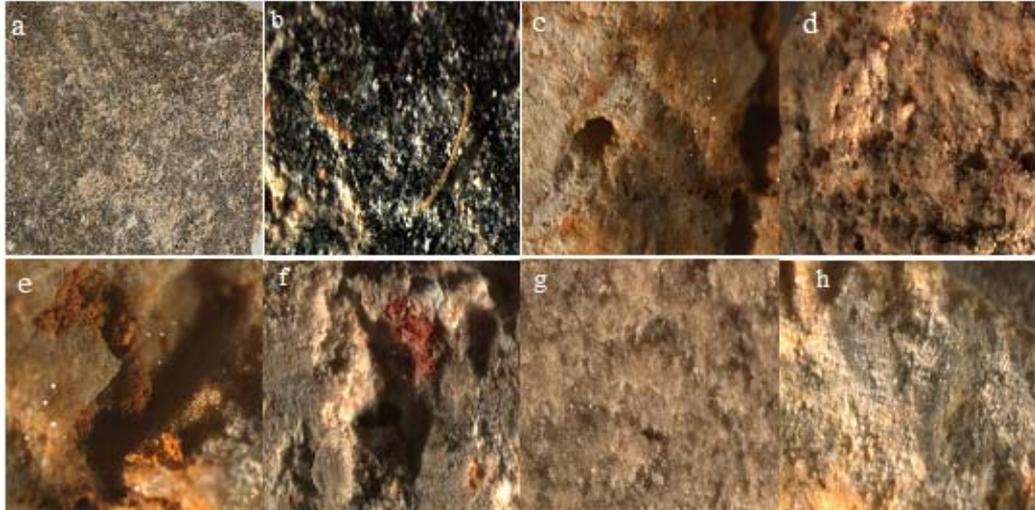
Optical microscopy revealed a wide range of deterioration features as shown in (Fig. 7a-h). Dust, smoke on the surface of calcite grains, eroded pits, cavities, loss of internal cohesion, efflorescence salts and the presence of some iron oxide (limonite and hematite) were noticed.

Fig. 7. Micrograph of investigated samples by LOM **a-** dusting form covering all stone surface **b-** smoking in outer surface of limestone **c-** eroded pits **d,e** cavities, voids and iron oxide as limonite **f** cavities and hematite, **g** loss of internal cohesion, **h** efflorescence salts.

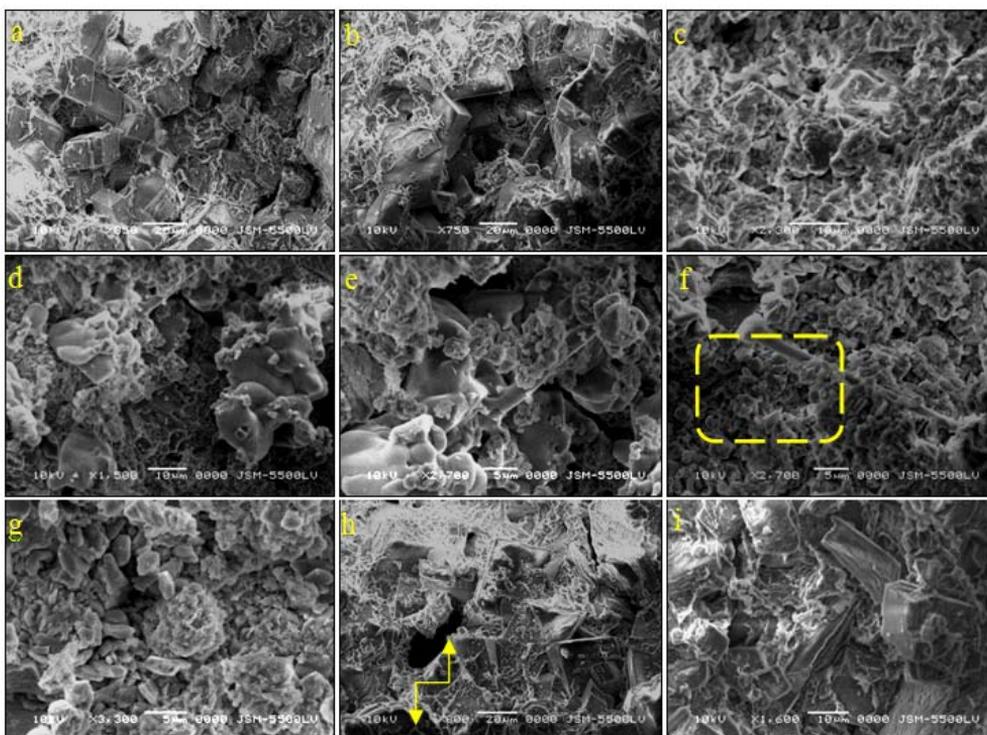
The obtained results showed that there is a wide range of deterioration features in the samples. Microscopic investigation revealed dissolution of cements occurred on the limestone, which lead to an increase in porosity (Fig. 9a-b). Moreover, the physical structure of stone has seriously collapsed and most stones became fragile and lost their cohesion (Fig. 9c). The SEM investigation showed that the soluble salts deeply move into the stone and destroyed their mineral constituents, the calcite crystals being seriously deformed and they have lost their original crystalline form (Fig. 9d, m, e). Sodium chloride in long and needle form and calcium sulphate were found between calcite crystals and the other mineral constituents of stone (Fig. 9f,g and h). Also, the study showed eroded pits, small fissures, micro cracks, dusting, splitting and micro exfoliation and cavities (Fig. 9i). The SEM investigation of the mortar samples which were taken from between stone blocks in the Sebil façade showed that two kinds of mortar were used: lime mortar, which consists of calcite and sand (Fig. 10a-b) and gypsum mortar (Fig. 10c). SEM photomicrographs showed the collapse of internal structure, voids, loose of binding material and NaCl salts crystallization between mineral grains. NaCl precipitation caused a considerable increase in the porosity of the building stone, increase of cavity and pore sizes, increase production and acceleration of micro fracture growth in the surface of the lime mortars and stones due to crystal pressure, and acceleration of the rate of stone exfoliation.

Fig. 9. SEM images: **a, b and c** - dissolution of cements and loss of cohesion between calcite crystals, **d, e** – porous crystalline salts, **f** - crystalline salts are long and then needle form, **g**- sulphide salts, **h and i** - splitting and exfoliation.

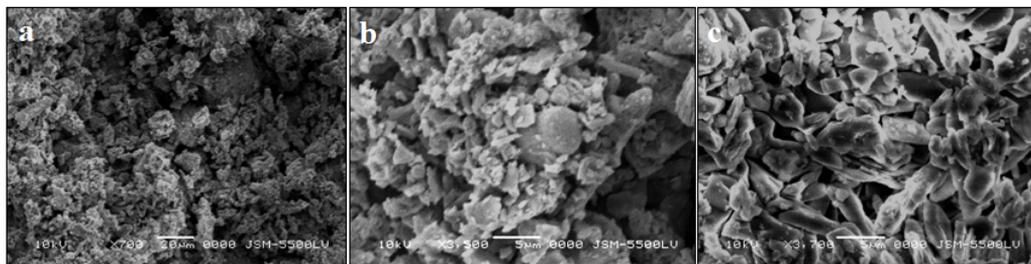
Fig. 10. SEM photomicrographs of mortar sample showing the collapse of internal structure, voids, loose of binding material and salts crystallization between minerals grains.
