STRUCTURAL DAMAGE ASSESSMENT OF HISTORIC TRADITIONAL MASONRY BUILDINGS: A CASE STUDY

Abstract

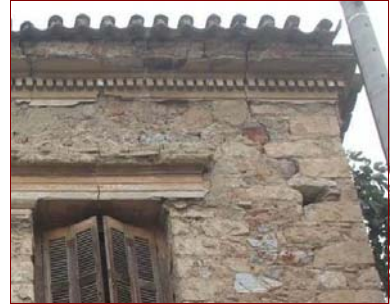
More specifically, Fig. 8 shows the vertical splitting that occurred near or at the joint of intersecting walls, whereas the lack of bracing tying together the individual trusses of the roof at their support in the wall recesses allowed excessive out-of-plane displacement under horizontal actions, which led to near vertical cracking at the top edge (crowning) of the wall (see Fig. 9). In-plane horizontal actions appear to be the cause of the inclined cracking shown in Figs 10 and 11. Such cracking often initiates at the corners of openings (windows and doors) due to the stress concentrations developing at such locations (see Fig. 11).

Fig. 9. Vertical cracking at to edge (crowning) of the façade of the building

From Figs 13 to 16, it can be seen that the most critical cracking develops when the horizontal load acts in the y-direction. Fig. 13 shows that the most critical locations of the cracking are expected to be on either of the side regions of the top edge of wall 1 (façade in Aktaiou Street); in fact, at the right-hand side region cracking is predicted to occur at the joint of wall 1 with wall 3. Cracking is also predicted to occur at the bottom corners of the main entrance in Aktaiou Street. Cracking similar to that of wall 1 is predicted to be suffered by walls 5 and 6 (walls parallel to wall 1, see Fig. 3). As for the case of wall 1, they are predicted to occur on either side of the top edge of the walls, as well as at the bottom corners of the doors (see Fig. 14).

Bracing can be achieved through the casting of a reinforced-concrete (RC) layer at the wall crowning that will form the support of the roof which will be replaced with a new one with the geometric characteristics of the old. Moreover, the timber beams of the 1st level floor will be strengthened (or replaced wherever necessary) and anchored with metal rods penetrating the walls and forming anchors at their external side. Bracing in the form of external and internal RC strips at the level of the basement floor is also proposed.

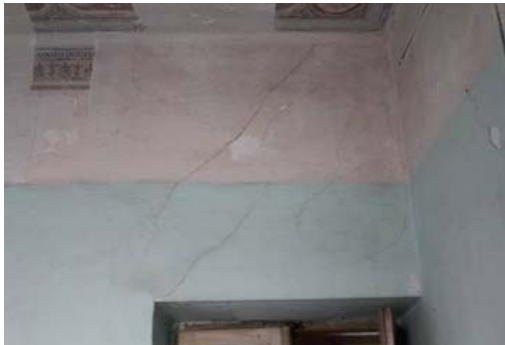
Fig. 10. Inclined splitting of masonry wall

However, as discussed in the preceding section, in spite of the above modifications, the development of tensile stresses larger than the tensile strength of concrete cannot be prevented in localized regions of the walls. In such locations cracking may be minimized, or even prevented, if the tensile strength of the masonry is improved. The latter can be achieved through grouting that will also restore the continuity of the masonry which was disrupted by the

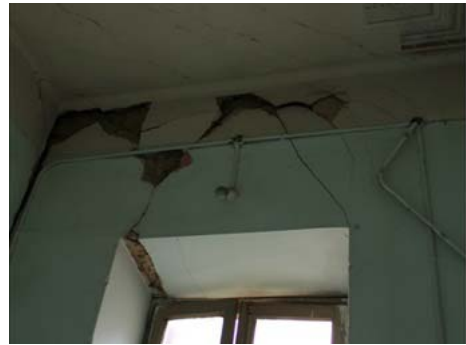
Fig. 11. Cracking at openings' corners

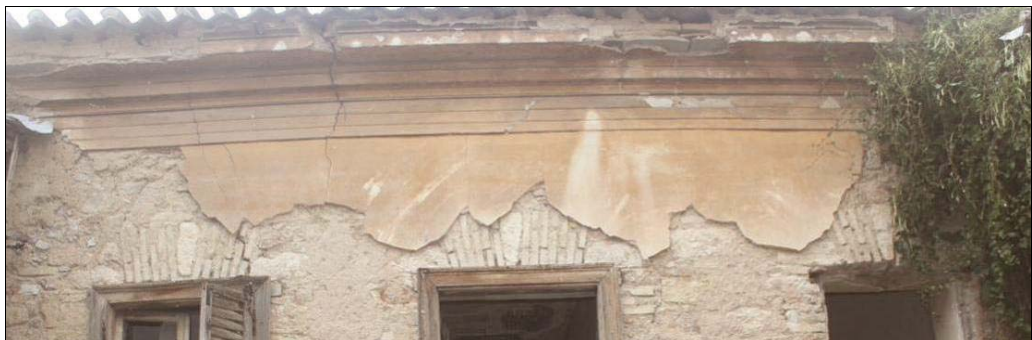
It is also important to note that the loss of the plastering of many of the walls (see, for example, Fig. 12) revealed fragmentation (bleeding) of the mortar used to bind together the stones of the masonry. This is considered to weaken considerably the structural system not only in terms of strength, but also in terms durability, since it reduces the stability of the walls in future seismic excitations.

Fig. 12. Loss of plaster revealing mortar fragmentation (bleeding)

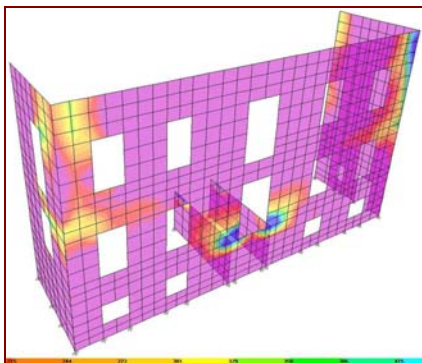
Fig. 13. Tensile stresses (in kN/m^2) exceeding the tensile strength of masonry developing at the wall crowning under seismic action in the y-direction (orthogonally to Aktaiou Street)

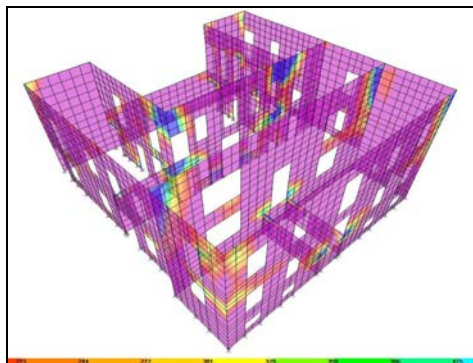
Fig. 14. Tensile stresses (in kN/m^2) exceeding the tensile strength of masonry developing in the region of the wall intersections under seismic action in the y-direction (orthogonally to Aktaiou Street)

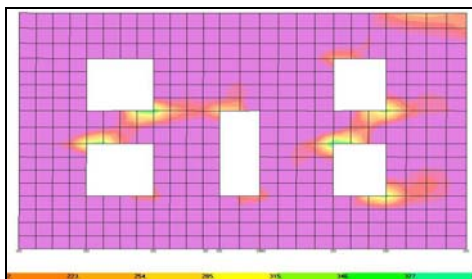
Fig. 15. Tensile stresses (in kN/m^2) exceeding the tensile strength of masonry developing in the region of the openings of a typical internal wall in the x-direction (i.e. parallel to Aktaiou Street)

Under seismic excitation in the x-direction, the internal walls are found likely to suffer cracking in the region of the diametrically opposite corners of door and windows; in fact Fig. 15 shows that the largest tensile stresses develop at such locations of the door and windows to the backyard of the building enclosed by walls 6, 4, 7 and 8. Moreover, Fig. 16 shows that seismic excitation orthogonal to walls 1, 5 and 6 causes out-of-plane displacement of the walls in the form of bending of their top edge (due to insufficient roof diaphragm) and, therefore, tensile stresses at mid-length which are likely to cause flexural cracking.

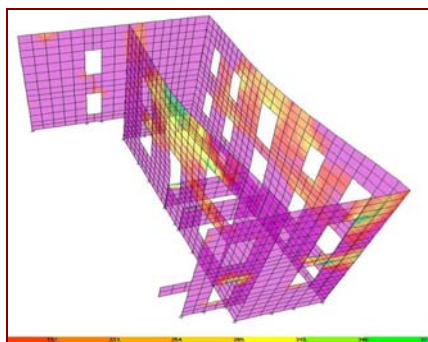
Fig. 16. Deformed shape and related tensile stresses exceeding the tensile strength of masonry (in kN/mm^2) under the combined action of the service load and seismic excitation in the y-direction (orthogonally to Aktaiou Street)

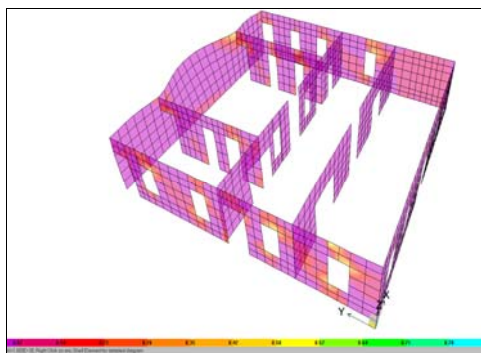
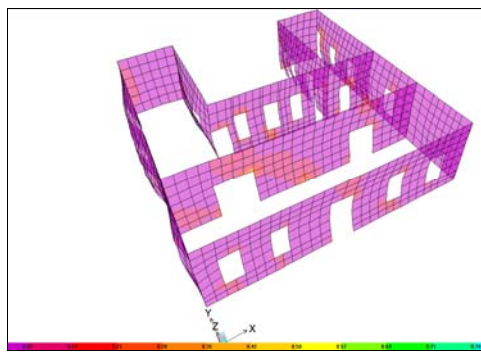
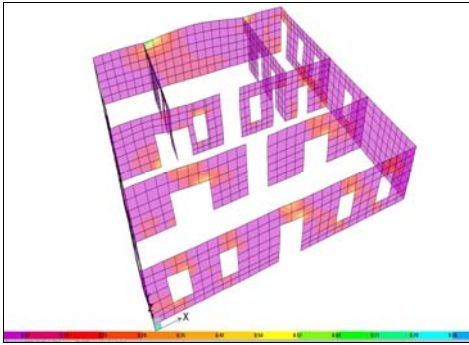
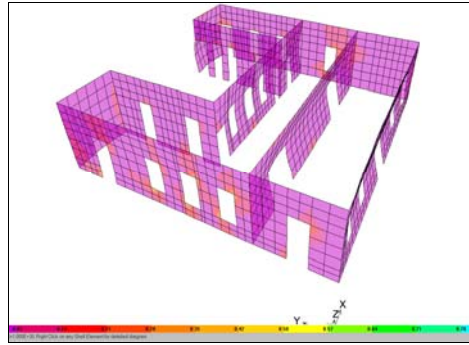
Fig. 17. Deformed shape and distribution of principal tensile stresses (in MPa) exceeding the tensile strength of the masonry of the walls of the first floor of the building under seismic excitation in the y-direction

Fig. 18. Deformed shape and distribution of principal tensile stresses (in MPa) exceeding the tensile strength of the masonry of the walls of the first floor of the building under seismic excitation in the x-direction (ACC3)

Fig. 19. Deformed shape and distribution of principal tensile stresses (in MPa) exceeding the tensile strength of the masonry of the walls of the basement of the building under seismic excitation in the y-direction (ACC5)

Fig. 20. Deformed shape and distribution of principal tensile stresses (in MPa) exceeding the tensile strength of the masonry of the walls of the basement of the building under seismic excitation in the x-direction (ACC3)

From Figs 17 to 20, it can be seen that allowing for diaphragmatic action at the levels of the floors and roof leads to a significant reduction of not only the values of the principal tensile stresses developing in the masonry walls, but also of the locations at which these values are larger than the tensile strength of masonry. In fact, diaphragmatic action is found to reduce the out-of-plane displacements of the walls to such an extent that cracking as a result of such displacement seems unlikely. Moreover, since allowing for diaphragm action also causes conditions of bracing at the levels of the floors and roof, the values of the tensile stresses developing at these locations due to the lack of bracing (see Figs 13 to 16) reduce well below the tensile strength of masonry.

Tensile stresses exceeding the masonry strength are found to develop at the diametrically opposite corners of the openings (doors and windows) (see Figs 17 to 20); smaller tensile stresses are also found to develop diagonally within the walls under the action of in-plane horizontal loading. It should be noted, however, that, in spite of the development of tensile stresses exceeding the masonry strength at localized regions, the structural system of the building is found capable of withstanding the actions specified by current codes for the design of earthquake-resistant structures (see Figs 21 and 22). Nevertheless, the interventions proposed in the following section are intended to minimize the likelihood of cracking that will violate the code requirements under both service and ultimate limit-state conditions.

As regards safeguarding diaphragm action at the level of the roof support, this is achieved through the use of diagonally arranged steel elements, whereas at the 1st level it is considered sufficient to stiffen the timber floor with two layers of cross-crossing plywood. Finally, at the basement diaphragm action is safeguarded by replacing the timber floor with an RC slab 25 mm thick.

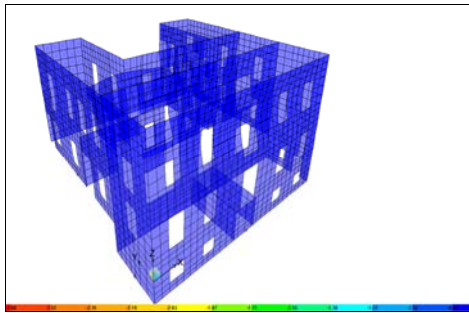
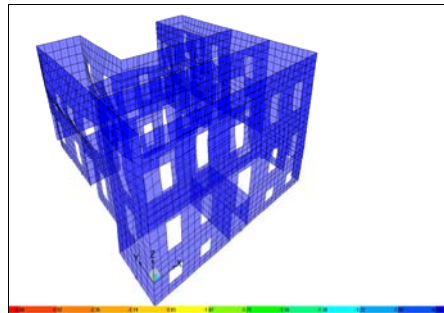
Fig. 21. Deformed shape and distribution of principal compressive stresses (in MPa) exceeding the compressive strength of the masonry walls of the building under seismic excitation in the x-direction (ACC3)

Fig. 22. Deformed shape and distribution of principal compressive stresses (in MPa) exceeding the compressive strength of the masonry walls of the building under seismic excitation in the y-direction (ACC5)
