INTERDISCIPLINARY STUDIES OF THE “VISTA DO DESTERRO” PAINTING: HISTORICAL APPROACH, ANALYSIS OF MATERIALS AND PRESERVATION/RESTORATION TECHNIQUES

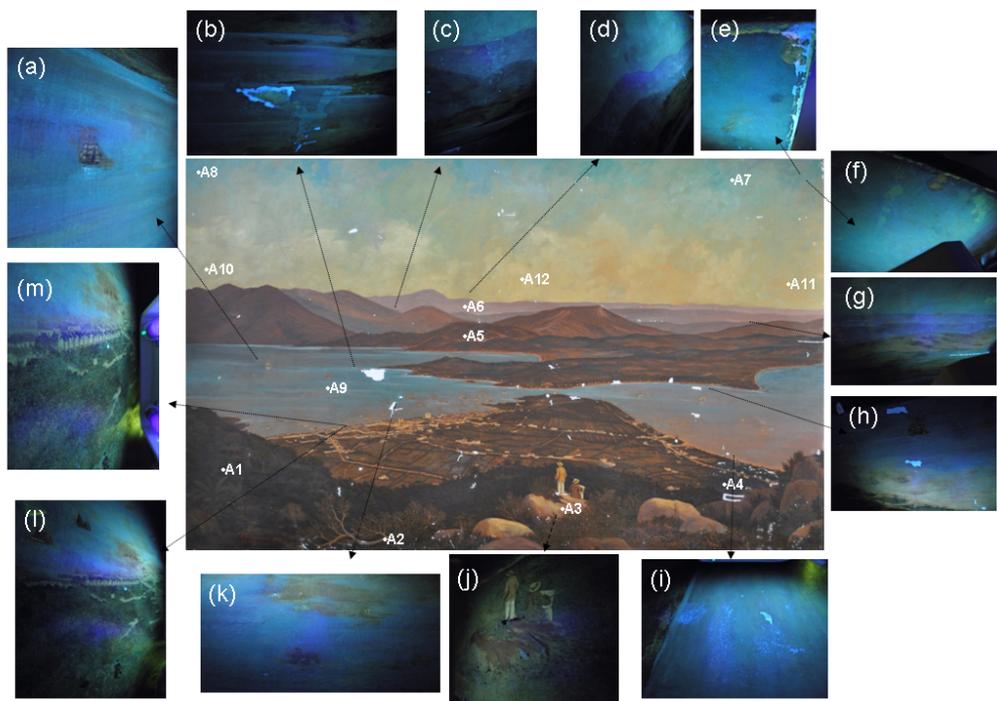
Fig. 1. Visible light photography showing the painting *Vista do Desterro* at the center, and UV photos revealing the interventions made

Figure 1 shows several areas that have materials with fluorescent characteristics. Figure 1a and b show a darker and lighter blue region, typical of ultramarine pigments ($\text{Na}_{8-10}\text{Al}_6\text{Si}_6\text{O}_{24}\text{S}_{2-4}$) [10]. Figure 1c and d are extremely important, as they show that part of the mountain (further above) has been repainted at some point in the history of the painting, and one can clearly see that this mountain has fluorescent material. The two other parts are characteristic of older materials and use of non-fluorescent material such as red ocher ($\text{Fe}_2\text{O}_3 \cdot n\text{H}_2\text{O}$), for example, or sienna, which contain compounds made of silicates and aluminates. Figures 1e and f, just like figure 1a and b, show the presence of the same type of material, and the same color pigment reacts similarly to ultraviolet radiation. Figure 1g confirms, once again, over coating of the top of the mountain and the non-fluorescence of the material used in the other two parts. Figure 1h reveals the same bluish region present in other regions, such as figure 1i, and the underside of the painting shows, again, a non-fluorescent brown color, confirming the use of red ocher. In figure 1j, two different areas can be observed: one displaying the older non-fluorescent brown color and a possible area of reintegration. Finally, figure 1k, l and m show the same situation of the other parts, proving the use of the abovementioned materials.

Sample A6 (Fig. 1c) showed the absence of Al and also the presence of Ba and some traces of lead as a result of contamination with the older pigment. Thus, this intervention was characterized by the use of permanent white, BaSO₄, and also a brown pigment with the absence of Al, possibly ochre brown, Fe₂O₃·H₂O and clay [10], proving the intervention that was evidenced by ultraviolet imaging.

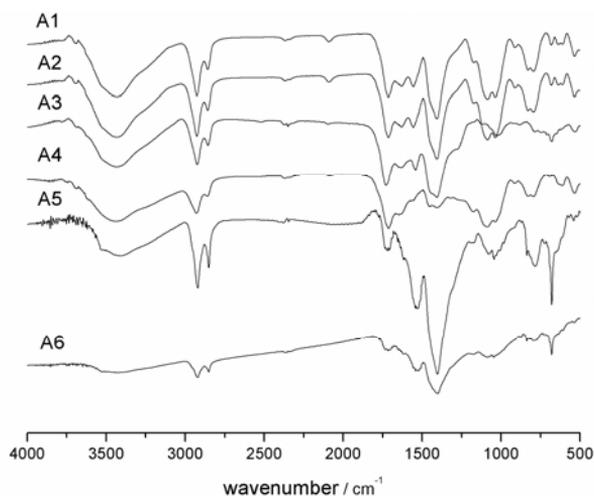
Samples between A1 and A6 are associated with brown and ochre pigments, whereas the older, supposedly original samples were identified by FTIR (Fig. 2) in bands at 1080 and 1040cm^{-1} , which could be associated with a terpenic varnish, because it presents a considerable rate of aging, making these areas yellowish [24].

Fig. 2. Infrared spectra of brown and ochre areas

Such aging is related to the exhibition of the painting in unsuitable conditions of humidity, temperature and even pollutants such as gases, sulfates, nitrates, etc. and also the proximity to the marine environment in an atmosphere rich in chlorides, especially, which can sharply accelerate degradation of the varnish. It was also possible to identify the absence of bands in the varnish in samples A3 and A6 (the stone and the third layer of the mountain respectively – Figs.1c, d and j), which is evidence of the interventions observed by UV light, whereby only the presence of pure paint can be seen, without the subsequent application of a layer of varnish. The analysis of these layers by EDS (Fig. 3) was crucial to determine the pigments used, and in all older areas, lead white - $2\text{PbCO}_3 \cdot \text{Pb(OH)}_2$ - was identified as a basic compound of the coating primer used by the painter and elements such as Fe, Si and Al, typical of natural sienna, $\text{Fe}_2\text{O}_3 \cdot n\text{H}_2\text{O}$, Al_2O_3 and silicates, were identified in the pigment used in areas A1, A2 and A5, characterized as being possibly original.

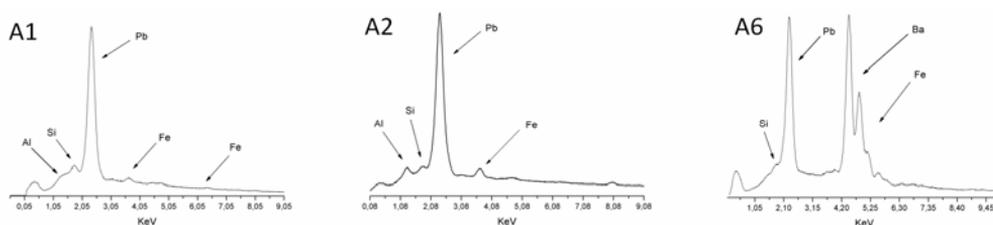
Fig. 3. EDX spectra of the brown and ochre pigments

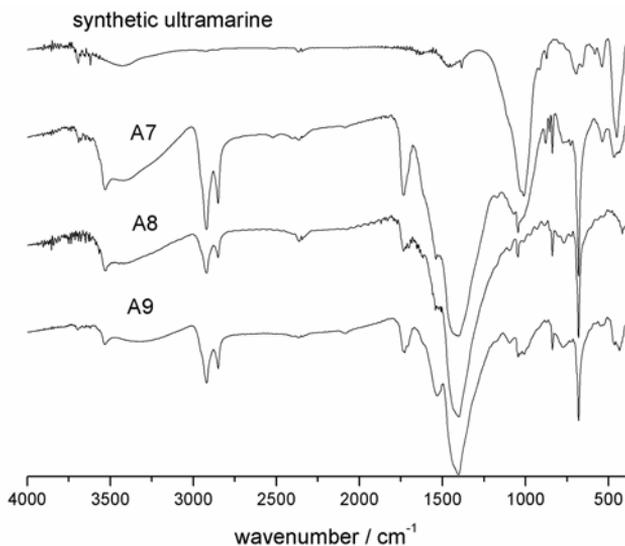
Samples A7, A8 and A9 refer to blue pigments which were also mixed with lead white when applied, at the FTIR spectra (Fig. 4) of the three samples. It is possible to notice a sharp signal at 1041cm⁻¹ which refers to the ν Si-O-Si stretch, characterizing the ultramarine blue pigment [24]. The absence of the band at 2341cm⁻¹ was also noted, confirming that the pigments used are synthetic and consistent with the date of the nineteenth century [25]. Natural ultramarine blue was traditionally obtained from the mineral lapis lazuli with a complex process of selective extraction of blue particles, as reported in the literature [26]. On the other hand, it had already become available as a synthetic pigment by 1830 [27]. The FT-IR spectrum is used to differentiate between natural lapis lazuli and synthetic ultramarine. It was reported that the FT-IR spectra of natural ultramarine blue samples from Afghanistan showed a narrow at band 2341cm⁻¹, which was absent in the spectra of synthetic pigments.

Fig. 4. Infrared spectra of the blue areas and synthetic ultramarine standard

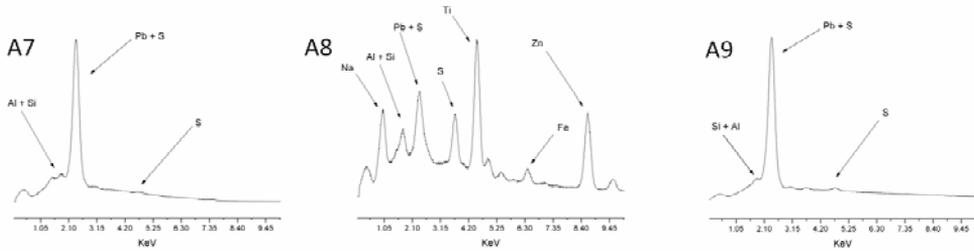
EDS analysis (Fig. 5) shows, in both samples, the elements Na, Al, S and Si, confirming the pigment used - Na₈₋₁₀Al₆Si₆O₂₄S₂₋₄ - as revealed by FTIR and ultraviolet photography. However, Ti was identified in sample A8, and associated with the white pigment titanium oxide, TiO₂, which began to be used only in the twentieth century and, thus, characterizes an intervention area. It is a different base pigment from the one used in interventions in the areas of the brown pigment, so it can be concluded that the painting had two interventions, one perhaps back in the nineteenth century and the other in the twentieth century. Another method for verification of synthetic ultramarine is the ratio between Si and Al atoms which is between 0.60 - 0.80 [28]. In the semi quantitative analysis, the weight ratio Al/Si was 0.66, 0.59 and 0.81 for samples A7, A8 and A9, respectively. The values were at the upper and lower limits, and this may be due to the limitations of the technique; nevertheless, it is a simple and effective means of proving the use of this synthetic pigment.

Fig. 5. EDX spectra of the blue areas

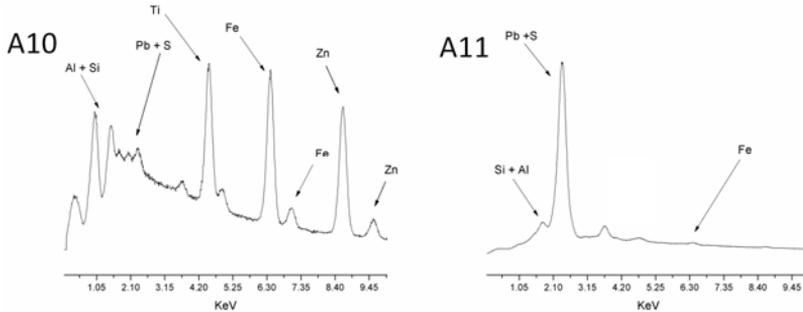
The yellow pigments present in the sky are characteristic of samples A10, A11 and A12. EDS spectra (Fig. 6) of sample A10 had the elements Al, Zn, Fe and Ti, featuring another intervention area, with the use of the pigments yellow ocher, titanium oxide and zinc white, possibly, since the absence of chrome rules out the possibility of zinc yellow and the typical IR bands (Fig. 7) showed only traces of terpenic varnish.

Fig. 6. EDX spectra of the yellow areas

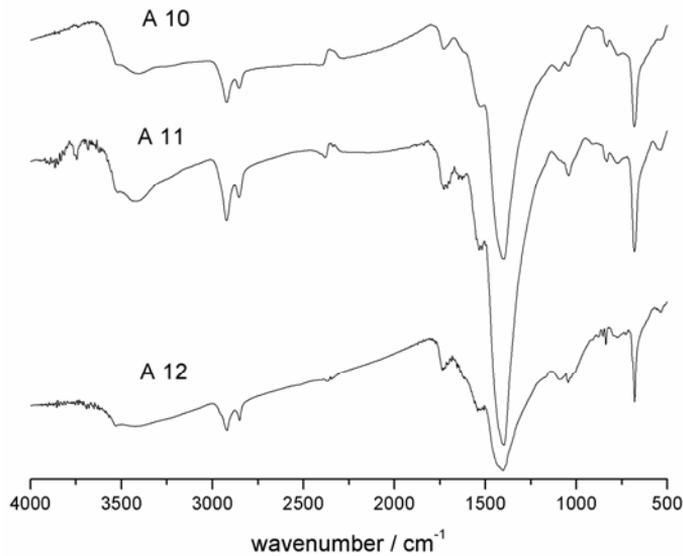
Fig. 7. Infrared spectra of the yellow areas

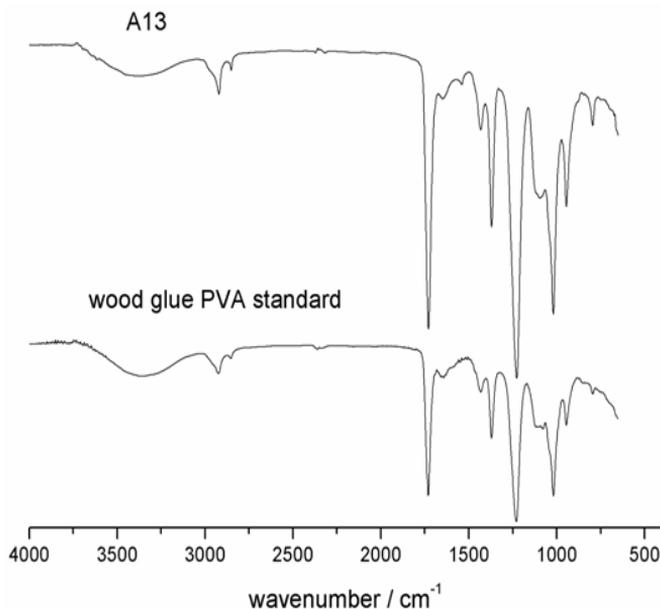
On the back of the painting, a process known as relining¹ was identified. It is an ancient and common restoration practice which strengthens the canvas with the original pictorial layer in areas with problems of degradation. The glue used in this process was collected, sample A13, and the result of FTIR (Fig. 8) showed mild features at 3379cm^{-1} referring to νOH and 1729cm^{-1} stretches assigned to $\nu\text{C}=\text{O}$.

Fig. 8. Infrared spectra of the glue found in the relining process as well as of the standard PVA wood glue

These spectra were evidence that standard wood glue could have been used. To prove this, a standard of type of glue was used in this study, proving that the type of glue used in this case was really standard wood glue. This investigation proves the second intervention abovementioned, because this type of glue got into use around 1915; this intervention may be associated with the last intervention to the painting because of the same material found as the basis for the paints (titanium white) dates from that time, as well.
