A CONTRIBUTION TO THE CONSERVATION OF 20TH CENTURY ARCHITECTURAL HERITAGE IN KHEDIVAL CAIRO

This paper discusses the restoration works carried out to save a balcony in a historic building dating back to the beginning of the 20th c. The corrosion of the steel beams carrying the balcony resulted in severe problems and the decorative units at the balcony bottom were detached. An intervention was carried out in which the steel beams were cleaned from corrosion products and strengthened using newly added plates. As well, the decorative units were restored. For revealing the adequacy of the intervention, a static loading test was carried out. The interventions presented here represent a good example that could be applied to many other similar balconies widely found in Khedivial Cairo, in specific, and other similar floors made of steel beams and concrete.

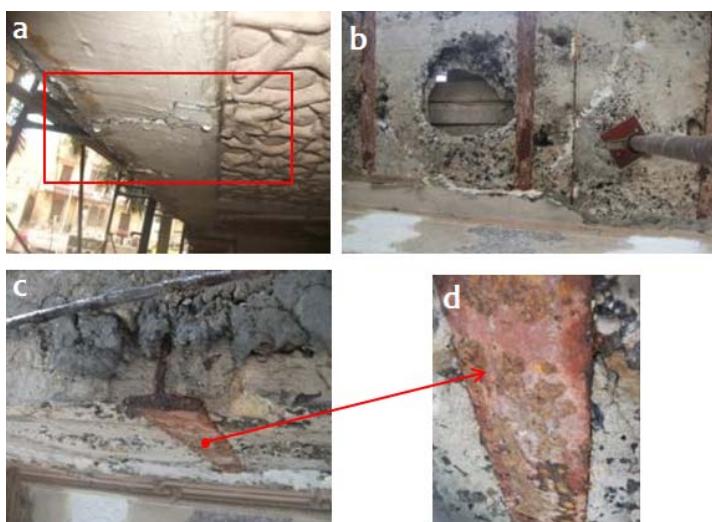
The air-conditioning unit installed in the balcony was the main source of the problems and the observed damage. The leaked water from the air-conditioning (Fig. 3a) infiltrated in the balcony's floor and resulted in series corrosion problems in the steel beams (Fig. 3b, c and d) and the steel bars used to reinforce the decorative units (Fig. 6).

Fig. 3. Damage of the balcony floor: a. Source of damage: leaked water from air condition infiltrated to the balcony bottom; b. Losing of some parts of the floor and corrosion of beams; c. Zoom to a corroded beam; d. A zoom to the beam bottom flange showing the severe corrosion

- 1) Supporting the balcony using lightweight scaffolding;
- 2) Dismantling of the decorative units from the balcony bottom (Fig. 15a);
- 3) Removing the old tiles from the balcony top (Fig. 15b);
- 4) Cleaning the top and the bottom flanges of the steel beams from corrosion products and dust;
- 5) Strengthening of the steel beams by adding steel plates of thickness 4mm perpendicular to the top and the bottom flanges and then connecting all the beams using steel plates of thickness 4mm from top and bottom (Fig. 15c and d and Fig. 16);
- 6) Filling the missed parts of the concrete floor using new concrete;
- 7) Adding flooring layers: steel mesh (Fig. 15e); cement mortar (Fig. 15f); water insulation (Fig. 15g); sand, cement mortar and ceramic tiles (Fig 15h), see also Figure 16.

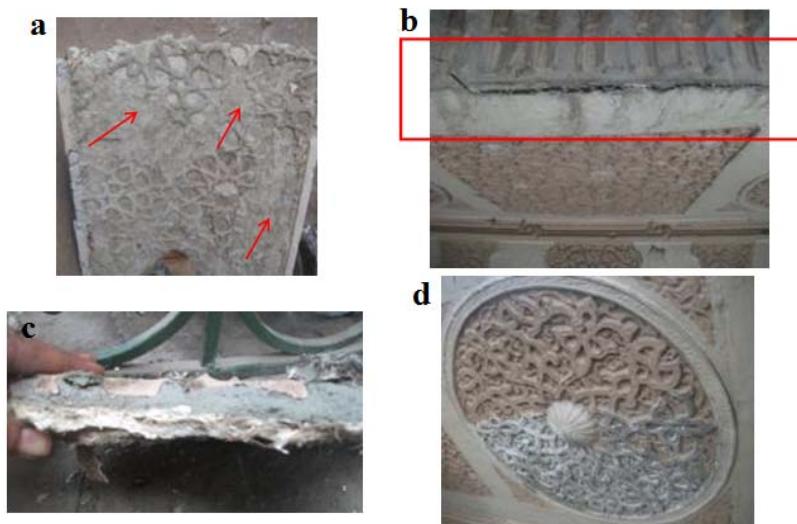
In addition, a narrow crack developed between the parapet and the balcony floor due to the deflection of the steel beams (Fig. 4b).

The decorative units at the balcony bottom suffered from: 1) inappropriate previous interventions in which the arrangement of the decorative units was changed (Fig. 5); 2) peculiar materials, not similar to the original ones, were used in that intervention. Instead of making all the decorative units from gypsum, a mix of an internal layer of gypsum reinforced with linen and external layer of cement was used (Fig. 4c). To connect the decorative unit with the steel beams and also to reinforce it, a mild steel bar was used (Fig. 6). Peculiar paints were used on the external cement layer (Fig. 4d); 3) complete deterioration of some parts (Fig. 4a) and 4) corrosion of the steel bars used in connecting the units to the steel beams (Fig. 6). In the aforementioned intervention, the original gypsum parapets were replaced with reinforced concrete ones.

Fig. 4. Problems and damage of the decorative units: a. Disappearance of some parts; b. A crack between the parapet and the decorative units; c. Inappropriate materials used in previous intervention, internal layer of gypsum reinforced with linen and external layer of Portland cement; d. Using of peculiar paints

- 1) Mechanical and chemical cleaning from peculiar colors and dust;
- 2) Fixation of pieces of gauze on the decorative units (Fig. 17a) and then sheets of foam and timber under the pieces of gauze for securing during dismantling process;
- 3) Dismantling of the decorative units (Fig. 17b) and then saving them in boxes;
- 4) Reproduction of the missed units using polyester molds created based on existing complete units found on other non-deteriorated decorative units in other balconies (Fig. 17c and d);

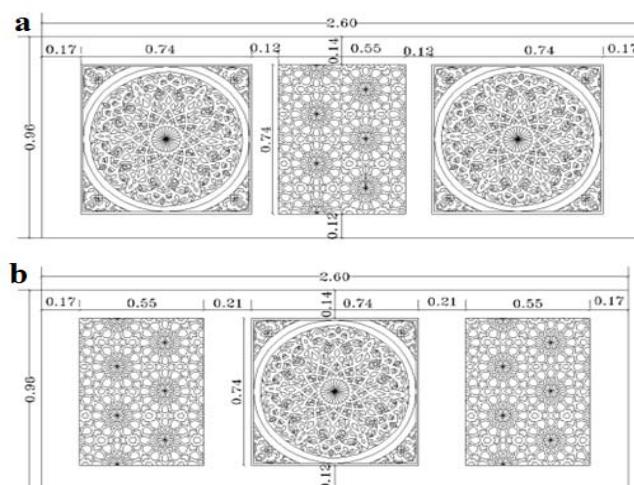
Fig. 5. The found arrangement of decorative units at the balcony bottom (a), and the correct arrangement (b) (dimensions in meters)

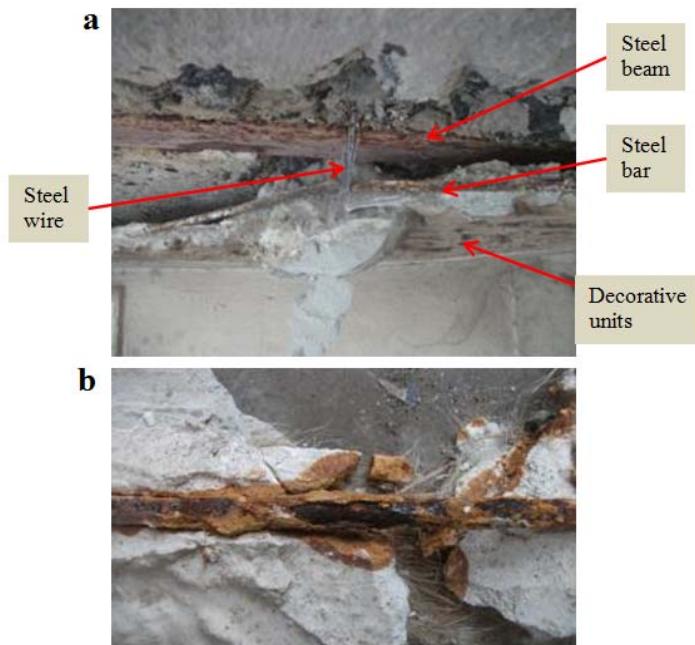
Fig. 6. The corrosion of the steel bar connecting the decorative units to the steel beam (a), and zoom to the corroded bar (b)

- 5) Re-attaching the decorative units to the balcony bottom using first stainless steel Fisher bolts (Fig. 17e), and then using gypsum mortar (Fig. 17f);
- 6) Recoloring using the same degree of old colors (Fig. 17g) and finishing (Fig. 17h).

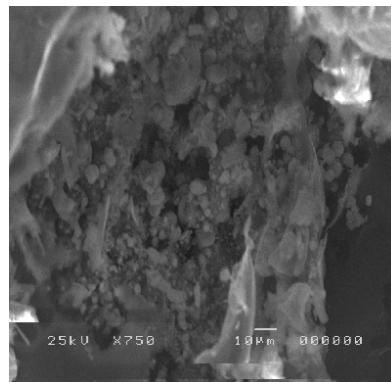
It is worth mentioning that SEM investigation showed that there was a clear interference between the concrete components (aggregate and binding material) and the corrosion products resulted from the corrosion of the steel beams (Fig. 13). Similarly, it showed the interference between the decorative units' components and the corrosion products of the corroded steel bar (Fig. 14).

Fig. 13. SEM image showing the interference between the concrete (dark color) and the corrosion products (light color).

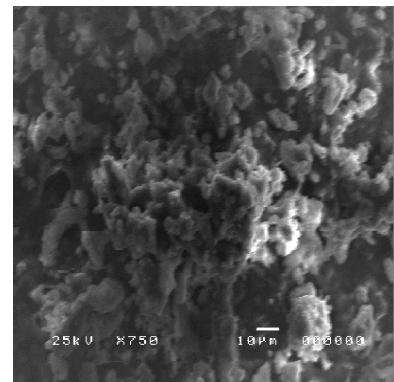
Fig. 14. SEM image showing the interference between the decorative units' materials (dark color) and the corrosion products (light color).

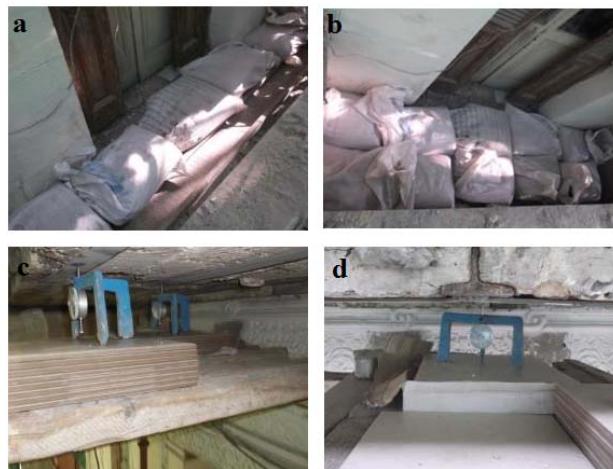
Substituting in the above equation δ_{max} was found as 0.288mm. This allowable deflection was higher than the maximum measured one 0.175mm. Therefore, the balcony after strengthening satisfied the code provisions.

Fig. 18. Static loading test: a. and b. Loading; c. and d. Measuring deflection

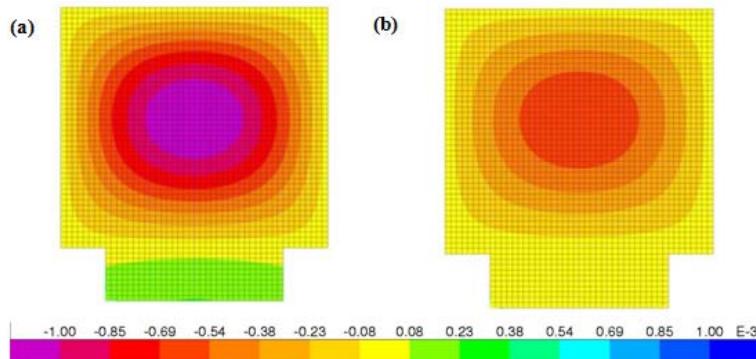
To reveal the efficiency of the intervention carried out, the model with strengthening was compared with that without strengthening. The applied loads were the slab own weight, the flooring, the parapet weight and the live load. In Figure 23, a comparison between the deflections of the two cases is shown, it can be noticed easily that the intervention resulted in a reduction in the deflection values. To show clearly the difference, the deflections of the points on the axis 1 (refer to Fig. 19) are plotted in figure 24 before and after strengthening. As observed, the maximum deflection value was reduced from about 0.24mm to 0.025mm. As well, the deflection of the points on three lines in the balcony shorter direction was plotted before and after strengthening (Fig. 25). These lines were on axes C, B and between the two axes (refer to Fig. 19). Again here, the maximum deflection value was reduced from about 0.24mm to 0.03mm.

Fig. 23. Contours of the deflection (m) of the balcony:
a. Before strengthening; b. After strengthening
