RESTORATION OF A CASELLA BROTHERS' ACOUSTICAL GUITAR AND CONSTRUCTION OF AN IDENTICAL COPY

Stylianos ANDREOU, Panagis SKLAVOS,
Anastasios A. KOKKINOS, Dionysios T.G. KATERELOS*

Applied Mechanics – Acoustics and Musical Instruments Design Lab, Department of Sound and Musical Instruments Technology, Faculty of Music Technology, Ionian Islands Technological Educational Institute, S. Typaldou ave, Lixouri, Kefalonia, GR-28200, Greece

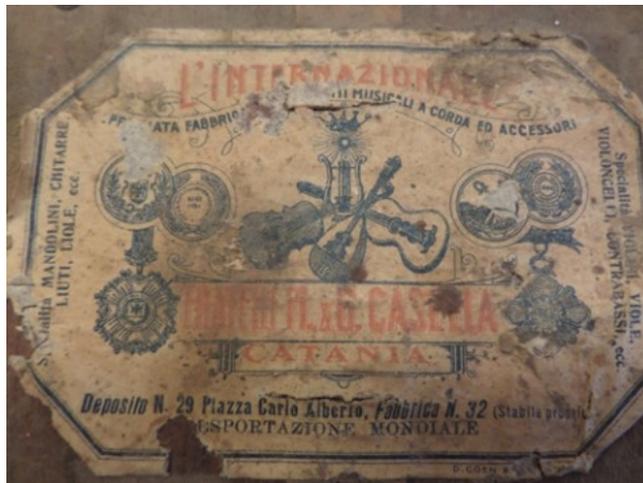
The acoustical guitar that came into the lab for restoration was made in Catania, Italy by Casella brothers as is written in the label attached in the instrument (Fig. 1). Casella brothers were namely Mario and Gaetano. Mario Casella was a known Catanese luthier. Apparently, for a while he also worked with his brother Gaetano. Both Mario and Gaetano made quite a range of very good string instruments such as mandolins, violins and a few guitars of great sound quality. The label of the guitar that was found inside it, writes the following title referring to the Casella brothers workshop: “L’ internazionale premiata fabbrica di strumenti musicali a corda et accessory”, which means “The first global musical instruments and accessories factory”, as can be seen in figure 1.

Fig. 1. Guitar Label

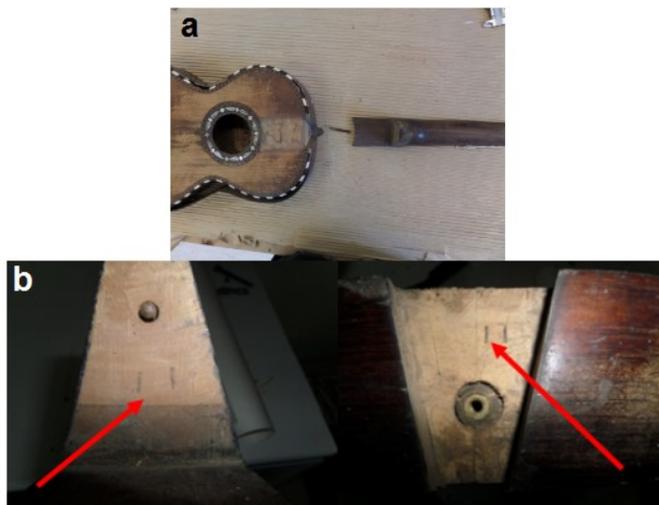
Fig. 2. (a) The guitar body and the neck removed; (b) The screw that stabilizes the neck on the body. The arrows point the marks made to note that this neck fits that nick

The neck was wedged in the guitar body, without any gluing between it and the body nor the top-plate (as is done today). In addition a screw was placed between the neck and the back chock of the guitar, in order to keep the neck stable at its right position (Fig. 2b). The constructors had marked the neck and the chock to remember that the specific neck fits perfectly in the specific nick (Fig. 2b).

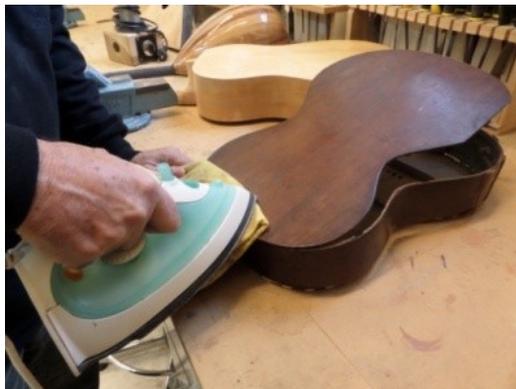
In all the glue joints animal glue was applied. As mentioned before this type of adhesive is easily removed by heating and hot water. This process was followed here (Fig. 3). Thus, the top-plate, the back-plate, the bracing struts, the saddle and the bridge, and the sides of the guitar were unglued and separated from each other disassembled completely the instrument in its parts. When the bracing struts were unglued, their positions on the top-plate were marked in order to be put back in their original places after repair.

Fig. 3. The ungluing process

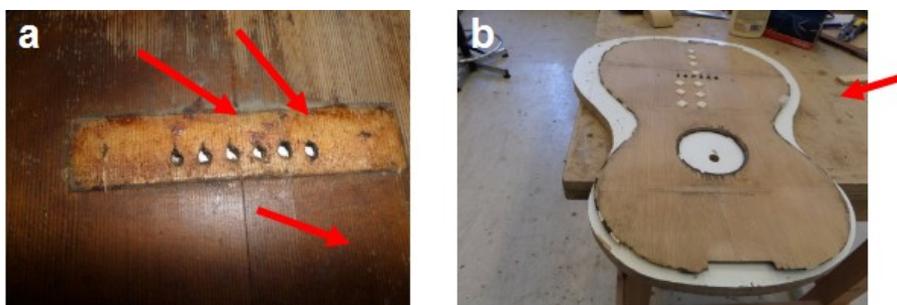
Since the instrument is in parts the restoration process was started. The first part to be repaired was the top-plate. The top-plate was made by a piece of picea excels (European Spruce). The top plate was cleaned from dirt and from glue using a piece of sandpaper. Next, small holes were drilled, filled with animal glue and pieces of spruce were added in the holes at the back side of the top-plate and near the bridge position in order to patch the cracks and to reinforce the position of the saddle and the bridge, where the strings exert mechanical loading (Fig. 4).

Fig. 4. (a) Arrows point the positions of cracks at the top-plate. (b) Small spruce patches added on the top-plate to repair cracks and reinforce the saddle/bridge position (arrow)

The next step was to clean the glue remaining around the patches and place back the bracing struts after cleaning them first. Thus, the top-plate is considered to be repaired and functional (Fig. 5). Some more work needed to be done for the top-plate to take its original picture will be completed during the assembly of the guitar.

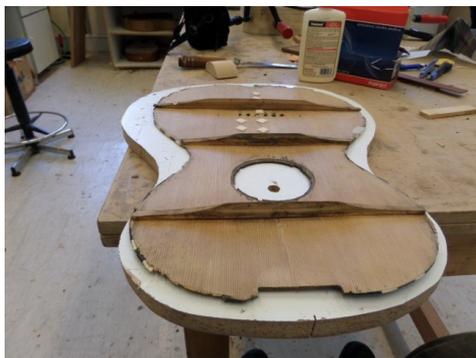
Fig. 5. The top-plate after finishing repair procedure

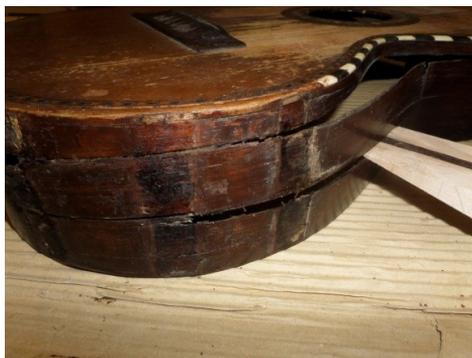
The guitar ribs were the most damaged parts of the instrument. They contained longitudinal cracks separated them into three pieces and portions of wood were missing (Fig. 6).

Fig. 6. The damaged ribs

In order to repair the ribs a mould was constructed by pine wood, which is tough and strong enough to withstand the pressure of clamps when the ribs will be putted inside. The ribs were then cleaned from dirt and glue. Following, the ribs were placed in the inner part of the mould and the broken parts were glued between them. A thick gauze filled with animal glue was used to stabilize the ribs. Pressure was applied using clamps and the ribs repair was completed.

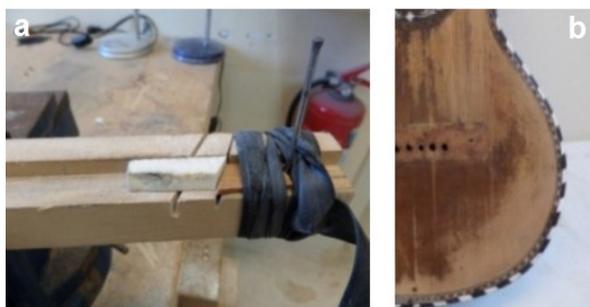
Fig. 9. a. The self-made jig used to cut equal size diamonds for the guitar decoration; b. The restored part of the guitar restoration

Using a self-made jig, all diamonds were cut at the same size and the guitar decoration was replaced. In figure 9a the jig for diamonds cutting is presented, while in figure 9b the replaced decoration is shown.

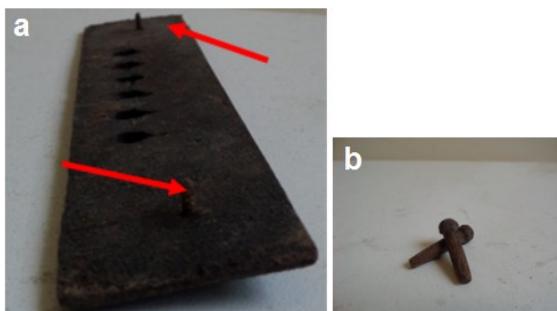
Examining the guitar bridge, the age of the instrument was verified for one more time from the way that the bridge is glued on the top-plate. Besides the adhesive (animal glue) it is stabilized at its right and left with small nails (Fig. 10a). This way of attachment is no longer present.

Fig. 10. a. Bridge attachment. Red arrows show the locations of nails; b. The pins that hold the strings on the bridge

After ungluing the bridge, it was cleaned and the rusty screws were removed. The bridge is manufactured by rosewood to withstand the strings applied stresses. Strings are hold on the bridge by wooden (rosewood) pins (Figure 10b). Then the bridge was attached back on the top-plate.

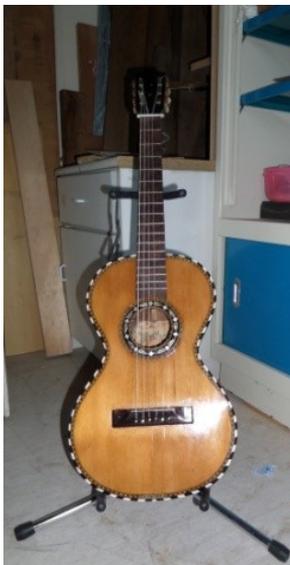
Fig. 11. The guitar after restoration processes completed

After varnishing, the last procedure in order to complete the guitar renovation, was the assemblage of guitar parts. The neck was attached on the guitar body in the way it was done by the manufacturers. The keys were screwed on the neck and the strings were put on the keys. The upper saddle, made by a piece of bone, was put at the beginning of the fretboard. The down saddle that is attached on the bridge is not made by bone, like in the contemporary instruments, it is just a piece of fret. Finally, strings were tied on the bridge pins and tuned with small correction in the neck slope, in order for the strings to touch only one fret at each time and not more. The final finished instrument is shown in figure 11.
