## MODIFICATION OF THE PHYSICAL PROPERTIES OF DETERIORATED STONE BY CHEMICAL CONSOLIDATION TREATMENT

Sanjay Prasad GUPTA \*

Archaeological Survey of India, Raipur Circle, Govind Sarang Comm. Complex,  
1st Floor, New Rajendra Nager, Raipur, India-492006

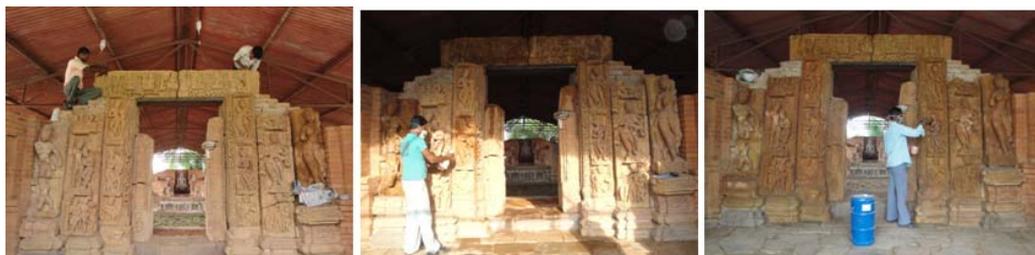
**Fig. 2.** Budh Vihar, Sirpur: during Consolidation

In order to analyze the physical properties changes in the stone caused by the consolidation treatment, measurements of porosity, compressive strength and ultrasonic velocity were performed. Samples of deteriorated stone were studied before the application of a consolidator (Fig. 1, 2 and 3). For capillary water adsorption and ultrasonic tests, we used small cubes of freshly quarried sandstone (50 x 50 x 50 mm) and irregularly shaped, deteriorated samples [8].

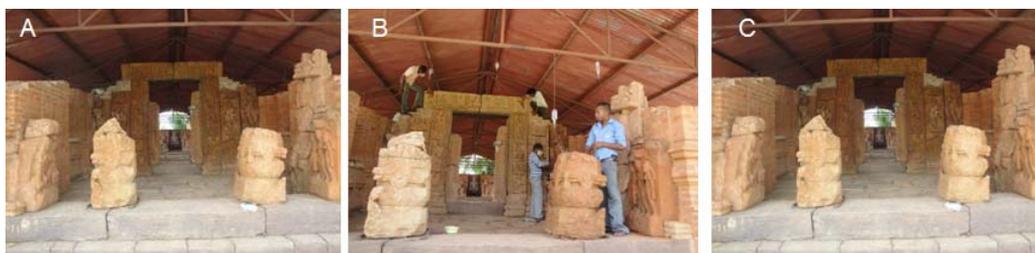
**Fig. 3.** Budh Vihar, Sirpur (front view): A - before Conservation, B - during Conservation, C - after Conservation
