ANALYTICAL IDENTIFICATION AND CONSERVATION ISSUES OF PAINTED PLASTER FROM QASER AMRA IN JORDAN

Firas ALAWNEH*, Fadi BALAA'WI, Naif A. HADDAD, Yahya AL-SHAWABKEH

Queen Rania's Institute of Tourism and Heritage, The Hashemite University, Zarqa, Jordan

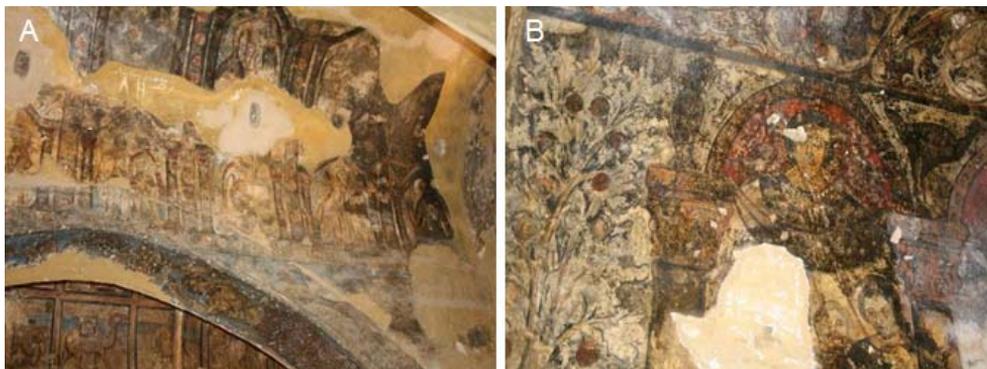
Fig. 2. Views of the interior of Amra palace showing different decoration features.

The extensive Fresco paintings of Qusayr Amra depict a seemingly disparate collection of subjects, hunting and bathing scenes, athletic activity, mythological images, dancing girls, acrobats and wrestlers, musicians, royal portraits, astronomical representations, as well as craftsmen at work (see figure 2). It has been suggested that such scenes depict the pastimes of members of the ruling elite as a way of indicating their royal status. According to the Arabian and Greek captions, one famous fresco in the Bath / palace depicts the enthroned caliph being paid homage by six contemporary rulers, among which *Basileus* (the king) of Byzantium. That scene, in particular, emphasizes the self-esteem felt by Umayyad rulers, after their decade-long conquest of lands from Spain to the Hindu Kush. They were a kind of secular self-celebration of success and wealth [14]. As a whole the frescoes in Qusayr 'Amra generate the impression that the new rulers adopted the lifestyle and tastes, as well as the desire for power, from their Byzantine predecessors [10-12].

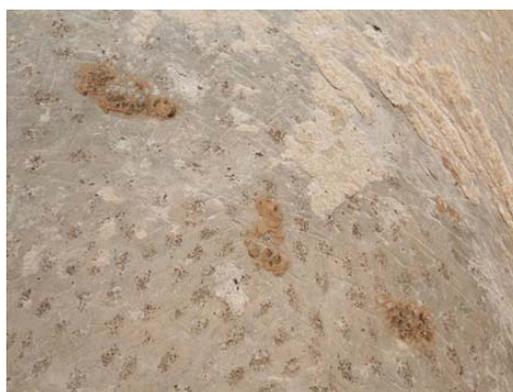
Fig. 4. Organism growth

- *Micro-organisms and organisms*; they play an important role in the decay mechanisms of organic and inorganic materials. The important acids and salts produced by micro-organisms are chlorides and nitrates and excreted sodium chloride. Micro-organisms produce nitrates from excrement and waste [15]. Atmospheric factors, such as chemical components and climate (temperature, water and light) influence their capacity for biological growth, which is enhanced in warm and humid areas. Figure 4 shows a sample of organism growth.

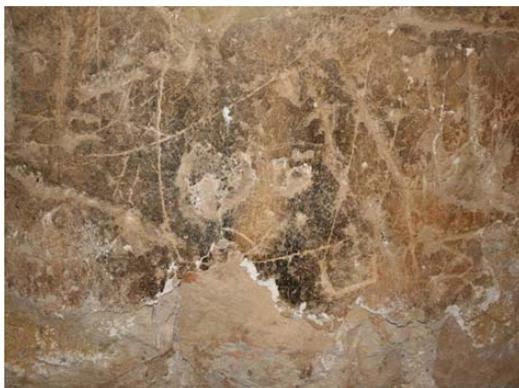
Fig. 5. The effects of salt crystals on both painting and mortars

the use of cement and adhesive materials from previous restorations, as in the case of the wall of the second entrance (Fig. 5). Another serious damaging factor to this monument is vandalism (Fig. 6).

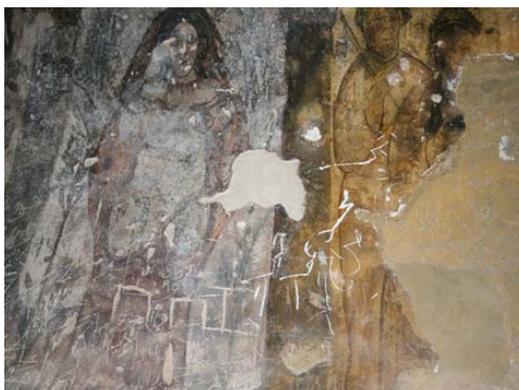
Fig. 6. Vandalism actions
