GROUTING OF MULTIPLE LEAF-MASONRY WALLS: APPLICATION ON SOME ISLAMIC HISTORICAL MONUMENTS IN CAIRO, EGYPT

Abstract

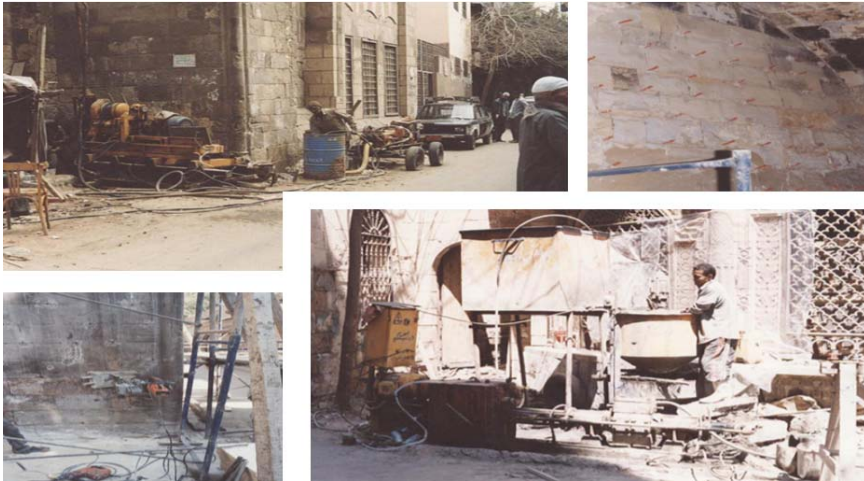
Fig. 5. Gonblat Mosque, Kutab and Sabeel in Cairo. Grouting and injection processes.

On the basis of the experimental data on wallettes, as well as based on recent data from tests on grouted cylinders made of filling materials, simple formulae are derived, allowing for the strength of masonry to be calculated, and scientifically interventions processes and techniques had been applied to selected historical monuments in Cairo, Gonblat mosque and Rabaa, Kuttab and Sabeel Al-Qazzlar, Figures. 4-9.

- Injection of the existing double faced walls with hydraulic lime based grouts
- Reinforcing the wall with vertical, longitudinal or transverse reinforcement.
- Removal and replacement of decay material
- Dismantling and rebuilding, either partially or completely.

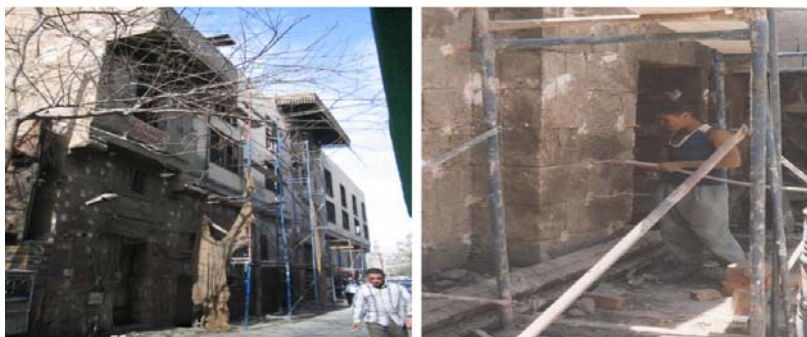
Fig. 8. Rabaa, Kutab and Sabeel Al-Qazzlar in Cairo. During restoration and intervention processes
