## CONSERVATION STATE OF MURAL PAINTINGS FROM A HISTORIC HOUSE IN FLORIANÓPOLIS-SC, BRAZIL. A MULTIDISCIPLINARY APPROACH

*The scientific approach to conservation and monitoring of mural paintings executed in a historic house with an eclectic style of the twentieth century, located in Florianópolis, Santa Catarina, Brazil, is an example of interdisciplinary collaboration between conservators, historians, and scientists in planning and development actions for preventive maintenance as well as interventions of restoration. The mural paintings are recognized worldwide as an architectural element and property, which records the representations of the cultural landscape of an age. In this context, the painting technique found in this house and its state of conservation were investigated by evaluation of pigmented surfaces and then by optical and spectroscopic (IR and EDX) techniques. These results were crucial for the record of the characteristic painting present in this building, showing a period marked by intense urban renewal in Brazilian cities.*

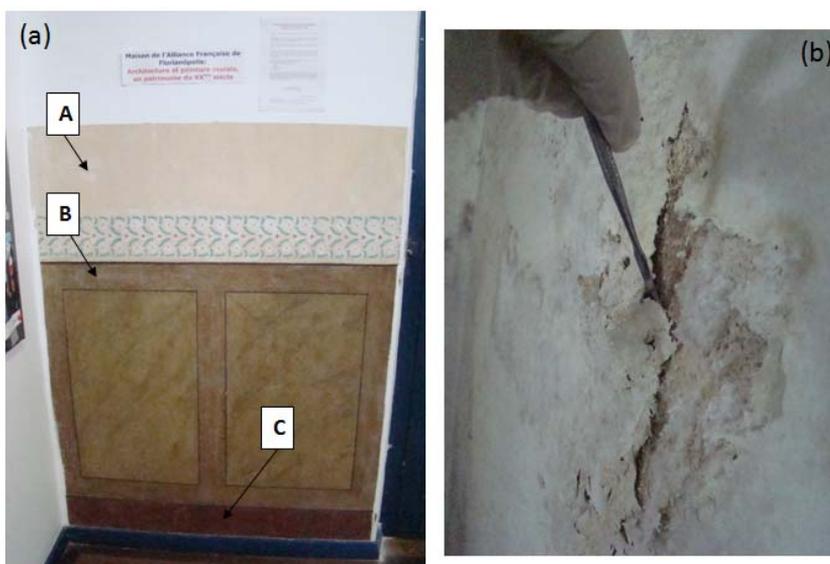
A serious problem observed during the work of removal of the re-paintings was the presence of insoluble salts, a pathology related to the geographic position of the building in order to help the works of removal of these salts, samples were also collected for analysis of infrared spectroscopy and EDX; Figure 2 shows the formation of salts on the oldest painting.

**Fig. 2.** (a) Mural paintings found at the historic house after pickling of the most recent ink layers; where **A** is the trace of green painting found in the ornament above, **B** and **C** is the ochre and dark brown color respectively (b) traces of soluble salts found during the process.

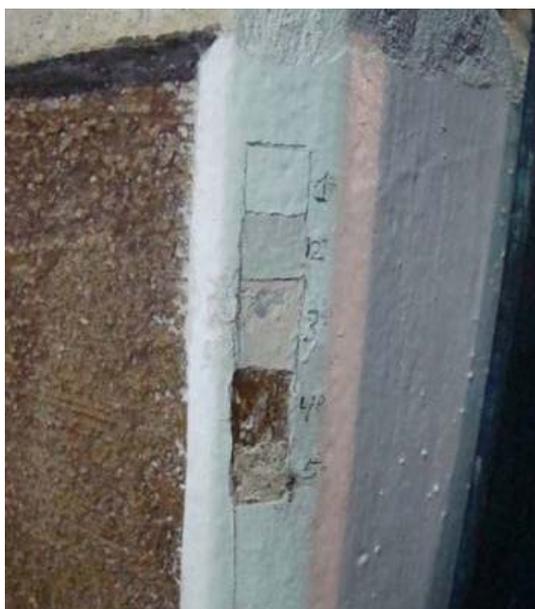
The result of the opening of the stratigraphic windows is presented in Figure 3. One observes five distinct layers, being the 1st, 2nd, and 3rd ones related to more recent later re-paintings, in the 4th layer one observes the oldest painting, which is found in all parts of the historic house, once the last one refers to the preparation layer.

The first three layers have been identified at the place with the help of solvents [14] and both are acrylic resin-based, probably of commercial source, taking into account that they are more recent re-paintings. The fourth layer, older, has been utilized for more detailed analysis of painting technique by utilizing instrumental methods.

**Fig. 3.** Stratigraphic windows referring to the five layers found at the historic house under study

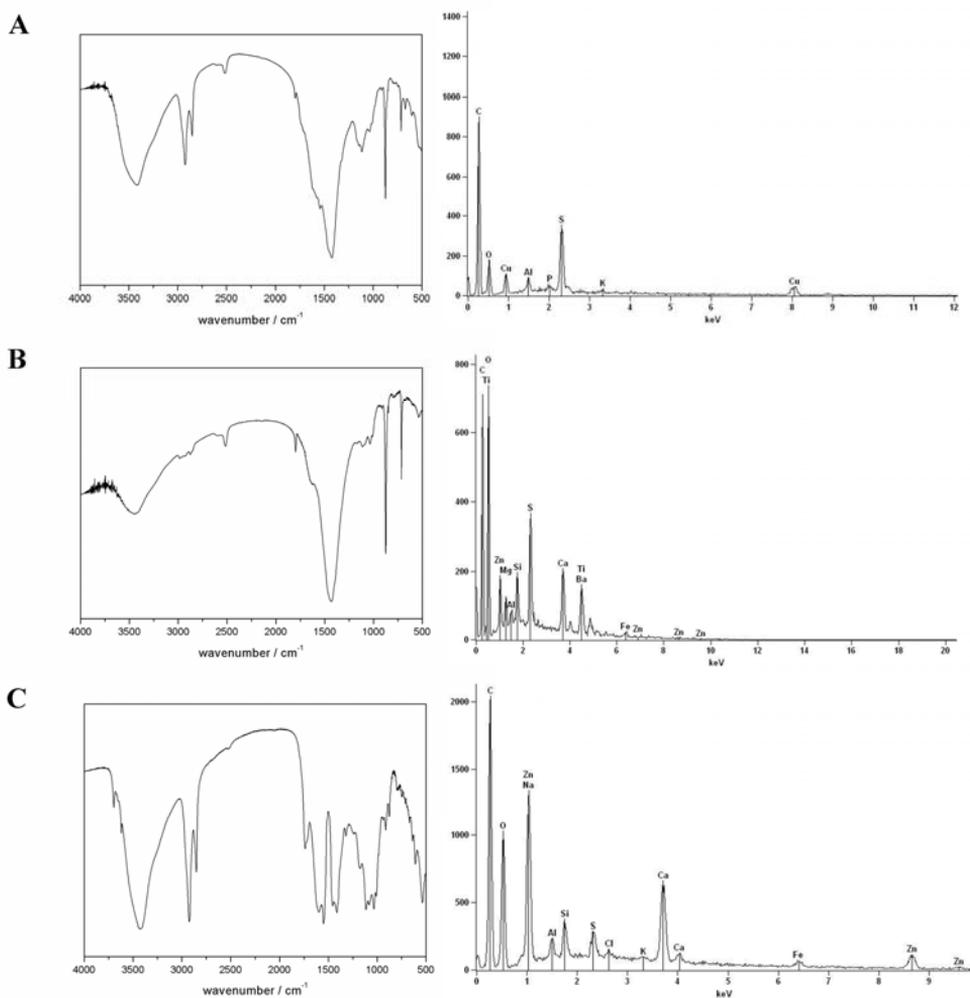
**Fig. 4.** EDX spectra collected from fragments of green, ochre, and brown colors, respectively, where in sample A the following representative elements have been detected: Cu, S, K, and O, in sample B: Fe, Zn, Ba, Mg, S, and O and, in sample C: Fe, Ca, K, S, Zn, Na, O, Cl. Infrared spectra of the fragments of colors were collected, where: A, B, and C represent the green, ochre, and brown colors, respectively.

More information about the type of pigment utilized has been possible by means of X-ray spectrometry analysis with a dispersive energy analyzer. The spectra are presented in Figure 4.

First, one observes the presence of Cu in the green pigment existing in the ornaments present in the mural painting, a characteristic element present in numerous pigments of this coloration [11]; observing the infrared spectroscopy data, where one observes waves in  $3400$ ,  $1500$ , and  $1095\text{cm}^{-1}$  and this one has also presented release of  $\text{CO}_2$  when in the presence of hydrochloric acid, which can suggest that this pigment contains carbonates [5] and the presence of the copper atom in the structure leads us to the conclusion that it deals with a malaquita that presents itself in the  $\text{CuCO}_3\text{Cu}(\text{OH})_2$  structure and was utilized as pigment very often at the time the historic house was built[12].

The EDX analysis of pigments B and C has presented some similarities, like the presence of Fe and Zn, and sample B has presented Ba. The experimental evidences reveal that the brown color comes from a clay mineral with the  $\text{Fe}_2\text{O}_3\text{H}_2\text{O}$  chemical composition. According to Stuart and collaborators [14], the presence of barium can be associated to a binary mix of minerals for dilution of the brown ink, giving rise to ochre, the lithopone [14],  $\text{BaSO}_4$  can have been utilized in this dilution, considering the evidence of presence of barium and sulfur in considerable amounts. These instrumental chemical analysis are describe on literature, where are utilizing for identification pigments in amount of cultural heritage [15-17].

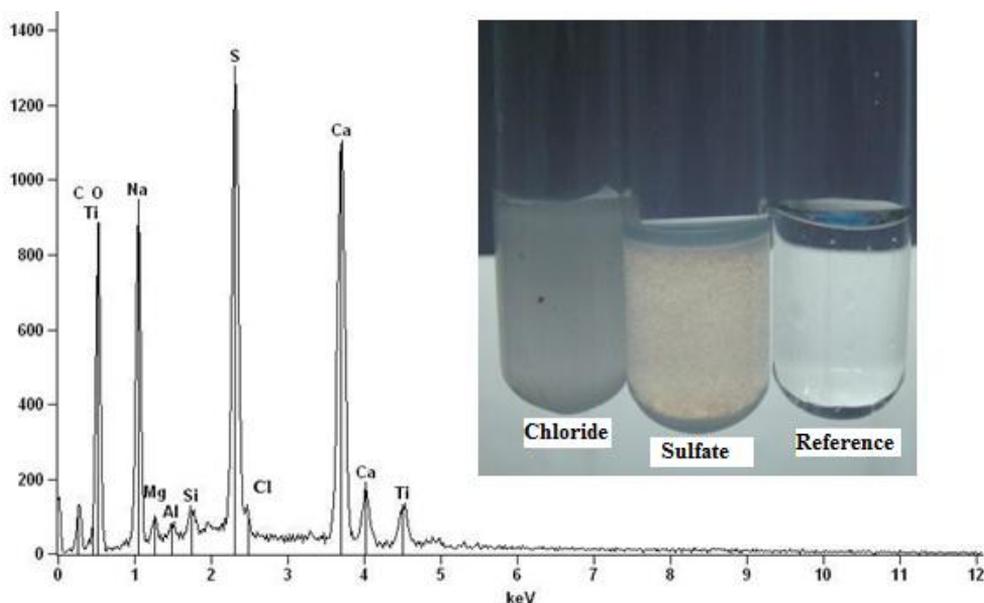
In the process of cleaning and withdrawal of the re-painting applied on the mural painting, one has come across a pathological problem of chemical origin which is the formation of insoluble salts in the plaster and between the original layers of the mural painting and the other more recent ones applied on them. A detailed analysis of the type of salt, that is, identification of ions that form part of these compounds is fundamental, having in mind that the identification of this pathology directly helps the conservers-restorers who at some moment will carry out the works at the historic house. Soon after being collected, the salt was qualitatively analyzed at the laboratory by the precipitation method detailed in the experimental part. The result of the analysis is presented in Figure 5.

Turbidity is observed in both analyses in both test tubes, when compared to the white one. This phenomenon results from the precipitation of the chloride and sulfate ions present in the analyzed plaster. The accumulation of salts in the plaster and between the layers has as its main origin the geographic localization of the building; first, for being located on an island and at less than 20km from the sea, an accumulation of chloride ions,  $\text{Cl}^-$ , is eminent, and also, being on a street with a great flow of vehicles, the deposition of sulfate,  $\text{SO}_4^{2-}$ , is also favored at the building. For identification of the complete chemical pathology, the samples have been submitted to dispersive energy X-ray spectrometry, the spectrum with all the elements found in the sample of analyzed salts is presented in Figure 5.

**Fig. 5.** EDX spectrum of the collected samples of salts, the detected elements Ca, Na, S, and Cl are directly linked in the formation of chloride and sodium and calcium sulfate in the plaster of the historic house and between the painting layers, confirming the results of the qualitative analysis of chloride and sulfate in the plaster of the historic house studied in this work.

It is reported that the presence of sulfate can lead to irreversible damages to the historic constructions, in the presence of humidity it can dilute and withdraw the ink layers present in the mural paintings and they can also serve as nutrients for some micro-organisms. As to chloride, it serves as electrolyte for oxidation/reduction reactions that may occur with some types of ink, resulting in fading and modifications on the pictoric layer [14-18]. The identification of these salts in this building, specifically, is of great importance, for it alerts about the preventive preservation of the mural paintings not only of this one, but also of other historic buildings present at the center of Florianópolis.
