TECHNICAL EXAMINATION AND RESTORATION OF THE STUCCO DECORATIONS OF AL HASAWATY MIHRĀB, FATIMID PERIOD, CAIRO, EGYPT

Abdullah M.A. KAMEL^{1*}, Hassan A.H. MARIE², Hala A. MAHMOUD¹, Mona F. ALI¹

¹Conservation Department, Faculty of Archeology, Cairo University, El-Gamaa Street, 12613 Orman, Giza, Egypt

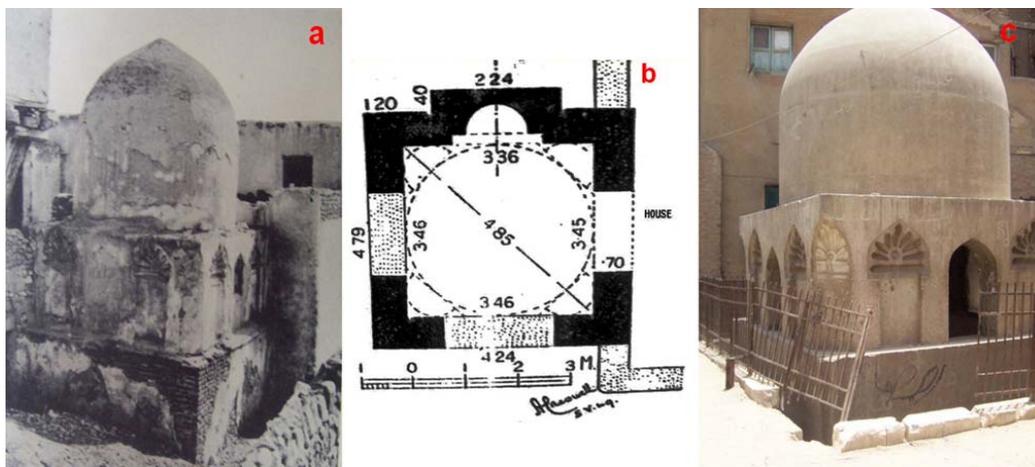
Fig. 1. Al-Hasawati mausoleum: a - before restoration (Creswell, 1952), b - the plan of Al-Hasawati mausoleum, scale 1:100 (Creswell, 1952), c - up to date picture of the mausoleum.

The Muhammad El Hasawaty Mausoleum is located just 60 yards south-west of the mausoleum of Imām Ash-Shāfī. Like most mausoleums, it consists of a cubical base averaging 3.41 m on each side internally, a zone of transition, and a dome, in this case without a drum. The whole structure is brick coated with stucco; the walls are 66 cm. thick. A large arched opening occupies the center of each face, except on the side of the mihrāb. The ground having risen considerably, only the upper part of the lower mausoleum is visible from the street (Fig.1).

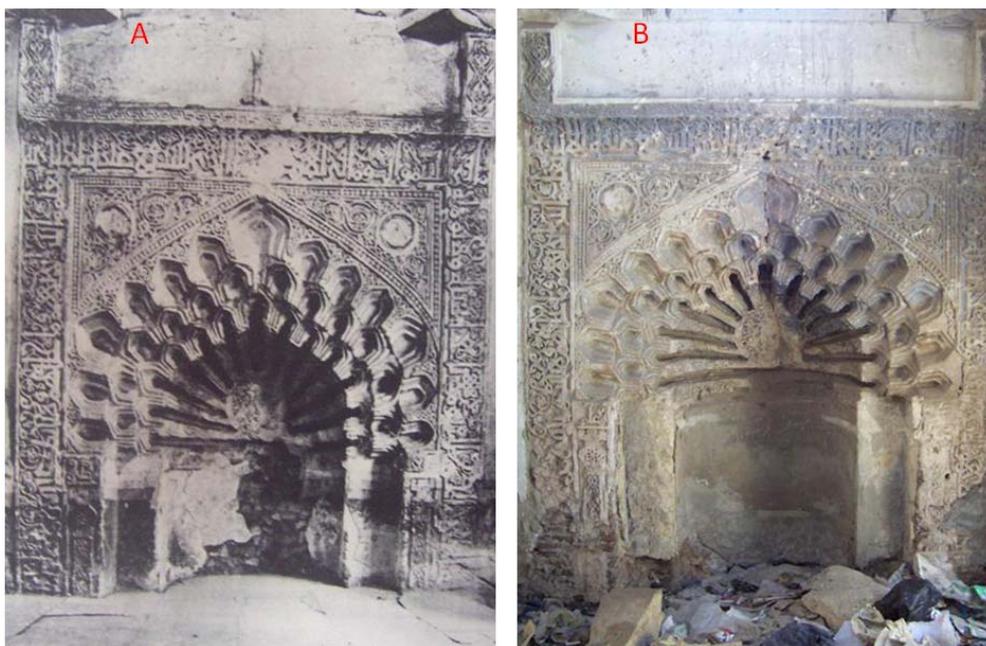
Fig. 2. The condition of the mihrāb of Muhammad Al Hasawaty: a – image taken in 1952 by Creswell, b – actual image of the mihrāb’s condition

These layers of lime paint were found on most parts of the mihrāb, especially at the upper part of the mihrāb as the lower parts were much deteriorated. The lime paint consists of two layers: blue and white, these layers are a recent painting and they have not any archaeological value, and they are man made deterioration (a well known phenomenon in the mausoleum area) (Fig. 2b).

The mihrāb bears the closest possible relationship to that of Sayyida Ruqayya. We have the same fluted conch with a large medallion in the centre, a triple scalloped edge, the same almost keeled arches, the same traces of bosses in the spandrels, etc. According to the features of the mihrāb and comparison of this mihrāb with other stucco monuments, Creswell suggested many dating times (first half of the twelfth century or 478H (1094 A.D.), 527 H (1133), or 519H (1125), etc. (Fig. 2) [1].

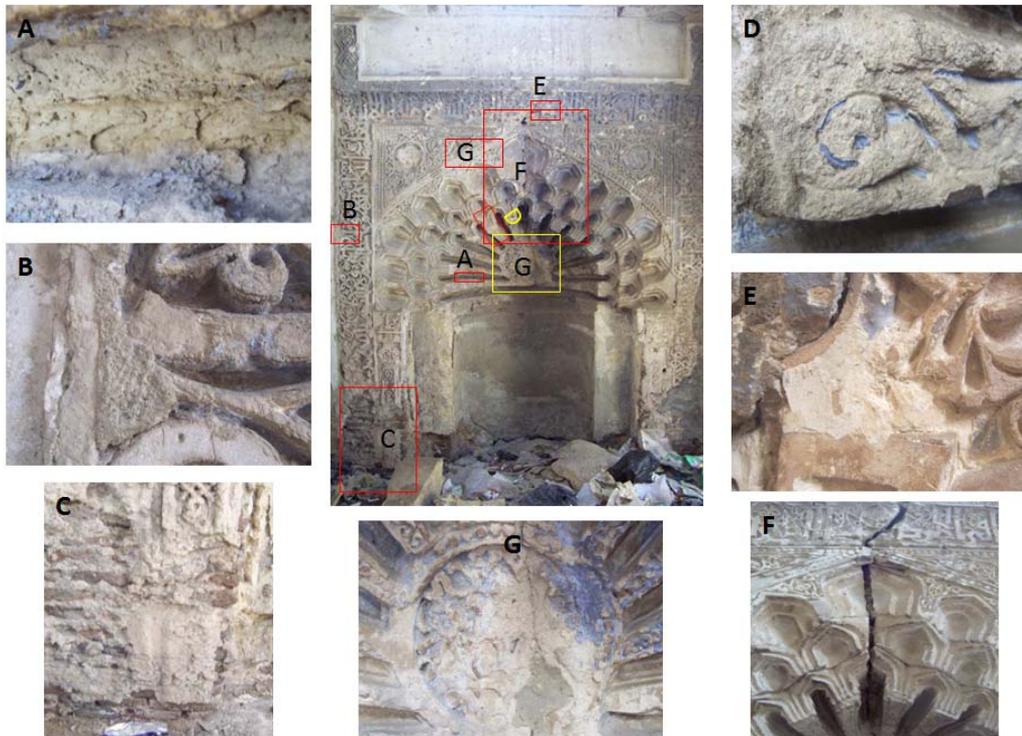
Fig. 3. The condition of the surface layers of the mihrāb: a - layers of hard salt layers and their effects, b - usage of Portland cement mortar on the surface of stucco, c and d - loss and degradation of stucco layer, e - bad usage of lime and gypsum mortars on the surface of stucco, f and g- presence of cracks and fissures on the surface of stucco

The loss of mihrāb stucco can be divided into three: complete loss of the stucco layer, loss of the surface layer of stucco decoration and degradation of the surface of stucco decoration (Fig. 3c and d).

The old restoration of the lower part of the mihrāb was done by using strong Portland cement mortar; also, strong Portland cement mortar patches were noted among the fragile stucco motives and as splashes on the surface of the stucco (Fig. 3b and g).

These mortars were used in filling the large crack at the center of the mihrāb, many decorations disappeared because of these mortars, also, gypsum mortar was used in completing the missing upper parts of the mihrāb, and there was spreading of gypsum spots on the stucco decoration of the mihrāb (Fig. 3e).

Cracks and fissures were found in many parts of the mihrāb, they ranged from small fissures to large cracks (Fig. 3f and g), these cracks may relate to substrate movement and the heterogeneity of wall materials differing both in porosity and thermal conductivity [3-8].

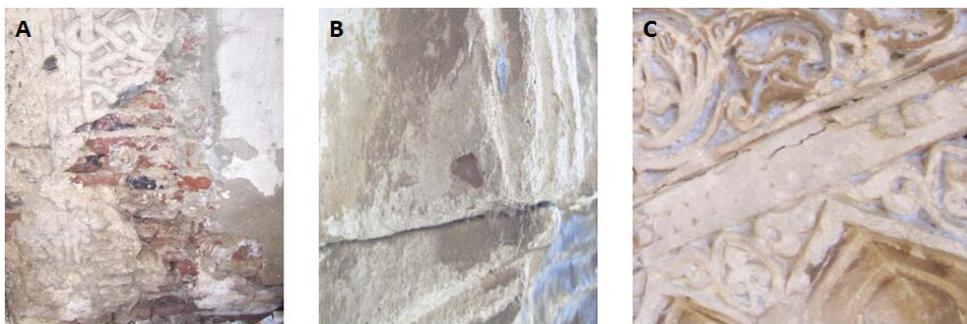
The following pictures show that the decoration of the Al Hasawaty mihrāb was executed by direct application of stucco mortar on the red brick substrate after which the stucco motives were engraved onsite. In the spandrels two layers of stucco were applied on the substrate; the first layer is flat plaster and the other layer bears the engraved motives (Fig.4).

Fig. 4. The application of different treatments: a & b - direct application of stucco mortar and engraving, c - application of two stucco layers on the substrate

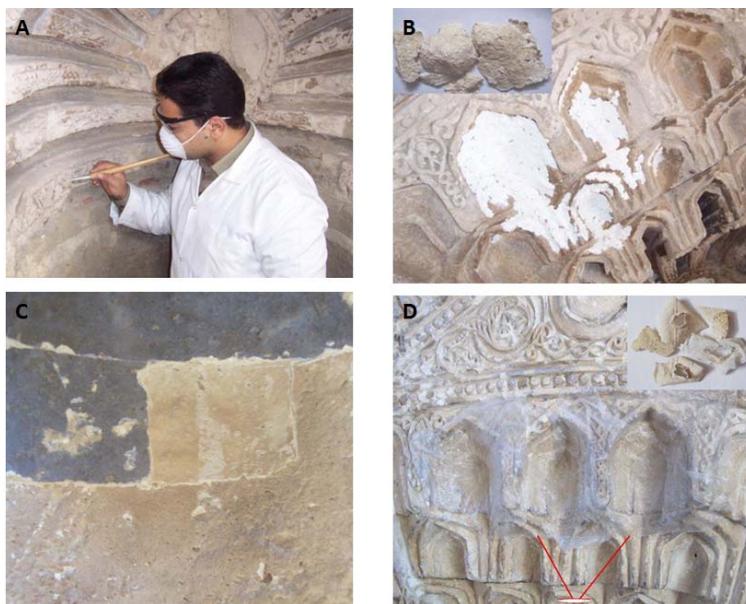
Fig. 5. Photographs during cleaning: a and b - the dusting and application of paper poultice with ethyl alcohol, c and d - the removal of lime layers by mechanical cleaning

Dusting with soft wide or narrow brushes and blowing tools; this was done from the upper to the lower parts of the mihrāb after the cracks and gaps had been filled with cotton packs. Then a paper poultice with ethyl alcohol was applied to the surface of the stucco surface to remove the residue of dust (Fig. 5a and b) [11].

Removal of the lime paint layer was done by mechanical cleaning after taking experimental samples, but many parts of the blue layer could not be cleaned mechanically so we used an AB 57 poultice to remove the residue of the lime paint layer (Fig. 5.c and d). Some parts of the stucco motives had disappeared completely because of the new bad restoration with mortar, these motives were revealed step by step by mechanical cleaning (Fig. 6).

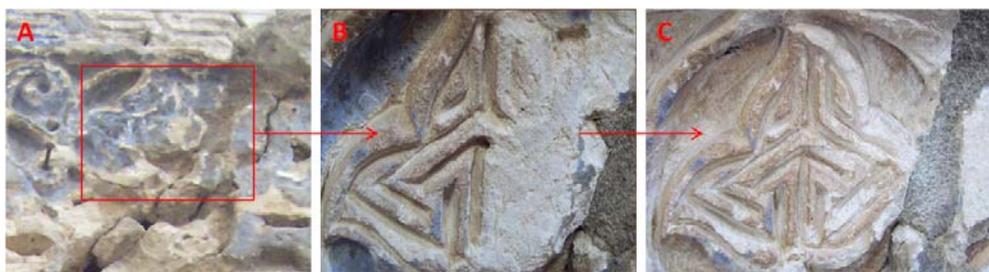
Fig. 6. Stages of revealing of the disappeared motives by mechanical cleaning

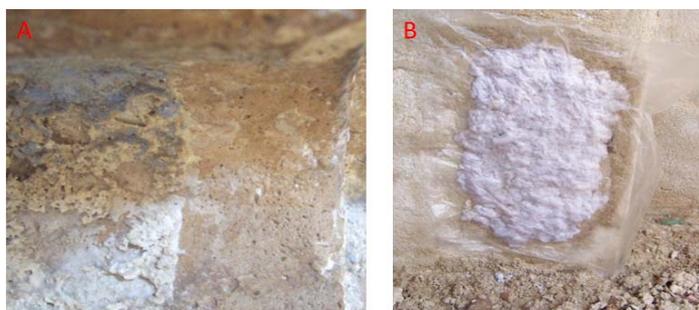
Fig. 7. Stages of cleaning and abstraction of sodium chloride salt from the stucco surface of the mihrab

Most of the salt layers were removed by mechanical cleaning after taking experimental samples, salt coagulations that were found between the stucco layers and the substrate were removed bit by bit and the gaps was filled with stucco mortar to strengthen and make a bond between the stucco layer and the substrate. The residue of salt that could not be removed by mechanical cleaning was abstracted using a paper poultice with water (our aim here was to remove or abstract a reasonable amount of salt, not the whole amount, which was to protect the strength of the stucco material), three rounds of application of the paper poultice was sufficient to arrive at our goal (Fig.7).

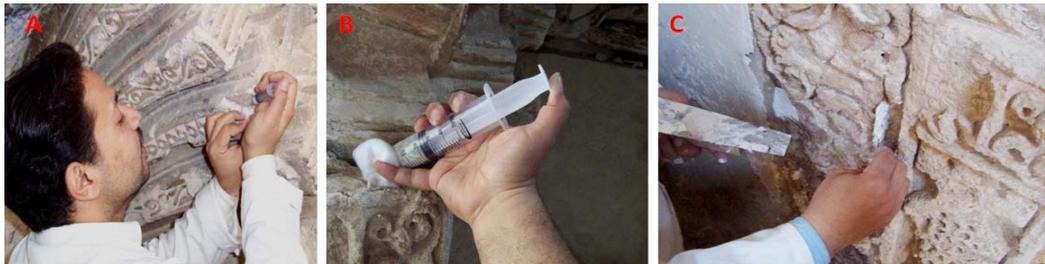
Fig. 8. Images during treatment: a - adhesion of detached pieces of stucco decorations, b - the injection of stucco decorations, c - the mechanical strengthening of stucco decorations by mortar.

After cleaning away the dust by brushing and blowing to avoid the harmful effects of dust on the ability to adhere, 50% Primal AC 33 in water was used in reattaching the detached pieces of stucco decoration with the aid of a piece of cotton with the syringe to avoid the flow

down of Primal AC. If any of the Primal AC 33 flowed, we left it until it hardened, and then removed it mechanically with wood sticks (Fig. 8a).

After preparing the voids by dusting and blowing, an injection of aqueous alcohol (50:50) was applied; this lowered surface tension and thoroughly moistened the inner surfaces of both stucco and wall in the detached area. Then we applied an emulsion of Primal AC 33 (1:1) as that may have a consolidating effect; after this a mix of gypsum and lime in an emulsion of Primal AC 33 was injected. At first the grout was very liquid, then it became more viscous, finally the outer parts of the cracks were finished with mortar that had the same components without the Primal AC 33 (Fig. 8b) [12].

This was done by cleaning and wetting the void surfaces between the stucco decorations and the substrate after which the voids were filled with a mortar consisting of 3.5 parts of calcium hydroxide, 3.5 parts of hemihydrates, and 1.5 parts of fine sand (these approximate ratios were according to analysis of the stucco). After finishing we patinated the new parts (Fig. 8c).

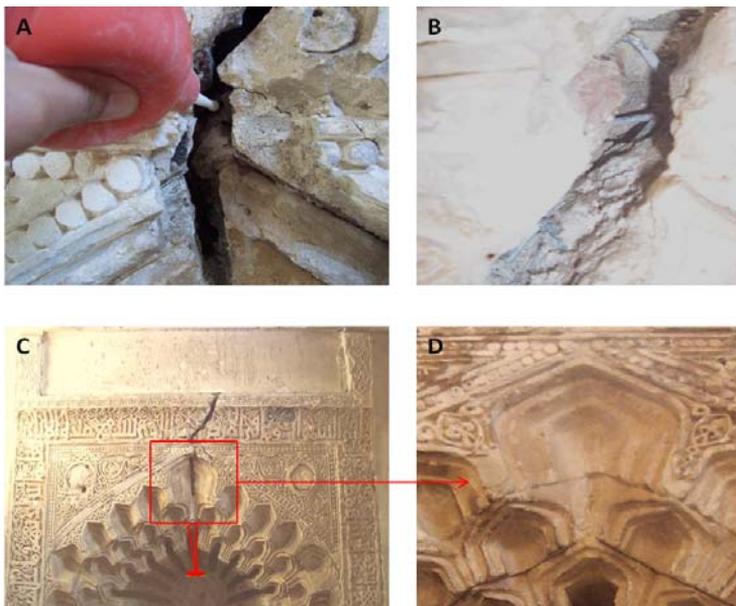
Fig. 9. Stages of filling and completion of the big crack:
 a – cleaning stage; b – after cleaning; c - area ready for filling;
 d – Detail of c after restoration.

This crack was cleaned of dust and the old bad restoration, then we moistened all sides of the crack with water as a preparatory step to applying an amount of mortar, which we used as a pad to support the stainless steel bars for bonding the two sides of the crack. After the mortar hardened we applied many layers of mortar up to the finishing of the outer surface. After that, the surrounding parts affected by mortar were cleaned immediately with mechanical cleaning and a wet sponge (Fig. 9).

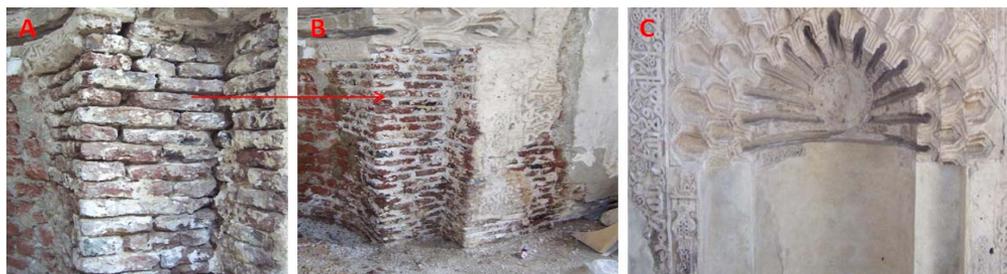
Fig. 10. The stages of removing of Portland cement layer cleaning of brick joints (a),
 b - the pointing of brick joints, c - the application of porous lime plaster (disposable layer)

This was done gently by the conservator himself to avoid the deleterious mechanical effects which may harm fragile parts of the stucco (Fig. 10A).

Joints were filled with the proposed mortar by spatula, the surface of the mortar used in the pointing process should be 2:3mm lower than the surface of the brick; after this the joints were finished with a wet sponge to open their pores (Fig. 10B), pointing was done at the light of directions of van Balen et al. [13].

After drying and hardening of the mortar joints, the lower parts of the mihrāb were washed three times with water to abstract more salt, then a layer of porous lime mortar consisting of 3.5 parts of rough sand, 1.5 parts of lime and quarter part of white Portland cement was applied. The excess of the rough sand ratio and use of ordinary lime were used to form a tenuous and porous plaster which helps to abstract soluble salt without affecting the historic layer of stucco. This sacrificial disposable layer can be replaced after it deteriorates (from about 6 months to one year according to the sequential examination of the specialist) (Fig. 10C) [14]. We selected this solution until the government provide suitable budgets for establishing a suitable Sanitary drainage water system which can prevent or reduce the effects of salts solutions.

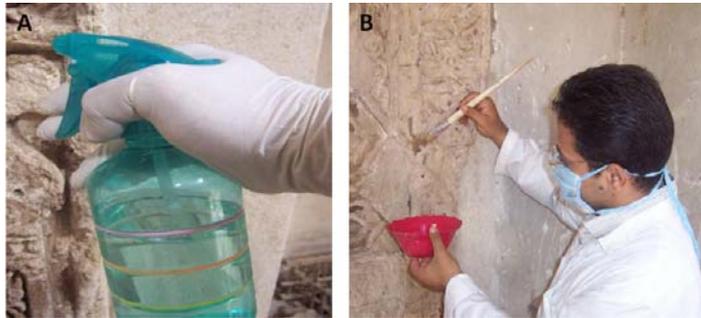
Fig. 11. The application of the solutions: a – fungicide, b - Eucosil consolidant

After application of a fungicide (Eminent, 10 p.p.m.) [13] we applied Eucosil by spraying and by brush according to the condition of the surface (Eucosil is a protective coating made by Swiss Chem. Company; its solution is a clear water repellent material which prevents

water-chloride ion intrusion (salts) form deteriorating the concrete. It penetrates deep into the substrate, hydrolyses in the pores and capillaries, condenses and forms a hydrophobic zone. It is used as masonry impregnation, strengthener (e.g. for weathered plaster surfaces and pointing mortars), protection against moisture induced damage, prevention of soluble salt blooming and etc. Through an experimental study made by the authors on Eucosil and three other consolidants, Eucosil achieved the best results, so we selected to be used as consolidant for the stucco decorations of El Hasawaty mihrāb) (Fig. 11).

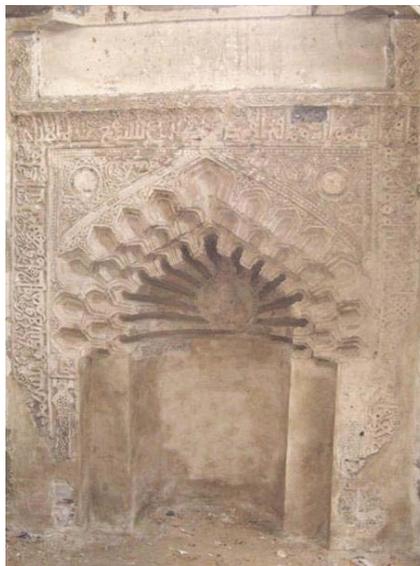
In figure 12 is presented the image of the Al-Hasawati stucco mihrāb after the consolidation treatments.

Fig. 12. Al-Hasawati stucco mihrāb after the consolidation
