ASSESSING THE RESTORATION OF SIDI EL BENNA MOSQUE IN TLEMCCEN (ALGERIA)

Abstract

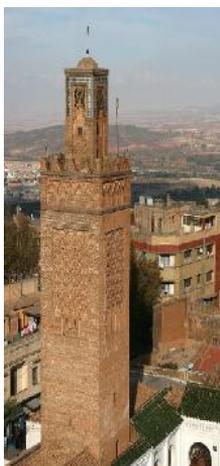
Fig. 1. Minaret of the Great Mosque before the restoration

Several restoration projects were carried out in Tlemcen before the 1962 independence of Algeria [35]. The locals in charge started the restoration of monuments in the 1960's in cooperation with UNESCO, completing 7 projects (2 in 1964 and 5 in 1965). Starting from the early 1970's until 1991, the citizens realized that the state was not interested in safeguarding the heritage of Tlemcen, and completed other 12 projects (5 in the 1970's, 5 in the 1980's, and 2 in 1991). In 1991, the state responsible organisms completed other 2 projects. The first national restoration plan (1996) included monuments of Tlemcen. The largest city-level restoration was completed in 2009, preparing Tlemcen to become Capital of the Islamic culture in 2011; 101 monuments were restored within 2 years. Nevertheless, the works disfigured the old Muslim buildings [36], including the oldest one, dating from the 11th century. The present study is triggered by the fact that during the restoration the color of mosque minarets was changed from red (Fig. 1) to white (Fig. 2) and the facades were applied a sparkling plaster.

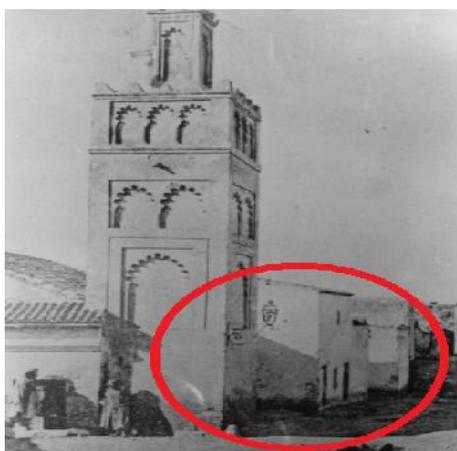
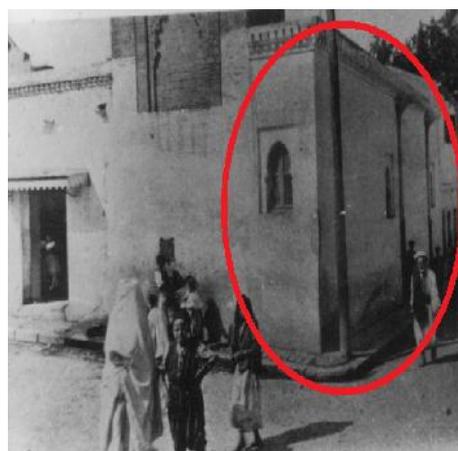
Fig. 3. Sidi El Benna Mosque before the intervention

Fig. 4. Sidi El Benna Mosque after constructing the maksourah

the 2009 emergency operations [37, 38]. It was already affected during the colonial period (before 1962) [39] when its authenticity was lost by the addition of a Maksourah (imam room) (Fig. 3-4) and the transformation of the wood framework roof in flat slabs embedded in metal frames (Fig. 5-6), and the addition of the bathroom which did not exist in a neighborhood mosque (believers are supposed to undergo the ritual bathing in their own homes).

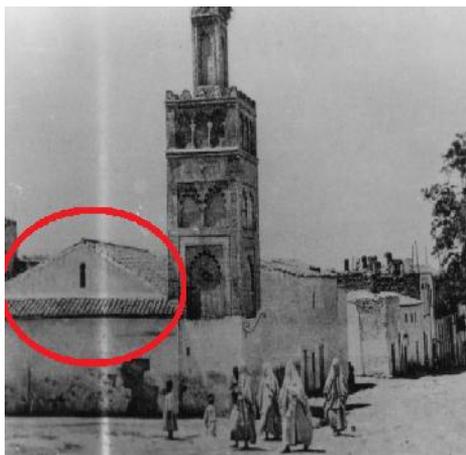
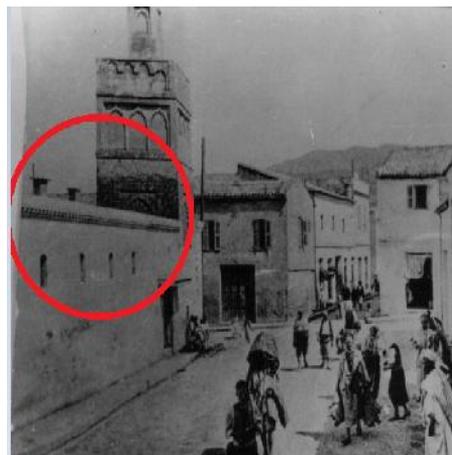
Fig. 5. Sidi El Benna Mosque with its original roof

Fig. 6. Change of the Sidi El Benna Mosque roof

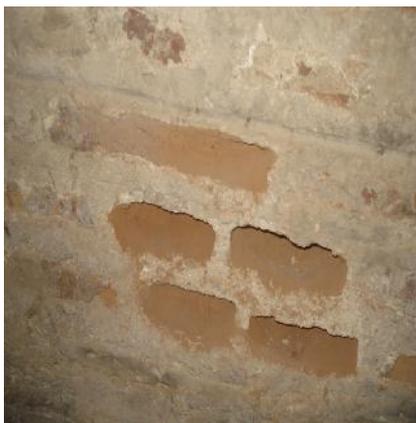
Fig. 7. Breking bricks

At this stage, no study looking at the compatibility of the technologies and integration of modern equipment was found. The interventions are abnormal; the broken bricks had to be replaced and not coated; the procedure did not stop the process, but allowed it to extend to the other bricks (Fig. 7). Similar, the minaret brick joints were filled with mortar under pressure, whitening the Islamic tower, as the mixture of sand and lime lacked the clay that gave the original red color of this architectural element. The coverage of outer and inner walls using cement coating is an error, as the original coating was composed by a mixture of sand and lime. Due to it, the cement coating detached five years after the restoration (Fig. 8). The implementation of the sealing using tarred plates and aluminum altered the authenticity, disfiguring the terrace (Fig. 9). The normal composition includes, from bottom up, clay, coal ash, and earth reinforced by straws. The replacement of the old wooden framework, roman tiles by flat ones, cast iron gutter and rainwater downspouts by PVC ones, old doors by new ones, terra cotta pavement by a granite one resulted into a permanent loss of the original architectural elements of the mosque. Furthermore, the partially degraded elements could have been repaired, and those seriously damaged replaced by a copy. The final action, introducing the air conditioning units and three water tanks, disfigured the mosque (Fig. 10).

- Filling the holes of broken bricks using lime mortar;
- Filling the minaret brick joints injecting mortar composed of lime and sand;
- Removal of the old lime coating and walls coverage with the cement coating from the oblation room, façades and bathroom;
