ASSESSMENT OF PHYSICAL AND MECHANICAL CHARACTERISTICS OF MASONRY BUILDING MATERIALS IN HISTORIC MILITARY TOWERS IN ALEXANDRIA-EGYPT: A CASE STUDY

Abstract

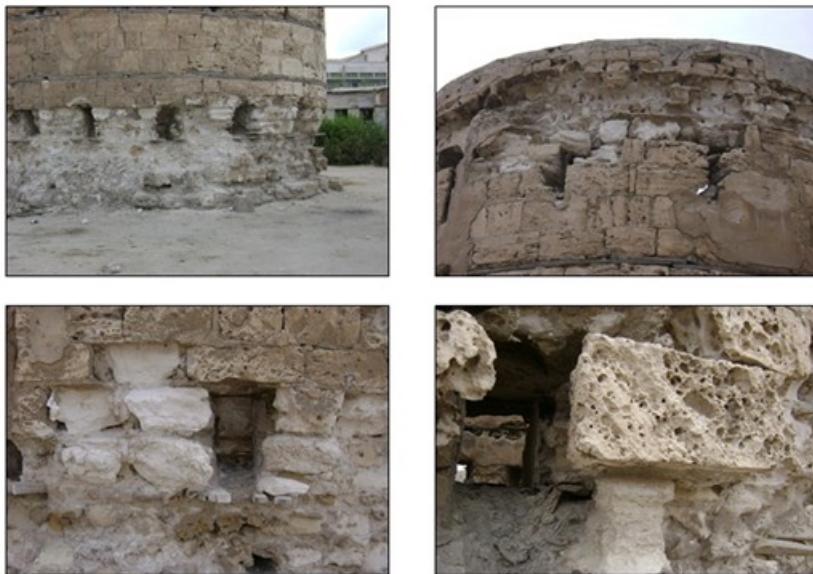
Fig. 2. Examples of deterioration phenomena in the military tower

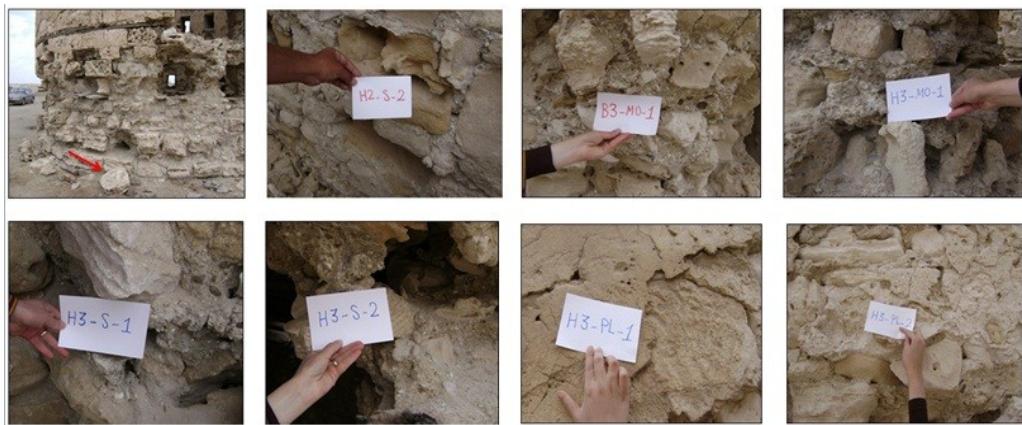
The main materials used for the building construction in the case study tower are limestone, lime-gypsum mortar and poor coating render. The sampling included many samples of limestone, mortar and render from different parts of the tower. The sampling processes were effected either by carefully removing relatively small stones through the use of chisel or small fragments of stone were removed from the underside of the tower or by collecting the isolated or fall stones. Scratched mortar and render samples were taken for chemical and mineralogical qualitatively analysis as shown in figure 3.

Fig. 3. different sampling processes (stone, mortar and render sampling)

The collected samples are shown in table 1. On the other hand figure 3 shows the locations of sampling. It must be noted that from the in-situ sampling the mortar was found very weak and friable due to the effect of groundwater and other deterioration factors.

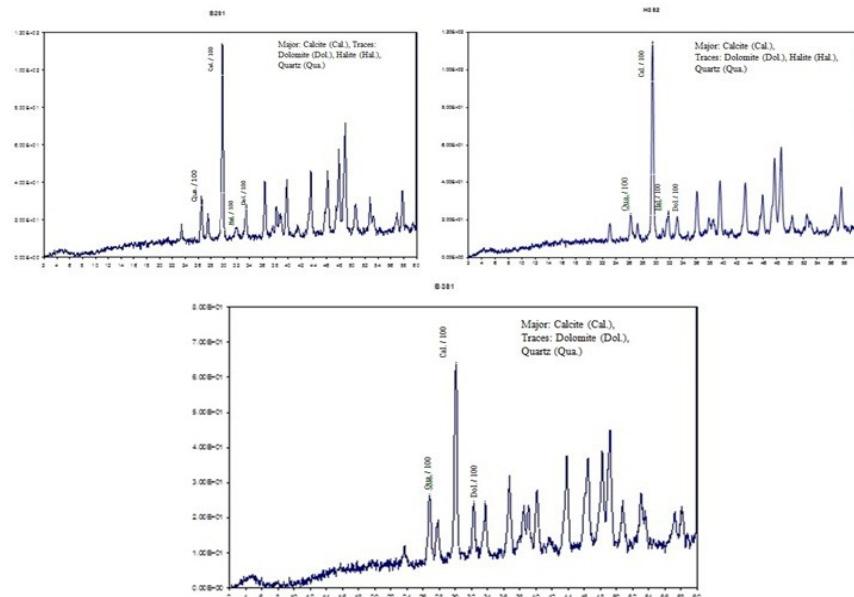
X-ray diffraction (XRD), method usually used in mineralogy and petrology of limestone that makes possible identification of the minerals that compose the investigated sample. X-ray diffraction spectra of patterns of limestone samples B3-s-1, B2-s-1 and H3-s-2 are presented in figure 4. For X-ray diffraction pattern presented in figure 4, one can observed the presence of the *Calcite* (CaCO_3), the main composite of limestone, *Quartz* (SiO_2), traces of *Dolomite* ($\text{CaMg}(\text{CO}_3)_2$) and *Halite* (NaCl) in addition to some minor elements which are showing by the peaks of lower intensities (Fig. 4).

Otherwise X-ray diffraction pattern presented also in figure 4, show the presence of the *Calcite*, *Quartz*, in addition to minor of *Dolomite* and *Halite*. On the other hand the same results were obtained for X-ray diffraction pattern presented to the third specimen (H3-S-2 specimen) where the main elements are *Calcite*, *Quartz* and minor of *Dolomite* and *Halite*.

Fig. 4. XRD patterns of B3-S-1, B2-S-1 and H3-S-2 specimens

X-ray diffraction patterns of limestone in figure 4 shows that the main chemical composite of limestone used in construction of military towers is *Calcite* and *Quartz*, in addition to some minor elements of *Dolomite* and *Halite*. Otherwise polarizing microscope examination shows that it has a lot of fossils and it is composed of skeletal allochems of different sized and shapes (Fig. 4). From the results obtained from XRD analysis and mechanical properties in tables 2, 3, 4 and 5 it appears that the stone is soft and porous, and has a considerable salt content. The results of the analysis listed in table 2 Indicate that it has high percentage of porosity (21%), and the highly porous content lead to adsorbed high content of moisture leading to dissolution and erosion phenomena.

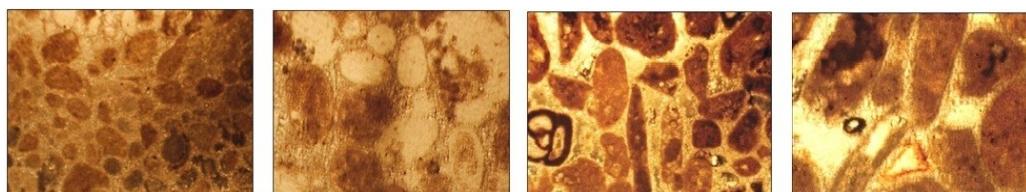
Where samples B3-S-1 and H3-S-2 indicate and show that the rock is dark yellow highly fossiliferous hard limestone. Microscopically the rock is larg foraminiferal (Oolitic). It is composed of skeletal allochems of different sized and shapes, and some scattered quartz grains embedded in fine grained micritic or pseudo spar which is partially dolomitized matrix as shown in figure 5.

Fig. 5. Samples B3-S-1 and H3-S-2 under the Polarizing Microscope (under the two horizontal polarizing 64)

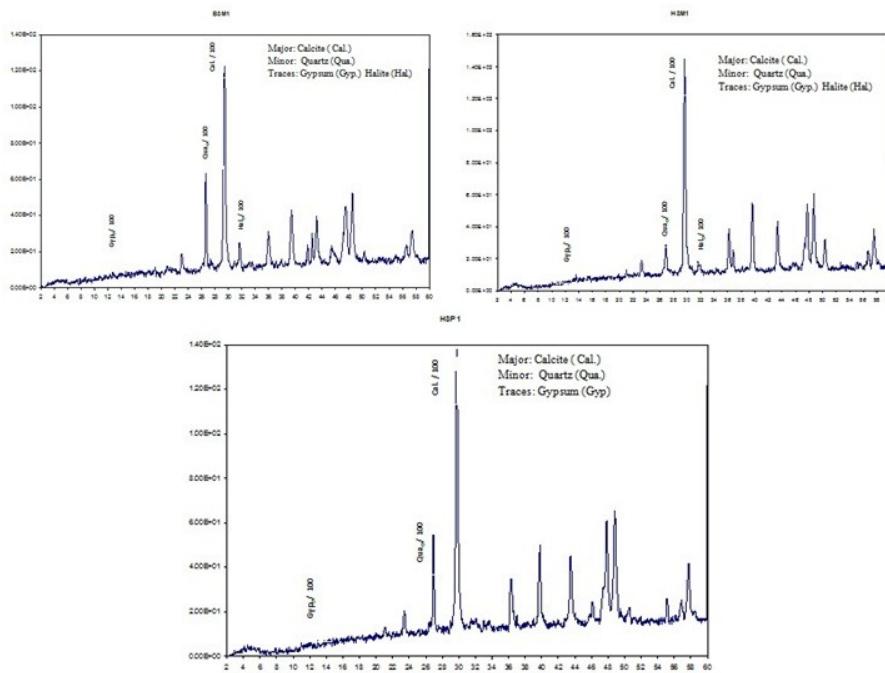
X-ray diffraction patterns of mortar layers used in between limestone units are presented in sample B3-Mo-1 and H3-Mo-1. Where Figure 6 presents the XRD results of mortar specimen B3-Mo-1 and also presents the XRD results of mortar specimen H3-Mo-1.

Fig. 6. XRD patterns of B3-Mo-1, H3-Mo-1 and H3-PL-2 specimens

X-ray diffraction spectra of patterns of render sample H3-PL-1and H3-PL-2 are presented in figure 6. The results refer to the use of lime-gypsum mortar with a huge amount of Quartz as a plaster coating in the tower and the room beside.

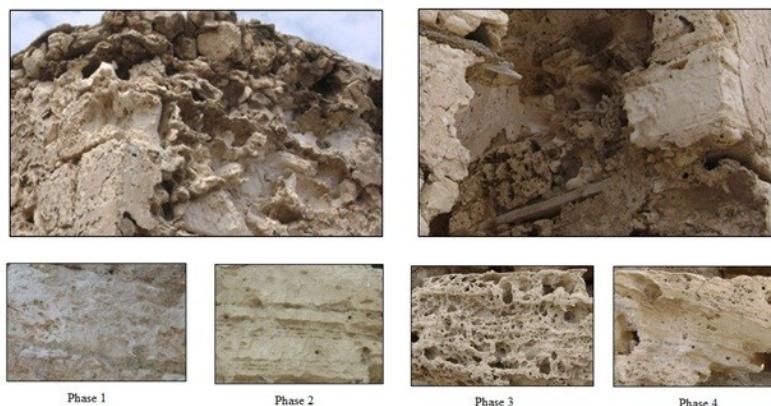
However from in-situ observation to limestone in lower and higher parts of the tower we can notice the varying in forms and intensity of weathering processes, this because of differences in salt content and types, the major contents of fossils and because of the differing quality and weathering resistance of limestone used see figure 7.

Fig. 7. Patterns of limestone surface weathering and dissolution

Surface dissolution decay in limestone as shown in figures 7 and 8 may begin with limited and localized surface missing parts through granular disaggregation (honeycomb weathering). By the time and with the long-term of weathering acts the small hollows of limestone honeycombing can amalgamate to form larger cavernous hollows, distinctive bedding and multiple flaking. Invariably this is associated with the near-surface presence of salts crystalline crusts.

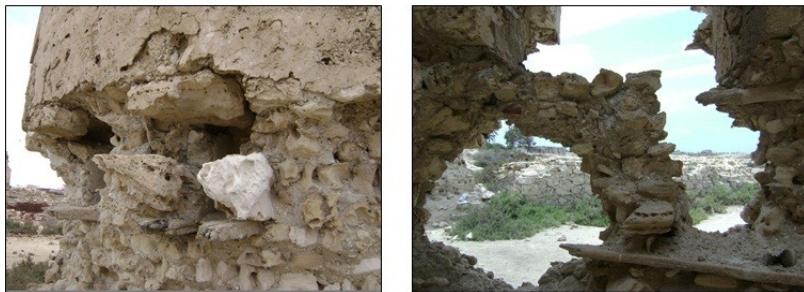
Fig. 8. Rapid decay to limestone blocks and collapse of whole sections of the wall

The result of such actions due to the salt weathering to Oolitic limestone used in the construction of historical military construction in Alexandria there is alarm visual evidence that individual blocks and ultimately, whole sections of the wall can become prone to rapid decay and, eventually, localized collapse (Fig 8).

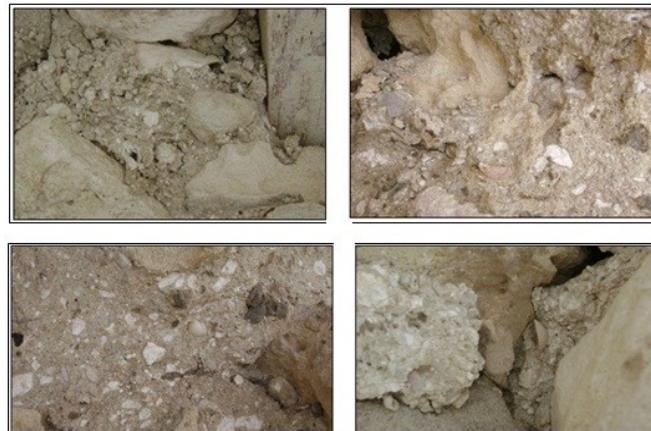
The mortar used in the construction of the tower and the adjacent room in the bad condition, it suffer significant damage phenomena due to some external and internal factors. From visual observation and survey the mortar is in bad current situation due to many cases (Fig. 9).

Fig. 9. Show decay of the mortar used

The harmful of deterioration surrounding factors and the poor composition of the mortar are the main factors lead to mortar loss and bleeding leaving stone courses without in-between mortar [15, 16].

One the other hand construction defects play an important role in mortar decay as the builder used the marine or beach sand which contain in its composition shells and various shaped of gravels as shown in Fig 9. In the long-term with the weathering actions shells and gravels fall down. As sequences mortar began to bleeding and form larger hollows in it. And the result is fragmentation of masonry mortar and missing the binder-based mortar layer between limestone blocks courses leading to localized collapse in the building.
