THE EFFECTIVENESS OF NANO MATERIALS AND NANO-MODIFIED POLYMERS FOR PRESERVATION OF HISTORIC BRICK MASONRY IN RASHID, EGYPT

Sayed HEMEDA^{1*}, Mervat KHALIL², Ahmed SHOEB¹, Ahmed Abd EL AZIZ¹

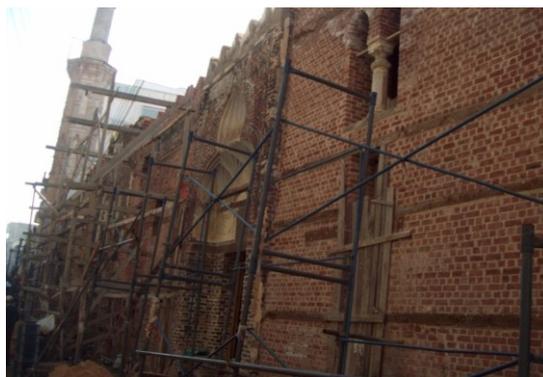
Fig. 2. The main and east facade of Al Mahalli mosque, under restoration and intervention processes.

Figure 1 presents the layout of Al Mahalli mosque and Figure 2 shows the main and east facade of Al Mahalli mosque, under restoration and intervention processes.

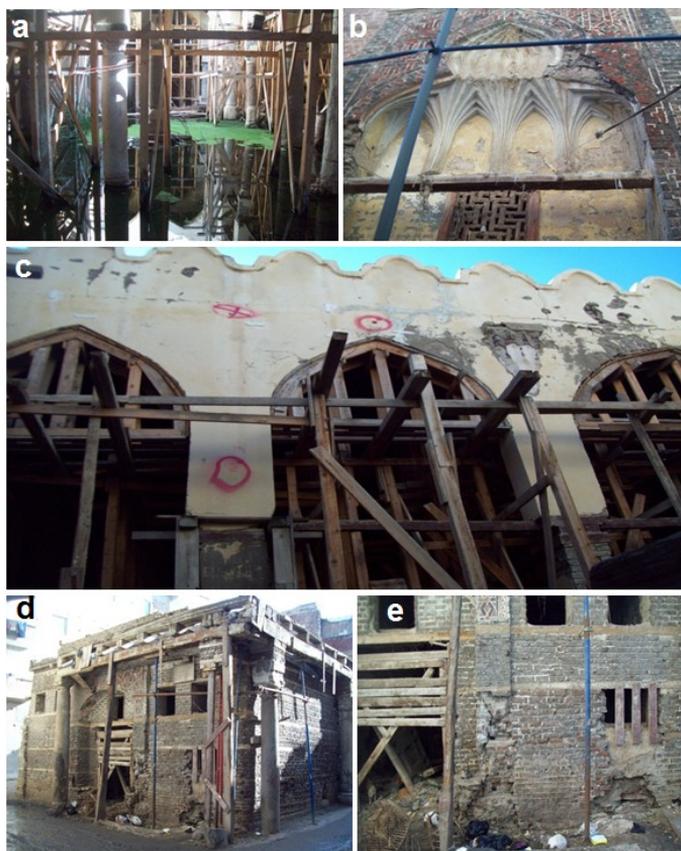
Fig. 3. Deterioration issues: a - Ground water rise inside Al Mahalli mosque; b - Deterioration due to rising humidity; c - Major arcades and the overhanging structure. cracks and fissures in the vertical walls; d - The main facade of El Manadily house, dangers cracks appeared in some pillars and separation between the façade and the radial walls; e - El Manadily house, deformation of the brick in the zone of the borders and main wall of the facade

Figure 3 show the main and east façade of Al Mahalli mosque, the effect of ground water on the mosque, Main entrance of the mosque and the damage effect on it, the vertical cracks and observed deformations in the structure of mosque and other buildings. Also the living organisms have a role of damage circle that attacked the building materials in ancient buildings in rational because the environment is suitable for the growth of these objects and gravity as produced from

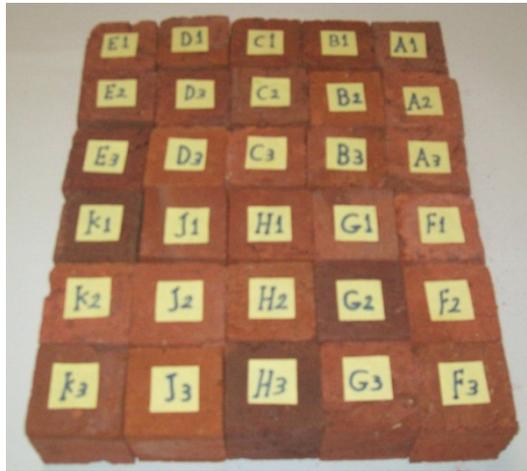
Fig. 4. Specimens with their code number before the consolidation treatment

prepared and divided to 11 groups each group of code name composed of 3 specimens. Figure 4 shows the specimens with their code number before the consolidation treatment.

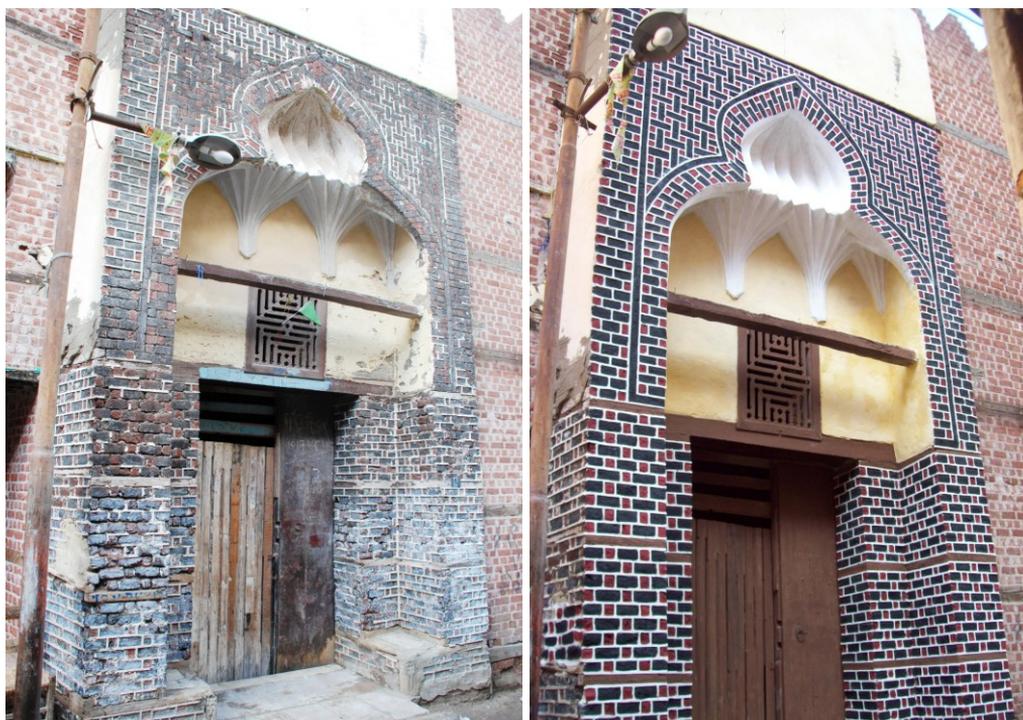
Fig. 8. The main gate of Almahhali Mosque in Rashid before and after the restoration processes.

In figure 8 we have the main gate of Almahhali Mosque in Rashid before and after the restoration processes.
