DAMAGE DIAGNOSIS OF PONTE ROTTO, A ROMAN BRIDGE ALONG THE ANCIENT APPIA

This paper describes the results of the damage diagnosis performed on Ponte Rotto, a Roman bridge on the ancient Appia way located close to the city of Benevento (southern Italy). Despite it can be considered one of the most important remains of this type of monument in Campania region, the bridge was abandoned for centuries, being in a rather poor state of conservation; therefore, an accurate damage diagnosis has been carried out using an interdisciplinary approach, in order to plan conservative, preventive and restoration work for the requalification of this archaeological heritage. Photogrammetric survey and damage diagnosis following the Fitzner's method allowed identifying and quantifying the geomaterials adopted for the construction of the bridge and the weathering forms affecting it. Georeferenced orthoimages permitted the mapping of their areal distribution, the definition of the damage categories, and the estimation of the linear and progressive damage indexes, that revealed a definitely bad conservation state.

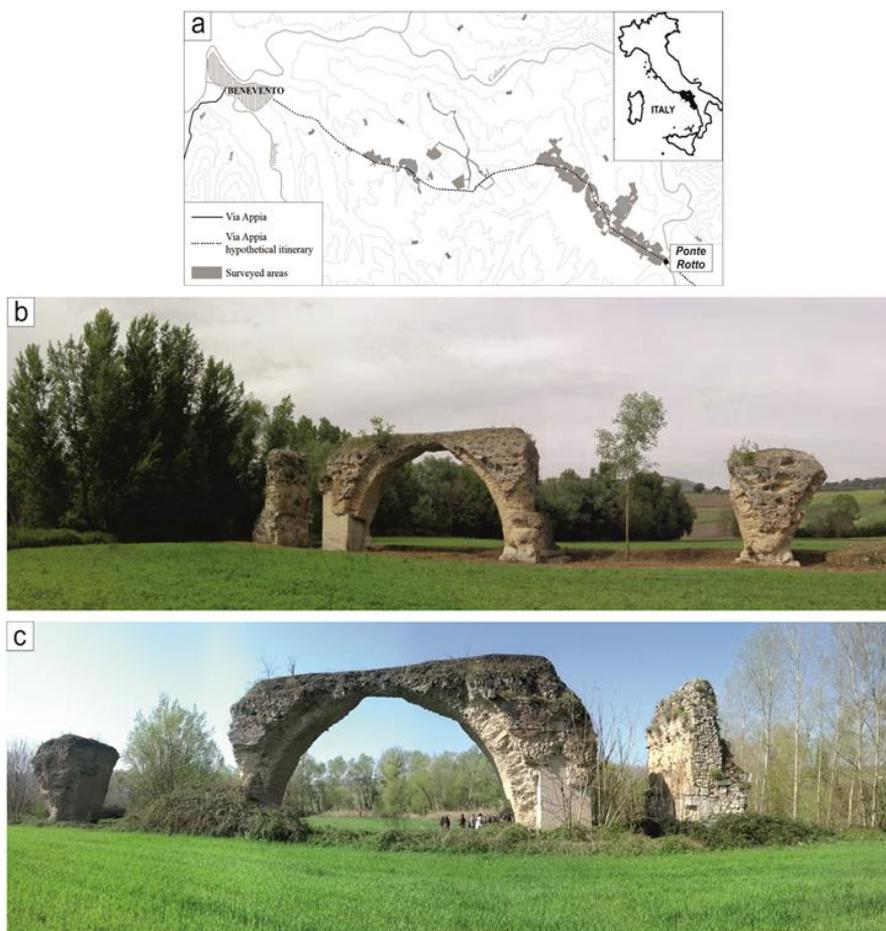
structures can be ascribed to a viaduct built with quadrangular pillars in *opus quadratum*, archways and head walls of gables in concrete covered by bricks. Unfortunately, only the western ramp on the left side of the Calore river, made of bricks and limestones blocks, and three pillars on the opposite bank and an archway, are nowadays preserved (Fig. 1b, c).

Fig. 1. Sketch map of Ponte Rotto location (modified from [33]); view of western (b) and eastern (c) side of Ponte Rotto.

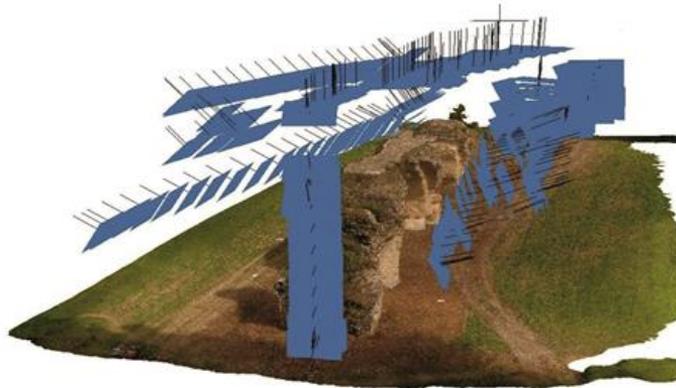
Fig. 2. Positions of camera during the flights of the drone.

Three flights and a total of 273 images were planned, according to 3 consecutive strips, acquired in time-lapse mode (5 s interval). In the first flight, 74 photographic shots were acquired in nadir mode (NW-SE direction, average height 19 m, ground coverage of about 29.9 x 22.3 m). Two other flights, with the camera tilted at 45° on the horizontal plan, were carried out acquiring, respectively, other 96 and 106 photos (17 m and 9 m on both sides; the ground coverages of about 26.8 x 20 m and 14.2 x 10.6 m, respectively) [11].

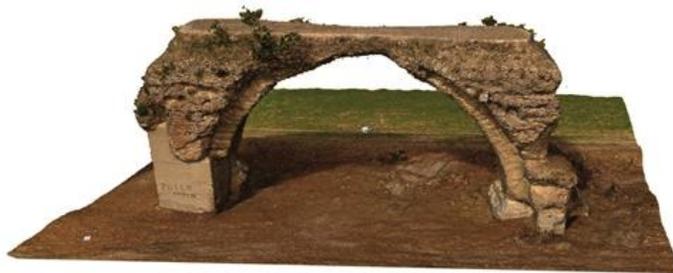
Fig. 3. Perspective view of the arch of the bridge, obtained by the generated point cloud.

Dense Cloud has been generated (Fig. 3), as well as the polygonal model (Fig. 4a) and the Digital Elevation Model (DEM) of Ponte Rotto (Fig. 4b). The model is rather accurate, showing an average error on GPC lower than 4 cm [11,18].

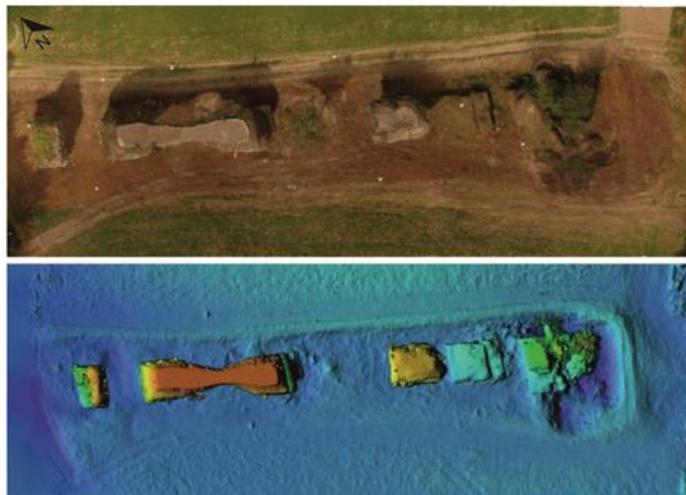
Fig. 4. Orthophoto (a) and Digital Elevation Model (b) of Ponte Rotto.

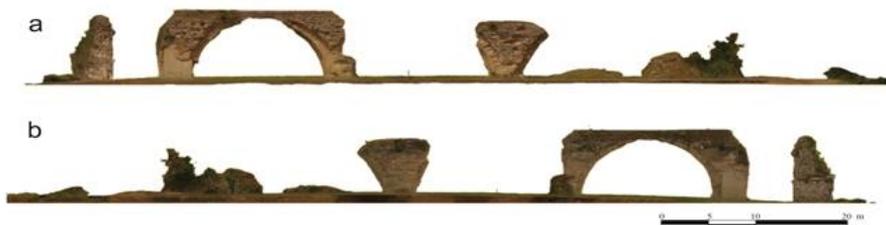
Completeness of data acquired and the appropriate resolution permitted the extraction of good quality orthoimages from the point cloud model elaboration of photogrammetric data. Lateral orthophotos, extracted from the coloured model points selecting planes of projection parallel to the western and eastern fronts of Ponte Rotto (Fig. 5), were used for a quantitative evaluation of lithotypes and damage diagnosis, as also carried out for decay analysis of other important monuments (e.g. [19]).

Fig. 5. Lateral orthoimages showing the western (a) e eastern front (b) of Ponte Rotto

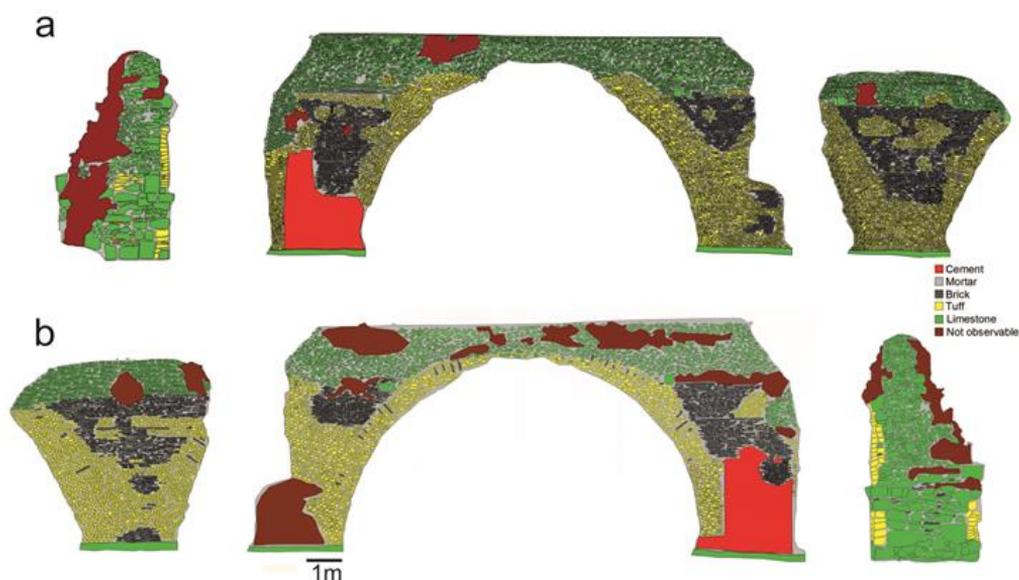
The bridge was built with different techniques and geomaterials, as observed in other coeval monuments in Benevento [20], which basically depend on the structural function they had. Lithological mapping highlighted the presence of tuff material, bricks and limestones welded by mortars (Fig. 6; Table 1). Concrete, due to recent restoration works, also occur (Fig. 6).

Fig. 6. Geomaterials distribution in western (a) and eastern (b) façade.

Yellow tuff material is the predominant building stone in both eastern and western façades (23.2%; Table 1), covering the lower part of the bigger lateral pillar and the central circular arch (Fig. 6). As also observed in nearby contexts [21], yellow tuff can be attributed to pyroclastic trachytic rocks (likely Campanian Ignimbrite in Yellow facies), one of the first building materials since Roman times, largely used for other coeval historical monuments of Campania region [22,23], also outcropping along the Calore river [24]. It is constituted by lithics, scoriae, pumices and crystals scattered in a cineritic yellow matrix which owes its color to post-depositional zeolitization processes [25,26]. Notwithstanding the widespread use in the building sector, its mineralogical properties made it suitable also in different industrial applications [25,27–31]. The framework of tuff blocks is made up in *opus incertum*, intercalated with bricks. Bricks (7.5% on average) were used as covering material in the upper part of all the elements of the bridge (arch and pillars; Fig. 6). They are generally horizontally oriented,

except for the archway where they signed the arch shape (Fig. 6). Bricks show a coarse-grained texture, with a temper mainly of volcanic origin (crystals and juveniles), mixed to siliciclastic grains scattered in the clayey matrix, in a mix-design consistent with coarse potteries and bricks from different buildings and archaeological sites in Benevento [20,32,33].

Limestones, occurring in different percentage on both sides (Table 1), have been recognized as large squared limestone blocks on the base of the pillars of the archway, and fluvial pebbles superimposed on the archway (Fig. 6). Geological availability in the surrounding areas [21], suggest that they could belong to the “Flysch Rosso” formation [24].

Mortar-based materials containing volcanic aggregate and covering around the 40% of the examined surfaces (Table 1) were used to bind the different building materials (Fig. 6). Such a mix-design of mortars is consistent with typical manufacturing techniques of Roman period [34–38], as also verified for other coeval monuments in Benevento [39].

Traces of the most recent reinforcement works were also detected such as a large concrete block used for the lateral pillar of the arch (4.6%; Table 1; Fig. 6)

A different framework was observed in the smaller lateral pillar (Fig. 6), made of large squared limestone blocks in *opus quadratum* along with larger tuff blocks (Fig. 6).

It should be remarked that a significant surface of the bridge (eastern façade 11.0%, western surface 6.5%) (Table 1) was not investigated due to the presence of plants mainly growing on the top and the bottom of the façades (Fig. 6).

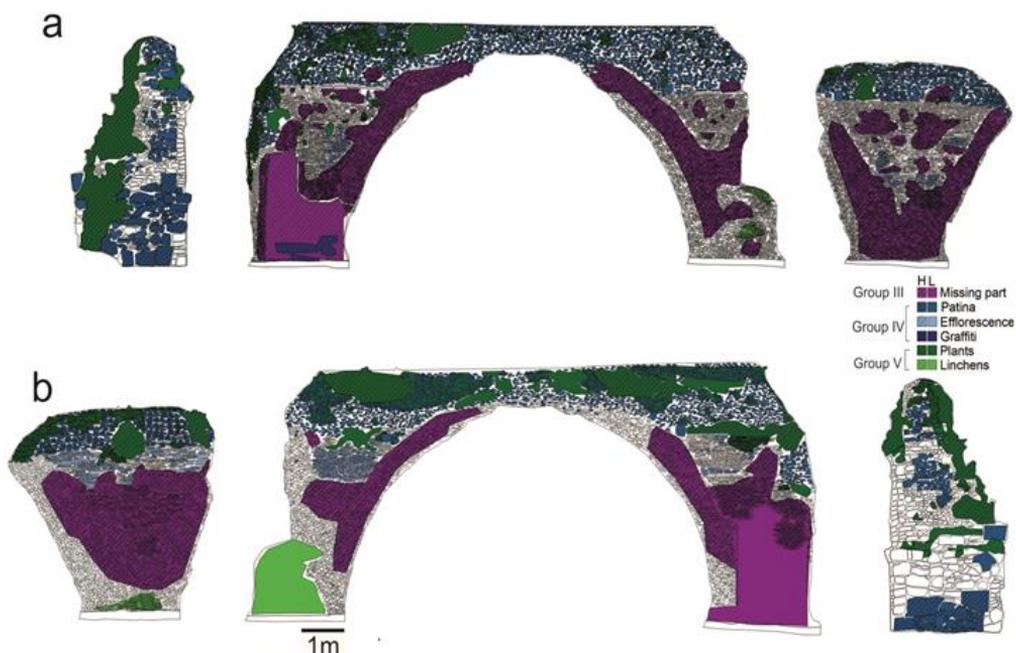
The missing parts represent the weathering form that extensively affects the bridge elements; it is generally due to the detachments of material from the upper part of the bridge (Fig. 7). The other types of weathering forms are related to the intrinsic properties of the building materials. For example, bricks are affected by efflorescences (Group IV), likely due to salts migrating from mortars to the pores of bricks through circulating aqueous solutions. Black patinas, instead, were mainly observed on the calcirudite and calcarenite pebbles on both façades (mainly in western façade; Fig. 7a) as a product of the natural decay of calcareous rock likely caused by the action of pollutants derived from urban and human activities [40].

Among the weathering forms of Group IV (discoloration and deposits) also graffiti have been observed on concrete blocks added during the consolidation works of 1980s (0.5 %; Table 2), attributed to an act of vandalism (Fig. 7a). The main weathering forms belonging to Group III (biological colonization) are represented by plants and lichens (Table 3; Fig. 7).

As described before, plants, located both on the upper and in the lower part of the bridge (Fig. 7) often hide the underlying structures. Moreover, roots provide serious structural damages, resulting in significant loss of material from the overall monument. Lichen colonization, instead, only affects the lower part of the pillars (0.4% on western façade, 2.2% on eastern façade; Table 3; Fig. 7); the latter, however, can be considered negligible since it does not imply direct decay effects.

Fig. 7. Weathering forms distribution in western (a) and eastern (b) façade. Legend: H: high intensity; L: low intensity.

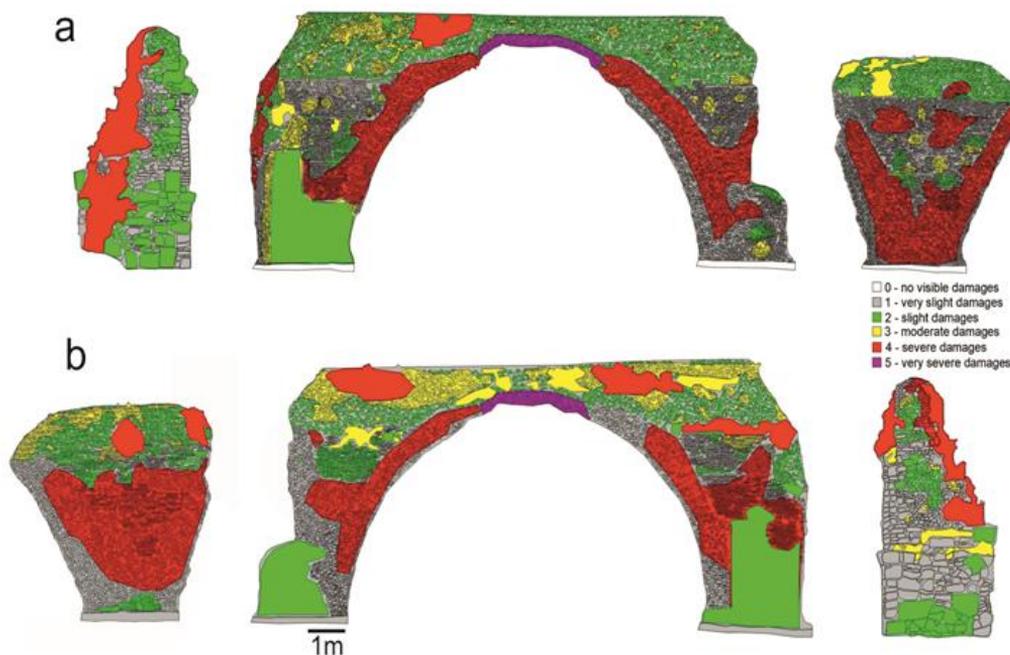
In general, Ponte Rotto is affected by a severe damage on both façades; actually, except for the areas affected by a very slight damage (Fig. 8), severe damage (damage category 4) affects a wide area of the analysed surfaces (29.1% on western façade, 30.1 % on western façade; Table 4). This situation appears more critical on the upper part of the bridge where different weathering forms (missing parts, patinas, plant invasions) are superimposed (Fig. 8). Moreover, in the central archway, a very severe damage (damage category 5) has also been recorded (Fig. 8), as the loss of materials provoked a noticeable and alarming thinning.

Fig. 8. Damage distribution in western (a) and eastern (b) façade

Roots of plants also determined a significant loss of material resulting in modest structural damages. For these areas, a damage category 3 (moderate) has been considered (12.3% on western façade, 10.8% on eastern façade; Fig. 8). Areas affected by black patinas, efflorescence and lichens colonizations, instead, were gathered in the damage category 2 (slight), as these weathering forms do not imply structural damages. For the same reason, graffiti were also considered a very slight damage pathology as it does not directly and significantly affect the conservation state of stone materials, except for its negative aesthetical impact (Fig. 8). Considering the global conservation state of the monument, a very slight damage category (damage category 1) was prudently attributed to the areas in which evident weathering forms were not detected (Fig. 8).

According to the proportion of the different damage categories, the damage indices DI_{lin} and DI_{prog} have been calculated. DI_{lin} on both facades suggest a rather severe damage (2.44 for western façade, 2.38 for eastern façade; Table 4), as well as the DI_{prog} which shows rather similar values (2.73 vs 2.70; Table 4). Such results describe a critical situation of the monument, making necessary potential monitoring and conservation works.
