THE EFFECTS OF AIR POLLUTION ON THE STATUE OF SAINT GEORGE AND THE DRAGON IN CLUJ-NAPOCA, ROMANIA

The study presents the effects of air pollution on a historical symbol of Cluj-Napoca. The statue of Saint George and the Dragon is a copy made in 1904 by Kalman Lux. The original statue built in 1373 by two metalworkers Martin and George from Cluj, is in Prague, Czech Republic. The pedestal of the statue was built using the "Baciu Limestone" due to its famous white color. The "Cluj Limestone" is a white-yellow Cenozoic limestone, with high water uptake and porosity, which allows large amounts of water to easily be stored within the limestone. According to the emissions inventory provided by The Regional Agency for Environmental Protection from Cluj-Napoca for the years 2004-2010 the emission values of SO₂, NO_x and SPM decreased comparing to the years 1992-2002, and the ammonia values were relatively constant. The results indicate the presence of a black layer of different thickness on the surface of the samples which consists mainly of new formed gypsum. The sample extracts indicate a dominance of phthalates, and the pyrolysis has identified substances characteristic for the product

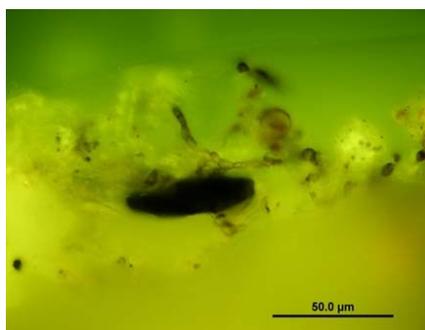
The black crust on the statue of Saint George and the Dragon (sample S.G.) is composed of basic mineral material with small amount of carbonaceous particles on the outside part (Fig. 7-10).

Fig. 7. Massive char fragment and plant organism residues. Reflected white light, immersion objective.

Fig. 8. Massive char fragment and plant organism residues. Reflected blue light, immersion objective.

Fig. 9. Massive char fragment and plant organism residues. Reflected white light, immersion objective.

Fig. 10. Residues of plant organism. Reflected white light, immersion objective.

On the surface, there is a thin lamina containing a few bigger particles of massive char (up to 50µm) with high reflectance ($R_r = 1.5 - 3.8\%$), small portion of soot and more residues of plant tissues and organs with chain structure too.
