## A NEW NON INVASIVE METHOD TO EVALUATE THE DETACHMENTS OF PLASTERS. FIRST RESULTS

*The conservation of the historical finishes represents a difficult issue, due to their aesthetical and functional roles. In particular, the investigation on surfaces (external or internal) with wall paintings represent a typical case where researchers has some difficulties to apply non invasive diagnostic technique about the detachment of these surfaces. The method here described is aimed at the definition of a scientific method for the evaluation of the adhesion between the fresco and the wall. To this end a proper measuring instrument, based essentially on the principle of stationary waves and suitable for easy use in situ, has been designed and realized. To better understand the range of reliability of the instrument and its limits, a set of measurements were carried out on a testing masonry. On this wall two layers of lime plaster were applied and different typologies of detachments were artificially created.*

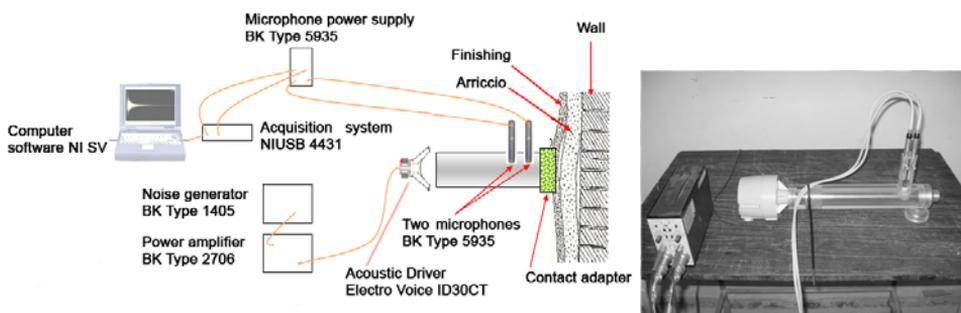
The experimental apparatus is schematically represented in figure 1a. The instrument measures the value of sound absorption coefficient and acoustic impedance in the portion of fresco where it lays. The adopted method is based on the evaluation of a transfer function between the two microphones inserted in the tube, as stated in the Standard ISO 10534-2 [10].

The tube lays on the fresco with a special head made by a 5mm thick synthetic material layer, whose deformability allows adaptation to the wall surface without damaging it. In order to lighten the instrument, loudspeaker and tube have been decoupled then connected through a flexible tube. It was demonstrated that the modified set up is compatible with the whole measurement process.

The tube is made of Plexiglas with 30 mm internal diameter and 360mm length. In the current setup the microphones spacing is fixed at 16mm, thereby the absorption coefficient  $\alpha(\omega)$  is limited at the precautionary frequency range 2000Hz - 5000Hz. Microphones can rotate of 180° as required in [10] for the instrument calibration.

**Fig. 1.** Diagram of the tube lying on the fresco (a) and the “Re-fresco Tube” (b).

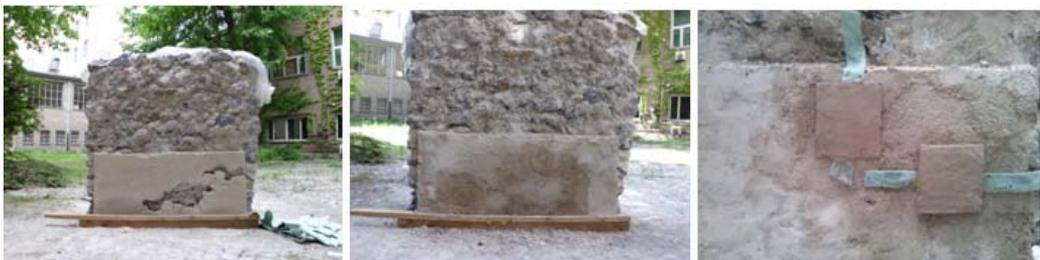
A testing masonry was built in order to validate the acoustical method and to better understand the limits which currently affects this technique. The wall is 150cm and, in this first step of the work, the plaster was applied only in the lower portion as shown in figure 2.

The masonry was realized in stone ashlar (gneiss) and hydraulic lime joints to respect the historical constructive techniques. The surface of the stone was not roughened before the application of the first layer of plaster. For this reason, the *arriccio* appeared irregular, with lacunae and it was non well stucked to the support in some points. All these defects were mapped. In order to simulate the presence of a non visible detachment of the *arriccio* from the stone masonry, the lacunae were filled with felt tissue and a thin layer of plaster was applied above it as reported in Fig. 2a and b. To increase the records of the defects, a thin finishing was then applied. In some case this layer is adherent to the *arriccio*, in other it was detached from the *arriccio* thanks to the interposition of the tissue, which was removed once the plaster was hardened (Fig. 2c).

**Fig. 2.** Lacunae in the *arriccio* of the testing masonry. The plaster was applied only in the lower portion of the wall (a). After the mapping, the lacunae were covered with a thin layer of plaster sustained by a tissue (b). Detachment of the finishing layer (c).

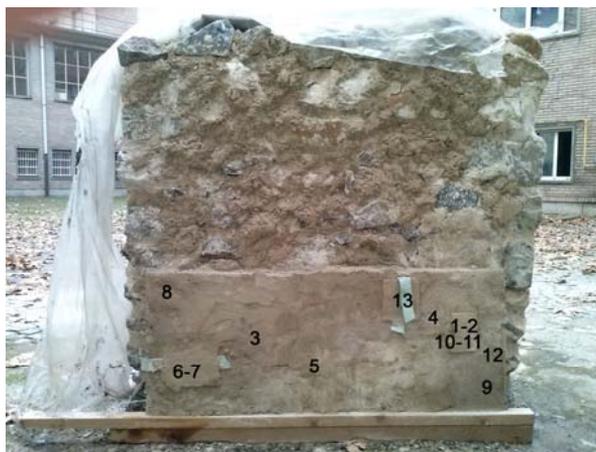
The measures were performed on different points of the wall where no detachment or detachment of one or two layers of plaster is present, as reported in figure 3 and in Table 1.

Fig. 3. Position of the measured points on the testing wall.

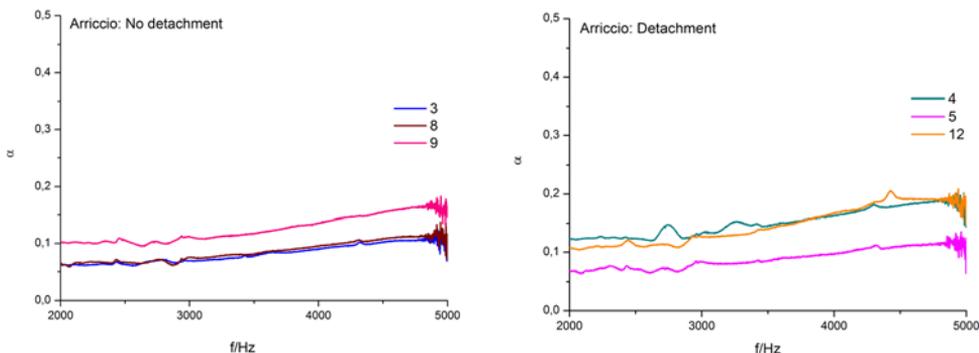
In figure 4a results on non-detached *arriccio* are reported. Absorption lines were rather uniform and did not show any peak. The absolute alpha-value, e.g. the vertical translation of the absorption lines in the graph, should be related to the variable roughness of the surface and to the relative scattering of sound waves. Investigations for this aim are in progress.

Detached *arriccio* responses are reported in figure 4b. Absorption lines were still rather uniform, save for the sample number 4, which shows two weak prominences approximately at 2750Hz and 3250Hz. However, these data could not be considered sufficient to recognize a healthy or defective *arriccio*.

Fig. 4. Measures performed on the undetached plaster (a) and on the detached arriccio layer (b).

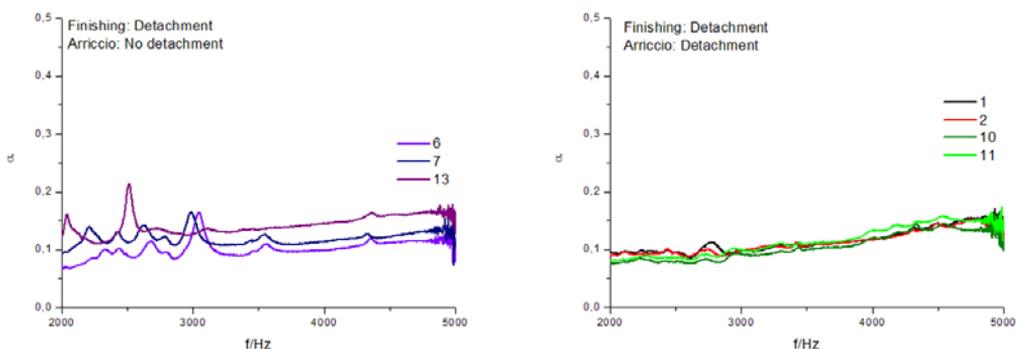
Cavity resonances were detected in the case of finishing detachment, as shown in figure 5a. Several absorption peaks appeared on the graph, each of which was related to the acoustical capacitance of the air cavities hidden behind the detached finishing.

Surprisingly, in the case of detachment of both the layers reported in figure 5b, absorption lines did not present authentic peaks even if they were more pleated. However a little peak approximately at 2750Hz, similar to the instance of sample 4 in figure 4b was detected.

Fig. 5. Measures performed on the non detached plaster (a) and on the detached arriccio layer (b).
