RESTORATION AND PRESERVATION OF ARTISTIC ELEMENTS APPLIED ON ISLAMIC ARCHITECTURAL FAÇADE OF SHAHIN AGHA SEBIL, CAIRO, EGYPT

Nabil A. Abd El-Tawab BADER^{1*}, ANWER F. MAHRAN²

¹ Conservation Department, Faculty of Archaeology, South Valley University, Qena, Egypt.

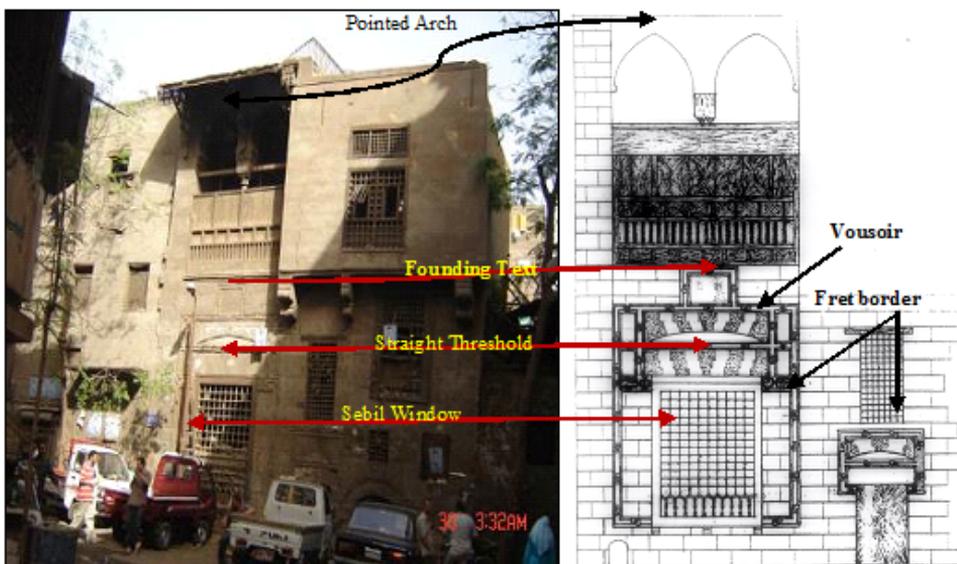
Fig. 1. Shahin Agha Sebil: The main façade with the Exciting Plan of Shahin Agha Sebil facade.

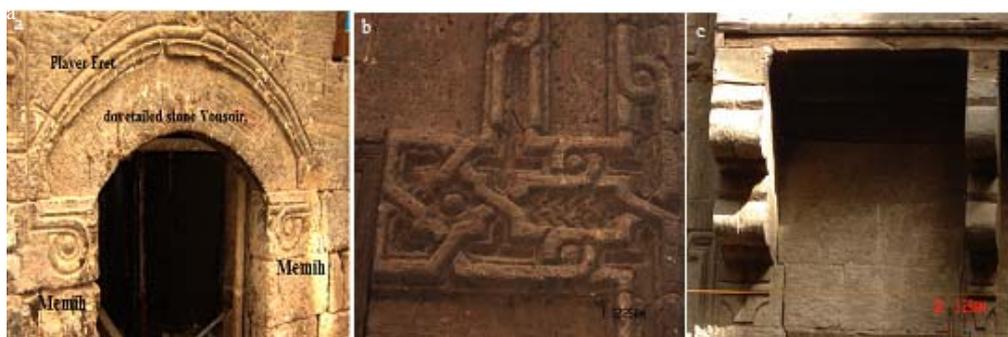
Fig. 2. The artistic and architecture elements at the façade of Shahin Agha Sebil, a-Player Frit, dovetailed stone Vousoir and Mehima b- Player Frit c. Cantilever (Corbel)

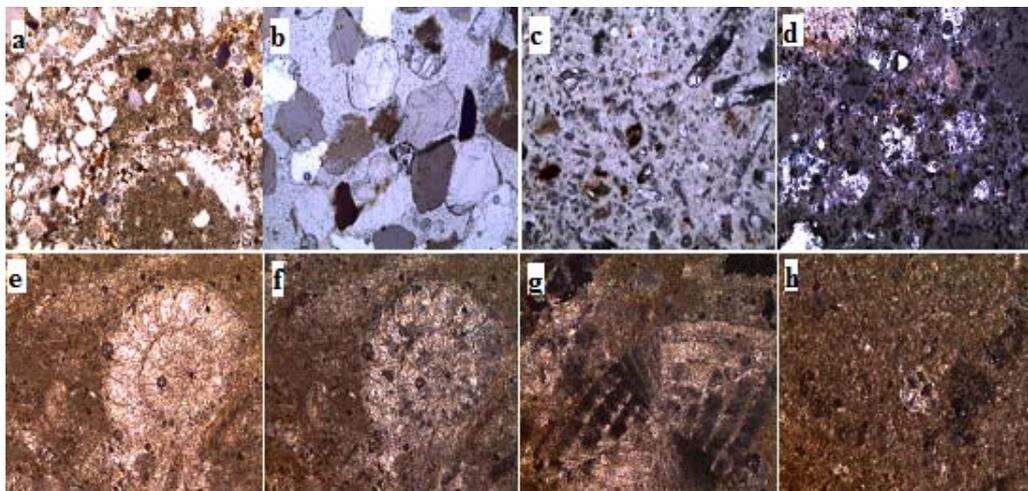
Fig. 8. Optical micrographs: **a** - Fine grained calcite (micrite), **b** - Quartz grains as sub rounded to angular, **c** and **d** - iron oxides and fossil fragments, **f** - Gypsum. Clay minerals and some fine grained quartz, **e;h** - Nummulite, shells and fossils fragments.

Examination of thin sections of the limestone samples under plan polarized light microscope (PLM) displayed fine-grained calcite crystals, on top of iron oxides, clay minerals and numerous grains of quartz that were also found occurring as sub rounded to angular. These

component; its increase the rate of stone decay. The study showed also Nummulite, shells and fossils fragments as shown in figure 8. Studies indicated that, the limestone used in Shahin Agha Sebil is Nummulitic limestone, which formed in the Middle Eocene from Mokkatam formation.

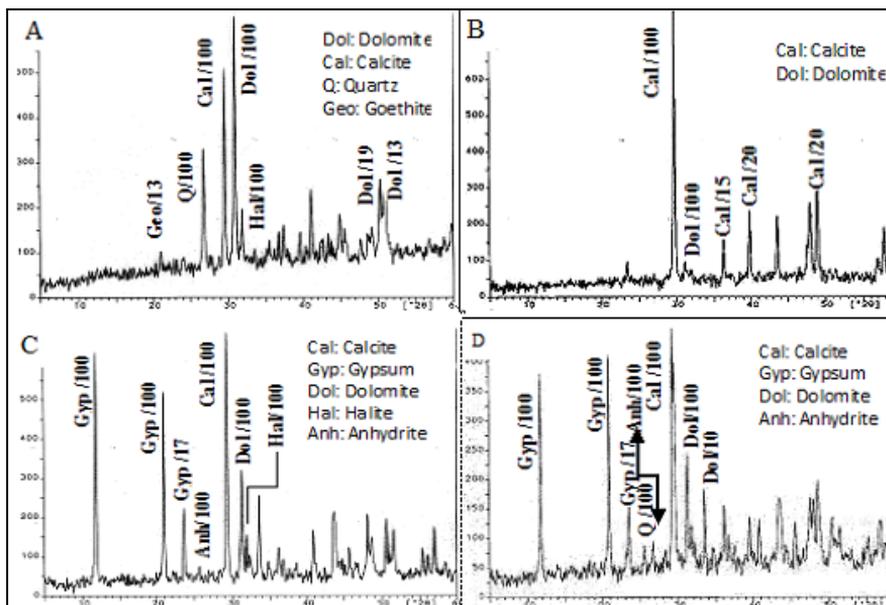
The collected limestone and mortar samples were studied by XRD in order to determine their mineralogical composition. XRD patterns of the studied samples are given in Figure 11 and Table 2, and show that the samples consists essentially of calcite CaCO_3 , Dolomite $(\text{Ca,Mg})\text{CO}_3$, small amount of halite NaCl , Quartz SiO_2 , Gypsum $\text{CaSO}_4 \cdot 2\text{H}_2\text{O}$, Anhydrite CaSO_4 and traces of iron oxide. According to this study, we claimed that the stone in the façade consisted of calcite as a major minerals and high ratio of dolomite (Dolomitic limestone) and small amounts of Quartz and iron oxide. The presence of halite and gypsum is related to salts. The presence of anhydrate is the result of the transformation of gypsum $(\text{CaSO}_4 \cdot 2\text{H}_2\text{O})$ by thermal weathering.

Fig. 11. Patterns of XRD analysis of limestone samples from the façade of Sebil shahin Agha

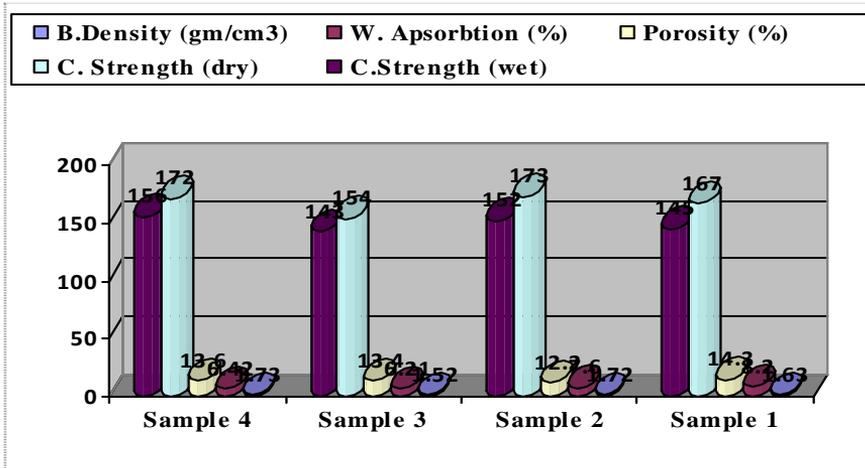
The physical properties detected that the limestone of the facade is characterized by high porosity (13.37%), which gives the stone a high water absorption rate (7.10%) and its consequent ability to absorb water with salt solution and this is the main cause of deterioration. The bulk density of the samples gives 1.66gm/cm^3 . The mechanical properties were measured, the results showed that the strength of limestone in the facade characterized by poor mechanical characteristics (by 166.6kg/cm^2 Dry and 149kg/cm^2 Wet). The changes of physical and mechanical properties of the stone were a result of weathering process.

Fig. 12. Physical and mechanical properties of limestone samples from the façade of Shahin Agha Sabil
