STRUCTURAL DAMAGE ASSESSMENT OF HISTORIC TRADITIONAL MASONRY BUILDINGS: A CASE STUDY

Abstract

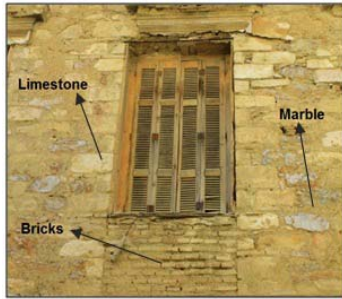
The main building materials used were limestone, marble, and volcanic stone, whereas semi fired bricks were in between the main building materials and under the windows (see Fig. 7).

Fig. 7. Building materials
