A CONTRIBUTION TO THE CONSERVATION OF 20TH CENTURY ARCHITECTURAL HERITAGE IN KHEDIVAL CAIRO

This paper discusses the restoration works carried out to save a balcony in a historic building dating back to the beginning of the 20th c. The corrosion of the steel beams carrying the balcony resulted in severe problems and the decorative units at the balcony bottom were detached. An intervention was carried out in which the steel beams were cleaned from corrosion products and strengthened using newly added plates. As well, the decorative units were restored. For revealing the adequacy of the intervention, a static loading test was carried out. The interventions presented here represent a good example that could be applied to many other similar balconies widely found in Khedivial Cairo, in specific, and other similar floors made of steel beams and concrete.

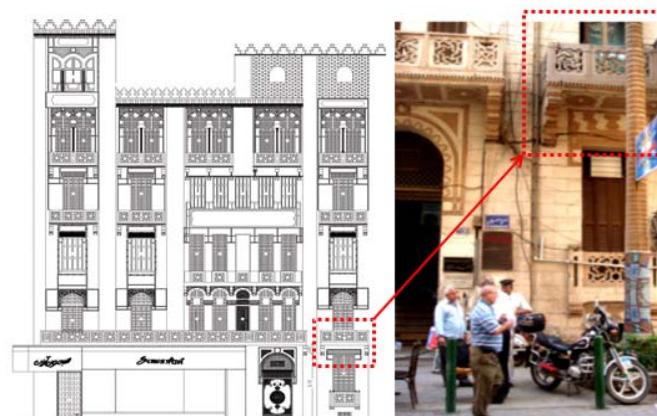
Fig. 1. Architectural documentation of the west façade of the historic building and the balcony is surrounded by red dashed rectangle (a), and old photo of the balcony before the start of the damage (b)

The building's facades are rich with decorative elements like the arched windows, the decorated parapets, and the wooden sheds. The balconies of the building, in specific, are well decorated with hunched corbels, parapets with hollow decorations and gypsum decorated units at the balconies bottom. The balcony of this research is at the west façade of the building, just to the right of the building's entrance (Fig. 1).

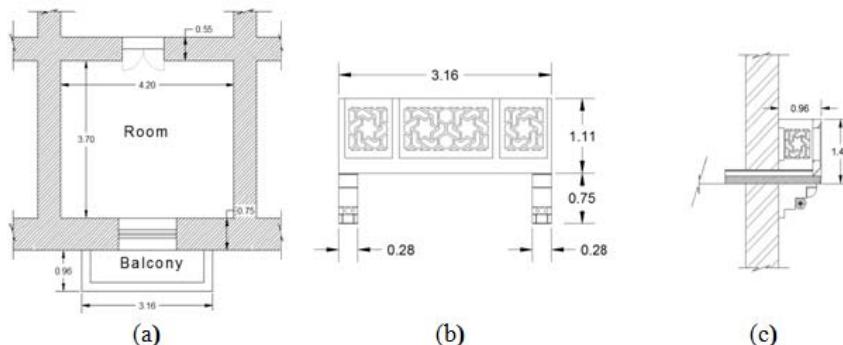
It is a cantilever with a span of 0.96m and the width is 3.16m with a parapet of 1.40m high (Fig. 2). The balcony's floor is composed of lightweight concrete made of cement, sand and slag aggregate. This concrete is supported by I-Shaped steel beams.

Fig. 2. Architectural documentation of the balcony: a. plan; b. elevation; c. side view (dimensions in meters)

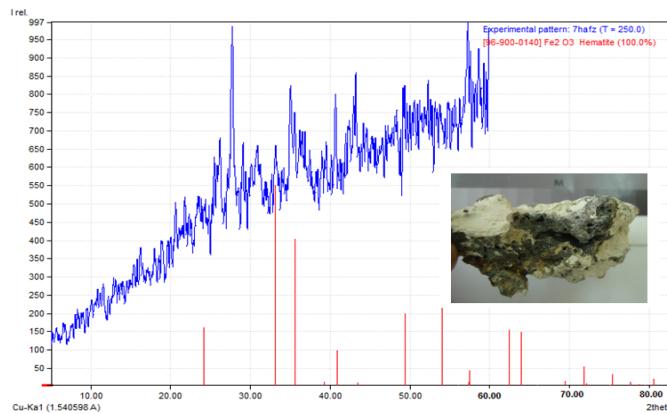
Eight samples in total were analyzed using XRD analysis method, three samples from the slag aggregate, three samples from the binding material, and two samples from the decorative units. The slag aggregate's samples showed that the main component was Hematite (ferric oxide, Fe_2O_3), as an example in Figure 7. Also, Quartz was found as filler. Calcite and Gypsum were found due to the binding material surrounded the slag sample. As for the samples of the binding material, it was found that the binder material (Fig. 8) composed mainly of Gypsum, Calcite, and Quartz. Some traces of hematite were found due to the slag aggregate existence. Due to the infiltrated water, the dehydrate was found. Regarding the samples of the decorative units (Fig. 9), it was observed that these units were composed of Gypsum, Calcite and Quartz.

Fig. 7. XRD analysis of one of the slag aggregate's samples.

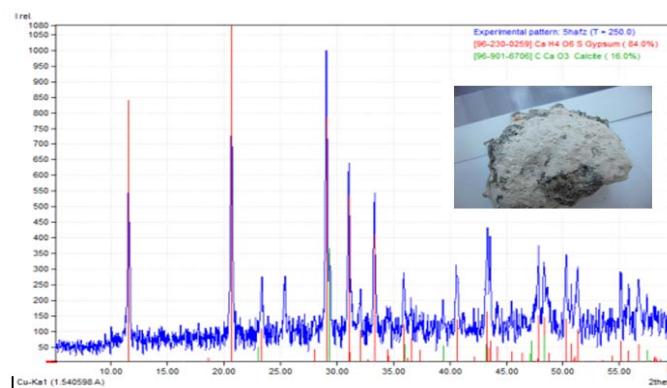
Fig. 8. XRD analysis of one of the binder material's samples.

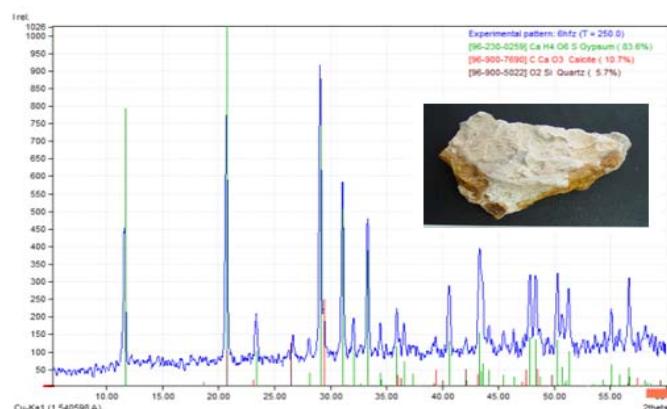
Fig. 9. XRD analysis of one of the decorative units' samples.

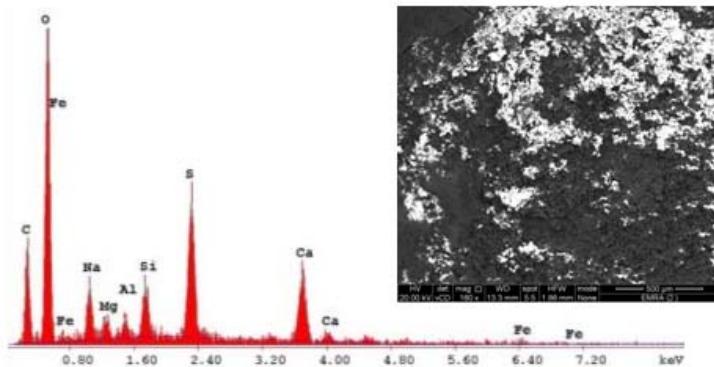
Five samples were examined and analyzed using SEM-EDX, one sample from slag aggregate, two samples from the concrete binding material and two samples from the decorative units. Table 1 reports the weight found for each element (W_i) in each sample. For the slag sample (Fig. 10), the Fe element was found and the SEM image shows the characteristic particle composition of slag. The samples of the concrete binding material showed that the Portland cement was used because of the existence of the elements of Al, Si, Fe, S and Mg,

Fig. 10. Slag sample (sample no. 1): EDX analysis, and SEM image.

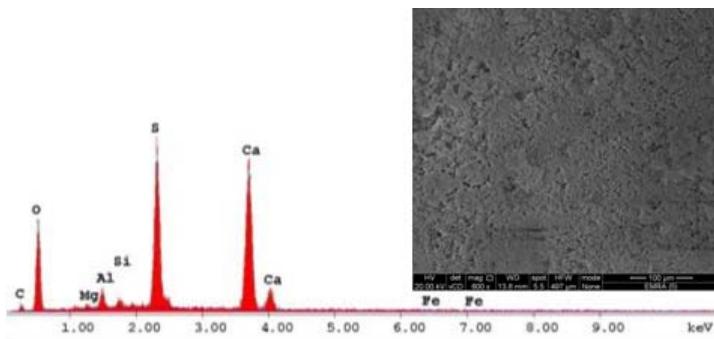
Table 1 and Figure 11. These elements are the main elements of Portland cement. As for the decorative units' samples, the corrosion products of the steel bar used in a previous intervention was evident as the Fe element was found with a high percent (Table 1). Additionally, the existence of the elements S and Ca showed that the gypsum is the main component of these units as found by the XRD (Fig. 12).

Fig. 11. Binding material in the concrete (sample no. 3): EDX analysis, and SEM image.

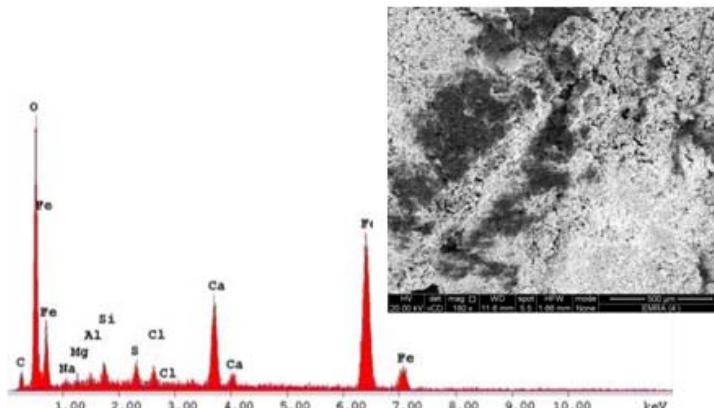
Fig. 12. Decorative units' sample (sample no. 4): EDX analysis, and SEM image.

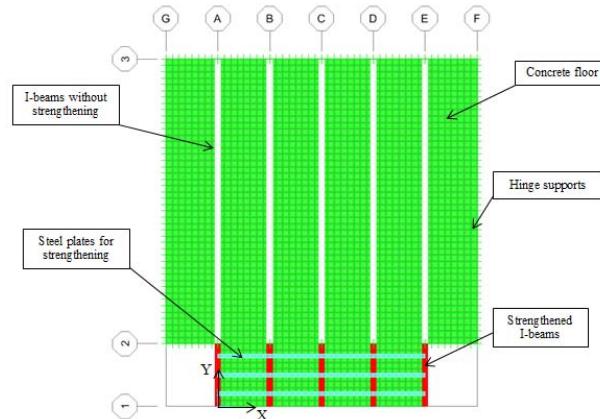
The case of the strengthened balcony was considered first. The concrete slab was modeled as shell elements. The steel beams and the steel plates used in strengthening were modeled as frame elements. The size of shell elements was about 0.09x0.09m. The model was composed of 2584 joints, 371 frame elements, and 2480 shell elements. The walls supporting the room floor were not modeled, instead, hinge supports were used (Fig. 19).

Fig. 19. FE model of the balcony and the adjacent room after strengthening

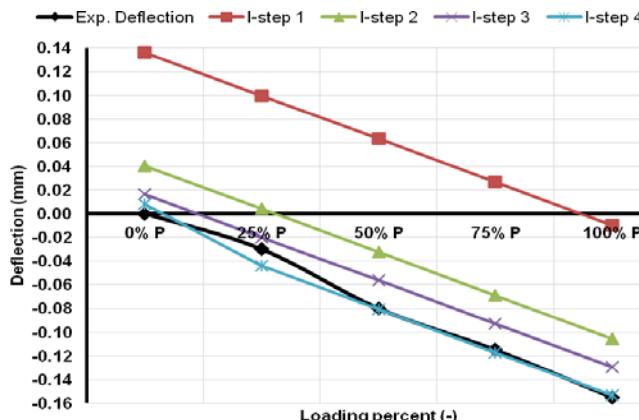
The model updating was carried out manually according to the procedure summarized in Table 3. In phase I, E was taken similar to that one of the modern concrete 20 GPa, and γ was changed from 2500 kg/m^3 (similar to modern concrete) to 1000 kg/m^3 in four updating steps. It should be mentioned here that the detached parts of this concrete had a lightweight due to the usage of slag aggregate. Figure 20 shows the results of this phase of updating. In this figure, the positive deflection is upward and the negative one is downward. The unit weight value of 1250 kg/m^3 gave a good match between experimental and numerical deflections and was therefore selected to be used in phase II of the updating process.

Fig. 20. Phase I of the numerical model updating

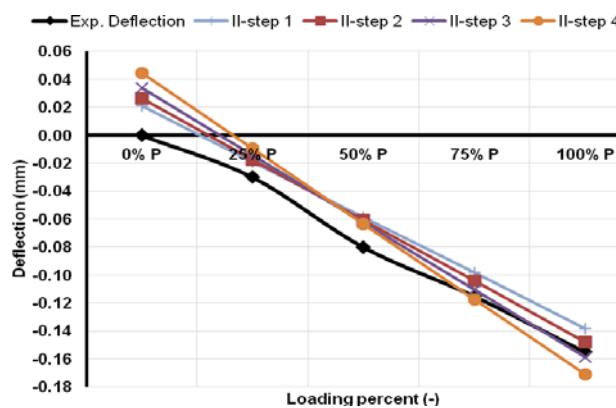
Fig. 21. Phase II of the numerical model updating

In phase II, the modulus of elasticity was changed gradually from 0.9 to 0.6 its initial value in four updating steps (Fig. 21). It was noticed that the two values of 0.8E and 0.7E resulted in numerical deflections near to the experimental ones.

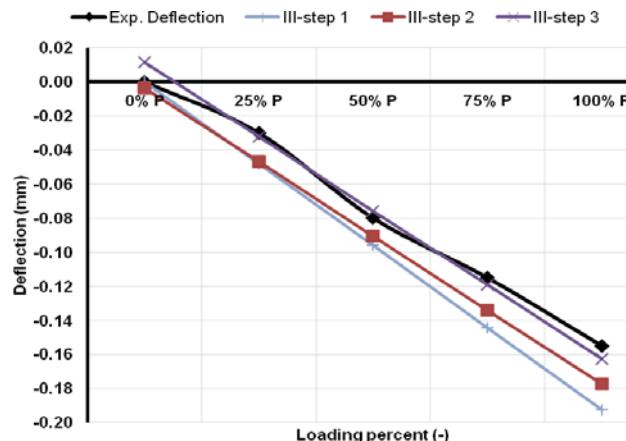
Fig. 22. Phase III of the numerical model updating

In the last phase of updating, phase III, three steps were carried out. It was found that the best values for the modulus of elasticity and the unit weight of concrete were 1.6GPa (0.8E) and 1125kg/m³, respectively. Using these values the experimental and numerical deflections were almost the same (Fig. 22).

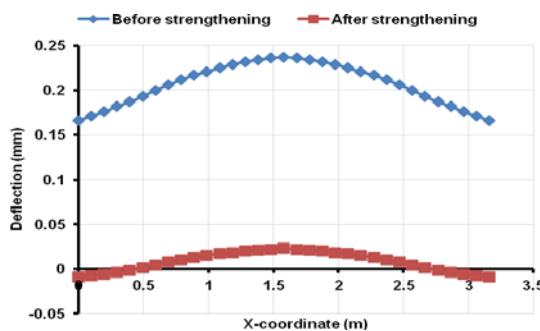
To reveal the efficiency of the intervention carried out, the model with strengthening was compared with that without strengthening. The applied loads were the slab own weight, the flooring, the parapet weight and the live load. In Figure 23, a comparison between the deflections of the two cases is shown, it can be noticed easily that the intervention resulted in a reduction in the deflection values. To show clearly the difference, the deflections of the points on the axis 1 (refer to Fig. 19) are plotted in figure 24 before and after strengthening. As observed, the maximum deflection value was reduced from about 0.24mm to 0.025mm. As well, the deflection of the points on three lines in the balcony shorter direction was plotted before and after strengthening (Fig. 25). These lines were on axes C, B and between the two axes (refer to Fig. 19). Again here, the maximum deflection value was reduced from about 0.24mm to 0.03mm.

Fig. 24. Reduction of the deflection in the longer direction of the balcony after strengthening (points on axis 1 in Fig. 19).

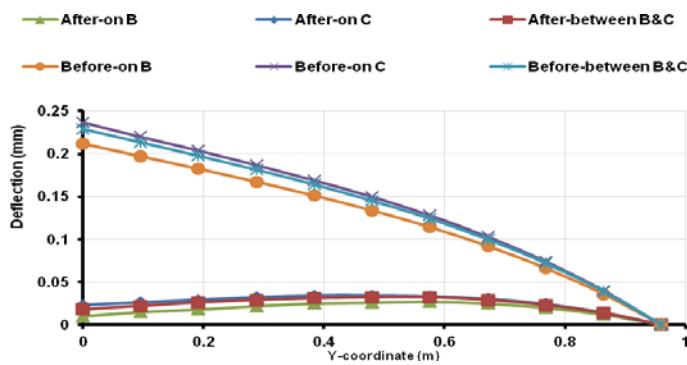
Fig. 25. Reduction of the deflection in the shorter direction of the balcony after strengthening (refer to Fig. 19 for locations of axes B and C).
