RESTORATION OF A CASELLA BROTHERS' ACOUSTICAL GUITAR AND CONSTRUCTION OF AN IDENTICAL COPY

Stylianos ANDREOU, Panagis SKLAVOS,
Anastasios A. KOKKINOS, Dionysios T.G. KATERELOS*

Applied Mechanics – Acoustics and Musical Instruments Design Lab, Department of Sound and Musical Instruments Technology, Faculty of Music Technology, Ionian Islands Technological Educational Institute, S. Typaldou ave, Lixouri, Kefalonia, GR-28200, Greece

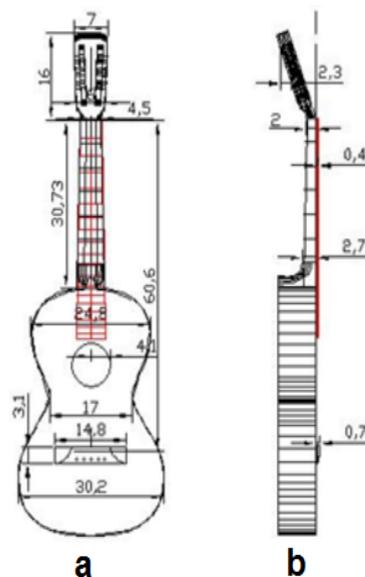
Fig. 12. Guitar drawings: a. Front view; b. Side view.
All dimensions are in cm

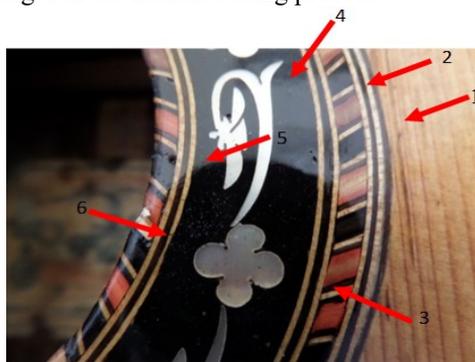
Fig. 13. The rosette six decoration levels

Rosette and bracing struts are the most important details during the top-plate construction. Rosette should be constructed first and added on the top-plate before the struts because this is easier. Rosette is divided into six decoration levels as shown in figure 13. From outer to inner it can be observed the following decoration sequence: black-white-black-white fillets, white-black-red rhombuses repeating along the perimeter, white-black-white fillets, shells in two repeating along the perimeter shapes and embedded into ebony powder, white-black-white fillets and another set of white-black-red rhombuses repeating along the perimeter.

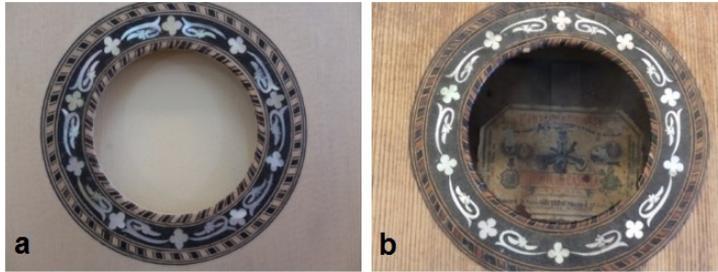
Fig. 14. Comparison of the replica rosette (a) to the original one (b)

First the rosette center was located on the top-plate as a point of reference. Next, concentric circles were incised, using a Dremel cutting tool centered at the marked rosette center, to cut the decoration levels. Shell shapes were copied from the original and cut from a piece of shell. Then, they were glued on the top-plate and the space between them was filled with ebony powder similarly to the repair work done in the original. Finally, rosette was completed with the inner sequence of fillets and rhombuses. The result is very close to the original as can be seen in figure 14.

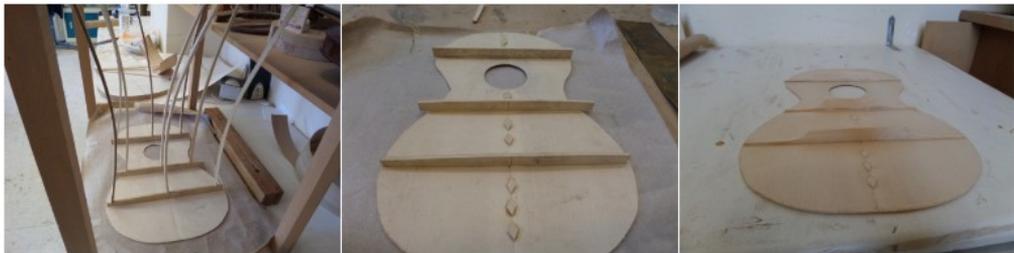
Fig. 15. Bracing struts gluing and forming

Since rosette was ready, the next step is to manufacture and glue the bracing struts. Spruce wood was chosen for the manufacturing, because it is light and withstands high pressure. Bracing struts are always cut along the wood grain. Struts were cut and fish glue was applied. Gluing was done using flexible wooden rods that pressed the bracing struts on the top-

plate (see Fig. 15). Next they were formed in the usual shape that is thicker in the middle and thinner at the edges, with a quadrant between the thicker and the thinner part (Fig. 15). This shape is chosen in order to reinforce the top-plate without putting too much weight on it.

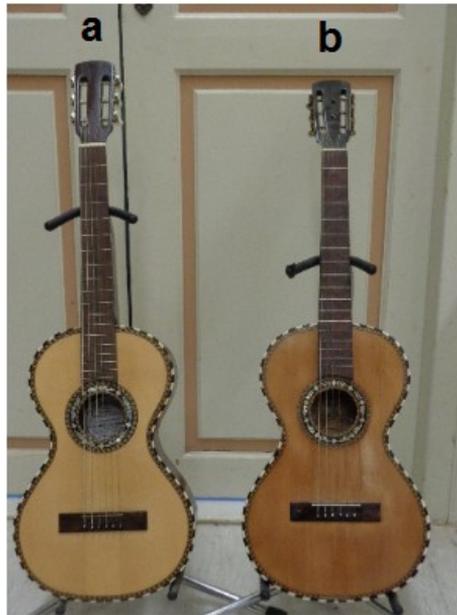
Fig. 16. (a) The original repaired guitar;
(b) The reconstructed replica guitar

The last two steps include the assembly of the neck and the placement of the keys and strings. Keys were placed in the neck prior to assembly. Then the neck was wedged on the guitar body and screwed to be stabilized. Finally, the strings were placed and the final result can be seen in figure 16. In the same figure the original guitar is also presented for comparison.

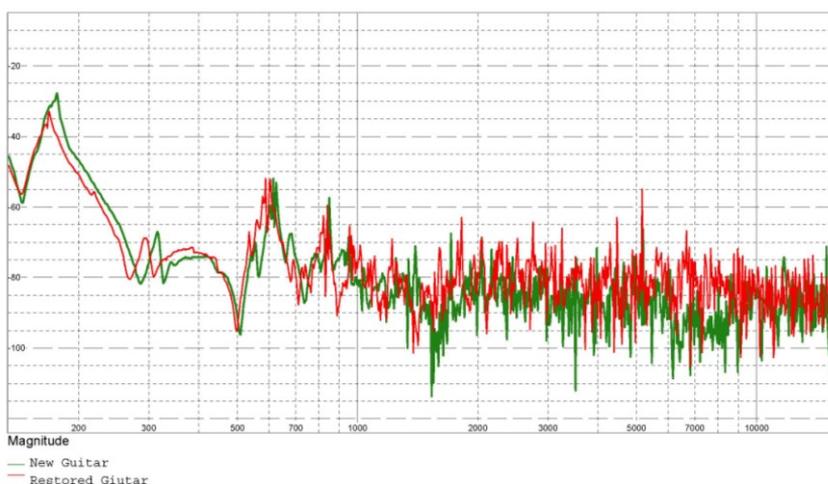
Fig. 18. Impedance curves of the two guitars. Red line represents the admittance curve of the restored original guitar, while green line represent the admittance curve of the replica

At the above picture we can see the admittance for both guitars. It seems that there is a very small difference between the two curves, which leads to the assumption that these two guitars have almost similar admittance curves at the range of 200 to 700Hz and the curve is too close in order to consider that the new guitar is a copy to the Casella's restored guitar. However, this difference could be attributed to higher mass of the top-plate, which could be reflects either on wood mass or the finishing materials mass. Nevertheless, this difference could be considered negligible regarding the acoustical behavior of the two guitars.

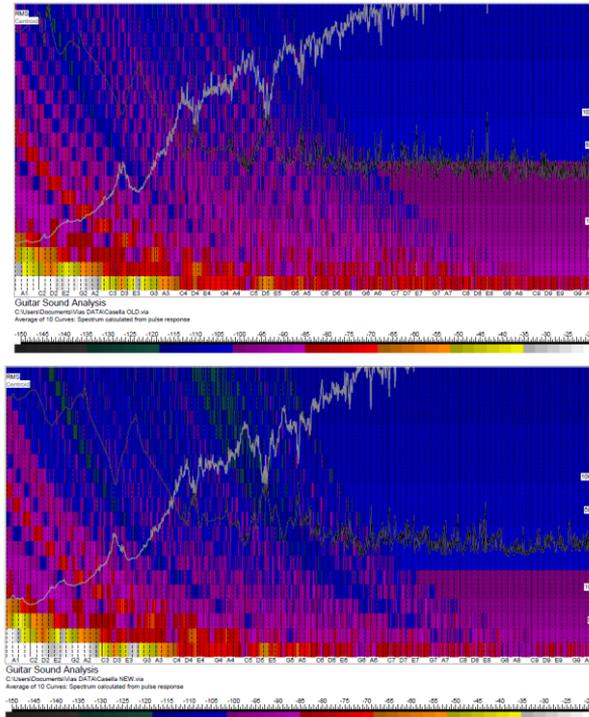
The graphs show the amplitude of each harmonic at every frequency point, in other words, the contribution of each harmonic to the sound of a playable tone. As it can be seen, figures 19a and b are quite similar and, thus, can be assumed that the replica guitar is a nice copy of the Casella's original [12].

Fig. 19. The spectrogram of the restored original Casella's guitar (a) and the spectrogram of the new identical with the restored Casella's guitar (b)
