EVALUATION OF SULPHATE ACTIVATORS AS CONSOLIDANTS FOR THE TRANSFORMED GYPSUM IN HISTORIC STUCCO

Stucco monuments suffer from many causes of deterioration; one of these is the transformation of the gypsum content of stucco to anhydrite, which causes disintegration and the appearance of fine fissures that sometimes culminate in the complete loss of archaeological stucco material; this problem makes thinking of a new protocol for its treatment very urgent. So the research proposes using sulphate activators, which may lead to retransformation of anhydrite to gypsum and thus will participate in protecting our stucco heritage. Many parameters have been used; including XRPD analysis, XRF, FTIR, measurement of physical and mechanical properties, SEM and aging by sodium chloride. All results proved that sulphate activator solutions have the ability to retransform anhydrite to gypsum and to increase the mechanical strength of stucco material.

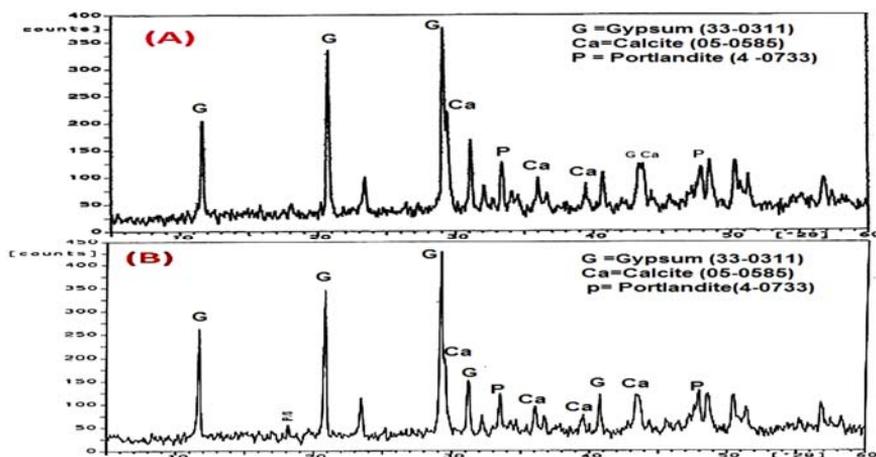
Fig. 1. X-Ray diffraction patterns of the gypsum lime stucco samples after 10 months of room atmospheric conditions exposure, most of portlandite ratio was converted to calcium carbonate.

The X-ray diffraction patterns of the gypsum lime stucco samples (which were prepared for the experimental study) after 10 months of exposure to room atmospheric conditions indicate that most of the portlandite ratio was converted to calcium carbonate as a result of the surrounding atmosphere, especially carbon dioxide gas (Fig. 1). The XRD results were proved by the results of FTIR analysis, (Fig. 2). The comparison between the bands of 1437cm^{-1} with 1426cm^{-1} and the band 872cm^{-1} with 874cm^{-1} allows the identification of CaCO_3 and the increase of its ratio after 10 months.

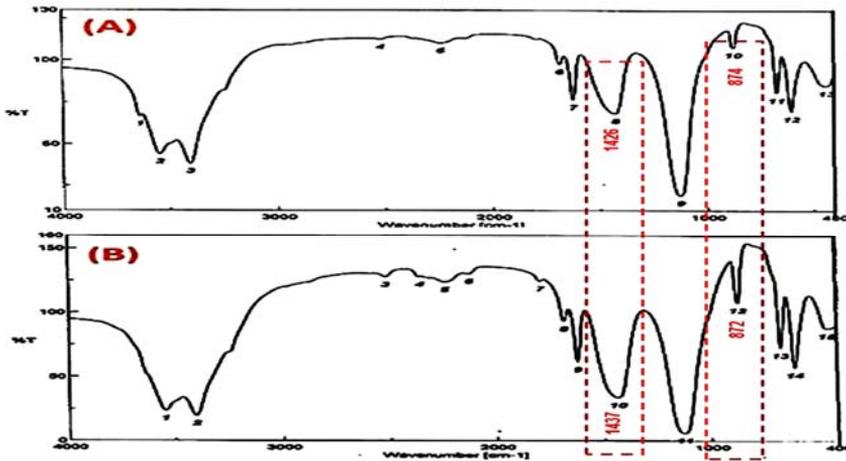
Fig. 2. FTIR spectra from the gypsum lime stucco samples (A) after 1 month (B) after 10 months, bands related to CO₂ prove the results of XRD analysis.

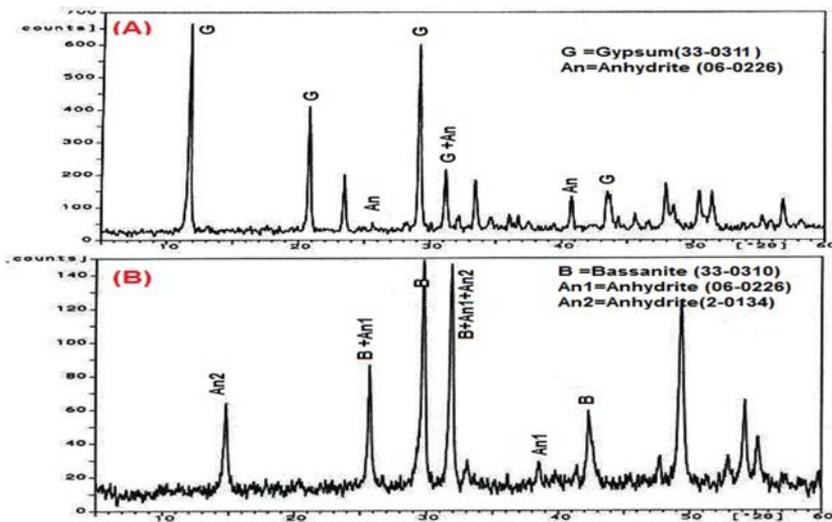
Fig. 3. The X-ray diffraction pattern of the gypsum stucco samples that were exposed to a temperature of 300°C ± 10 for six hours, in comparison with the non-heated gypsum sample. The figure shows the transformation of gypsum content to anhydrite and other intermediate phases of gypsum.

The X-ray diffraction patterns of the gypsum and gypsum lime stucco samples that were exposed to temperature degree $300^\circ\text{C} \pm 10$ for six hours, in comparison with the non-heated samples show the transformation of gypsum content to anhydrite and other intermediate phases of gypsum (Figs. 3 and 4). After this point of transformation, the samples were ready for the application of sulphate activators solutions.

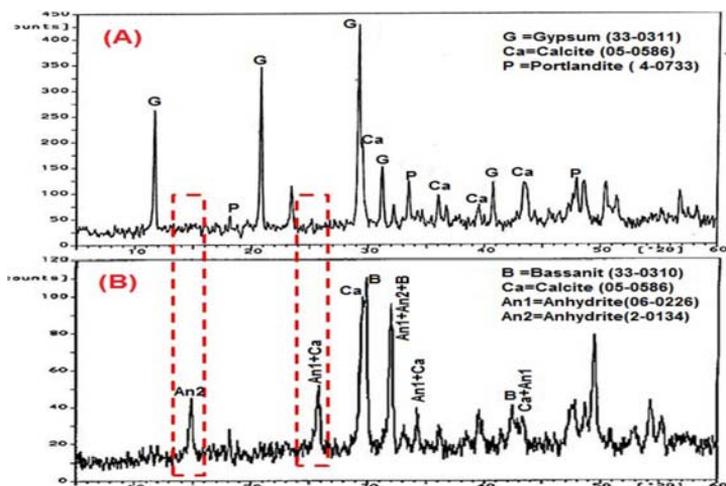
Fig. 4. The X-ray diffraction pattern of the gauged stucco samples which were exposed to a temperature of $300^{\circ}\text{C} \pm 10$ for six hours, in comparison with the non-heated gauged sample, the figure shows the transformation of gypsum content to anhydrite and other intermediate phases of gypsum.

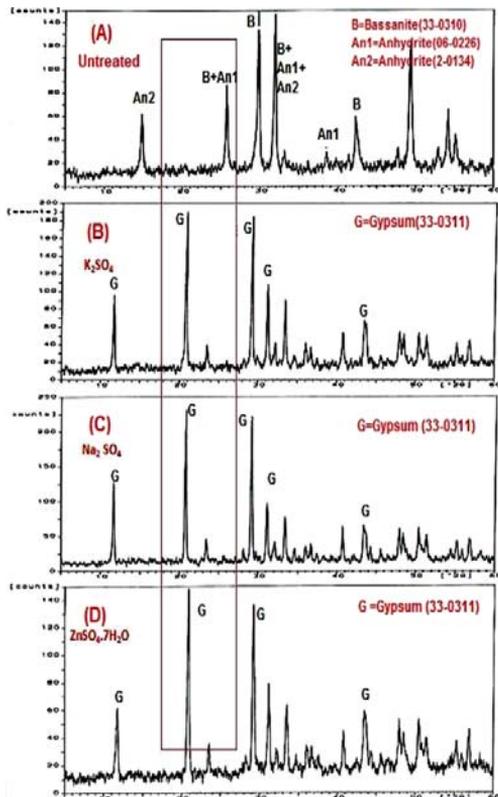
Fig. 5. The X-ray diffraction patterns of the treated gypsum stucco samples with the selected sulphate activators solutions, after more than 28 days, in comparison with the untreated sample, the patterns indicate the appearance of gypsum and the approximate disappearance of anhydrite

The X-ray diffraction patterns of the treated gypsum and gypsum lime stucco samples with the selected sulphate activators solutions (after more than 28 days in comparison with the untreated samples) showed the appearance of gypsum and the approximate disappearance of anhydrite (Figs. 5 and 6) that emphasized the ability of the selected sulphate activators solutions to retransform anhydrite to gypsum, which may increase the strength of the stucco samples. Fortunately, none of the three compounds; potassium carbonate, sodium carbonate or zinc carbonate, was detected in the X-ray diffraction patterns of the treated samples, which decreases the possibility of formation of harmful salts, or reaction of sulphate activators with the other components of the stucco, such as calcium carbonate.

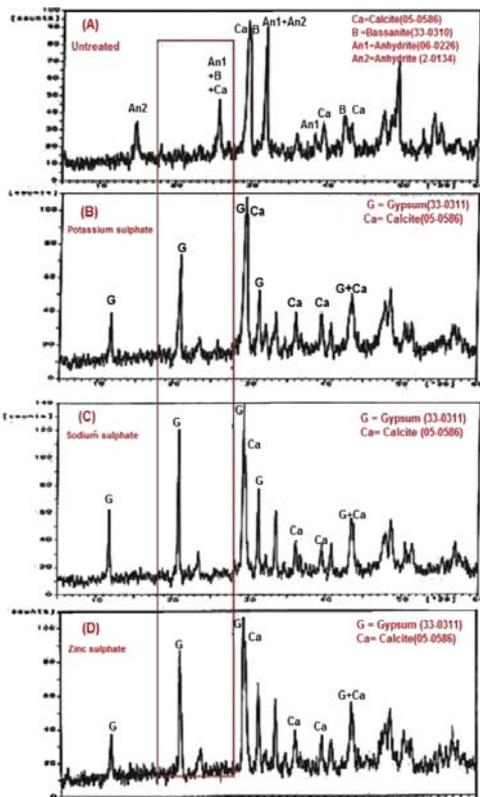
Fig. 6. The X-ray diffraction patterns of the treated gauged stucco samples with the selected sulphate activators solutions, after more than 28 days, in comparison with the untreated sample, the patterns indicate the appearance of gypsum and the approximate disappearance of anhydrite

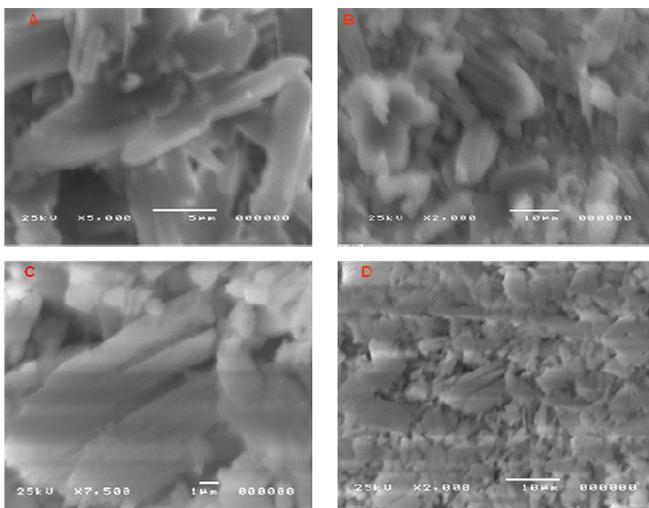
Fig. 7. SEM micrographs of the standard gypsum stucco samples: A & B untreated and non-aged gypsum stucco samples, needle-like crystals relate to gypsum crystals, C & D untreated and aged gypsum stucco samples, the noticeable difference in most of the crystal forms may be related to the transformation to anhydrite as a result of heating at $300^{\circ}\text{C} \pm 10$.

The observations made by using SEM for the treated gypsum stucco samples showed the appearance of interlocked needle-like crystals, which may be related to the reformation of gypsum crystals in all the treated gypsum stucco samples with the selected sulphate activators (Figs. 7 and 8). This may cause an increase of cohesion among crystals (that will be proved by measurement of the physical and mechanical properties), also, in the micrographs of the treated gauged stucco samples with the selected sulphate activators, the appearance of some elongated crystals may be related to the reformation of gypsum crystals (Figs. 9 and 10). However, in the samples treated with Na₂SO₄, some mineral crystals were found among the elongated gypsum crystals may be related to the formation of sodium chloride crystals as proved by XRD analysis (Fig. 8C and 8D; Fig. 10C and 10D).

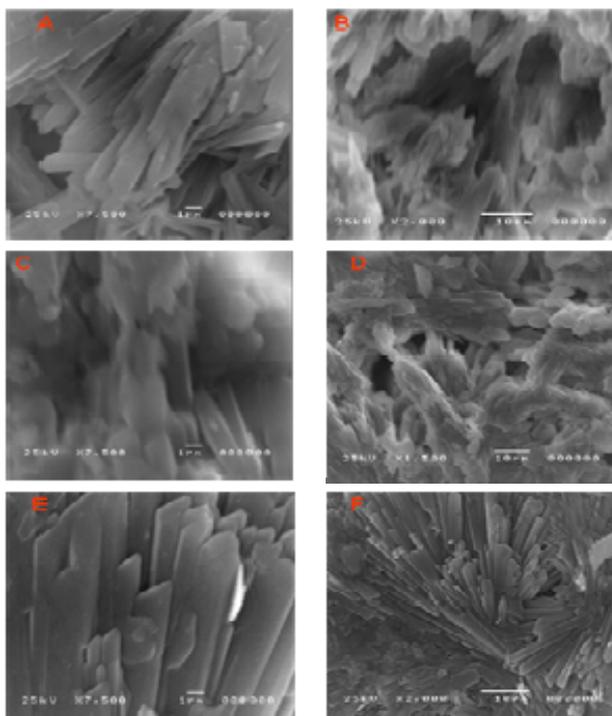
Fig. 8. SEM micrographs of the treated gypsum stucco samples with the selected sulphate activators. A & B, aged gypsum stucco samples after treating with K_2SO_4 , the interlocked needle-like crystals relate to the reformation of gypsum crystals, C & D, aged gypsum stucco samples after treating with Na_2SO_4 , the interlocked needle like crystals relate to the formation of gypsum crystals, E & F aged gypsum stucco samples after treatment with $\text{ZnSO}_4 \cdot 7\text{H}_2\text{O}$, again, needle-like crystals relate to the formation of gypsum crystals.

Samples	Gypsum and mixed (gypsum lime) stucco samples
Parameter	
Bulk density	All treated stucco samples achieved bulk density average greater than the aged stucco samples, which may be a result of retransformation of anhydrite to gypsum (Fig. 11)
Water absorption ratio	All treated stucco samples achieved average water absorption less than the aged stucco samples (Fig. 12).
Apparent porosity	All treated stucco samples achieved average of apparent porosity less than the aged stucco samples (Fig. 13).
Compressive strength of dry and wet stucco samples	All treated stucco samples achieved mechanical properties (compressive strength of wet and dry stucco samples) average greater than the aged stucco samples (Figs. 14 and 15), especially K_2SO_4 and Na_2SO_4 that may be due to retransformation of anhydrite to gypsum. But the strength increasing ratio in $ZnSO_4 \cdot 7H_2O$ gypsum stucco samples was very low, and that may be related to the non-interlocked gypsum crystals (Fig. 8E and F).

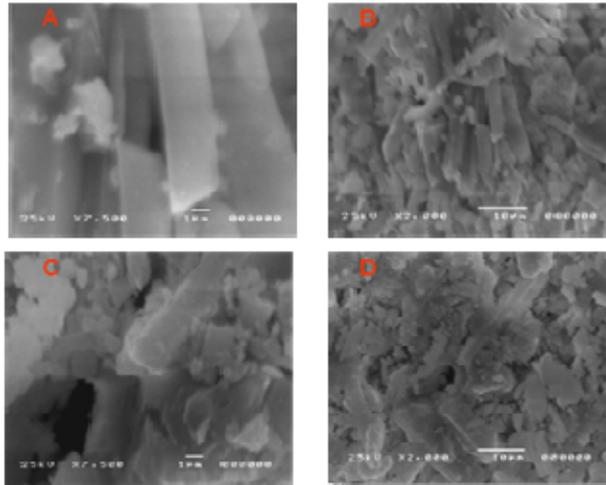
Fig. 9. SEM micrographs of the standard gypsum lime stucco samples: A and B untreated and non-aged gypsum lime stucco samples, needle-like crystals relate to gypsum crystals, C and D untreated and aged gauged stucco samples, the noticeable differences in most of crystal forms may be related to the transformation to anhydrite as a result of heating at $300 \pm 10^\circ\text{C}$.

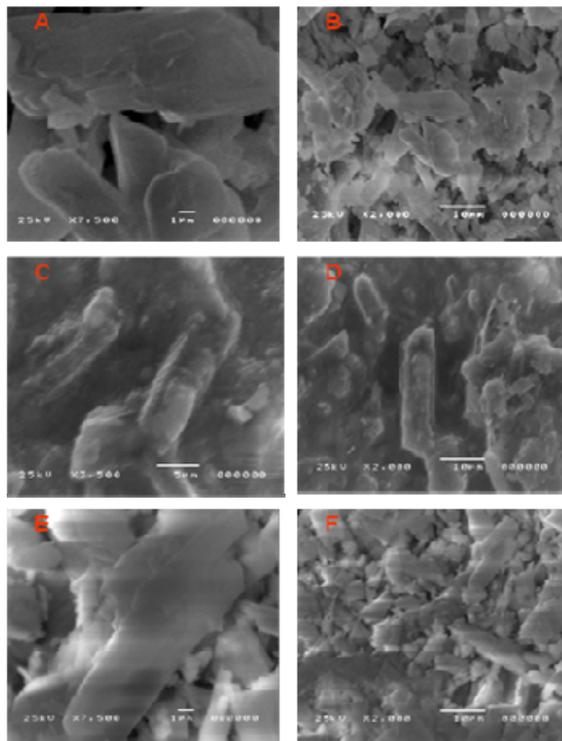
Fig. 10. SEM micrographs of the treated gauged stucco samples with the selected sulphate activators: A and B, aged gauged stucco samples after treating with K_2SO_4 , some elongated crystals may be related to the formation of gypsum crystals, C and D, aged gypsum lime stucco samples after treating with Na_2SO_4 , something among the elongated gypsum crystals may be related to the reformation sodium chloride crystals as proved by XRD analysis. E & F aged gypsum lime stucco samples after treating with $\text{ZnSO}_4 \cdot 7\text{H}_2\text{O}$; also, some elongated crystals may be related to the formation of gypsum crystals.

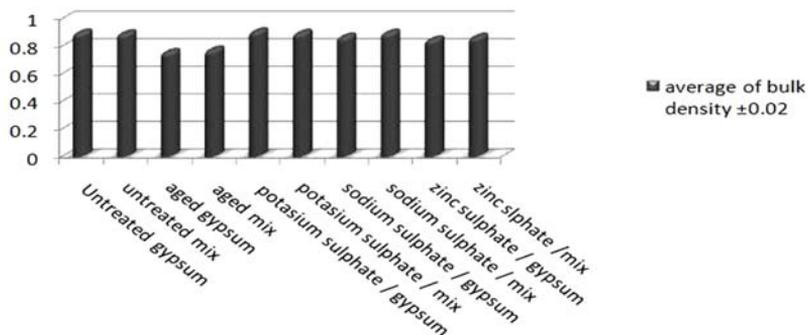
Fig. 11. All stucco samples achieved a bulk density average greater than the aged stucco samples, which may be a result of retransformation of anhydrite to gypsum.

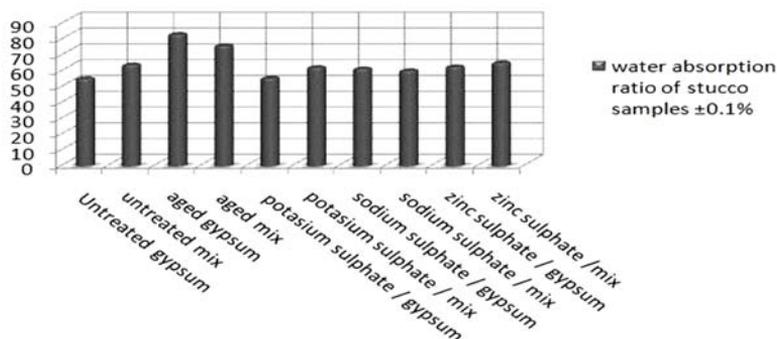
Fig. 12. All stucco samples achieved average water absorption less than the aged stucco samples.

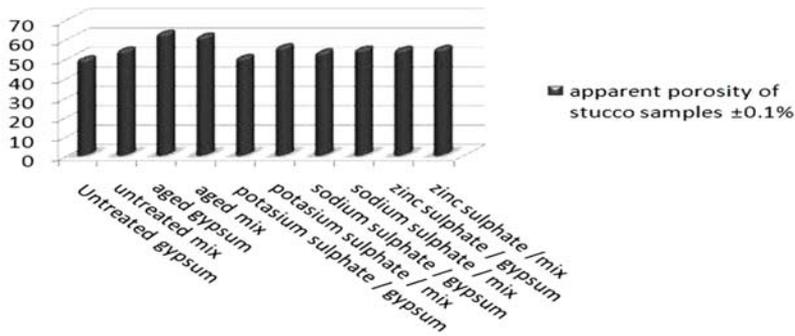
Fig. 13. All stucco samples achieved average of water absorption and apparent porosity less than the aged stucco samples.

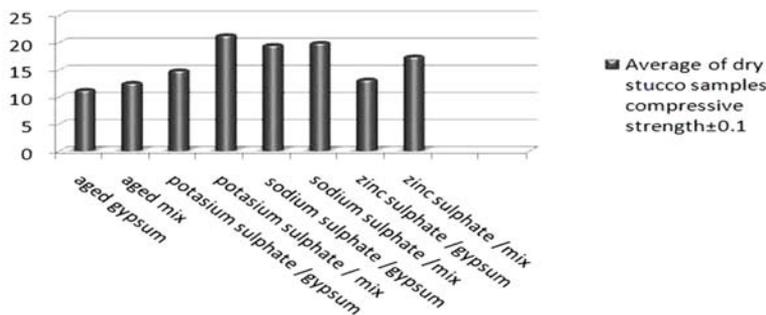
Fig. 14. All stucco samples achieved average of compressive strength of dry stucco samples greater than the aged stucco samples, which may be a result of retransformation of anhydrite to gypsum. The increasing ratio in $ZnSO_4 \cdot 7H_2O$ gypsum stucco samples was very low, that may be due to the non-interlocked gypsum crystals.

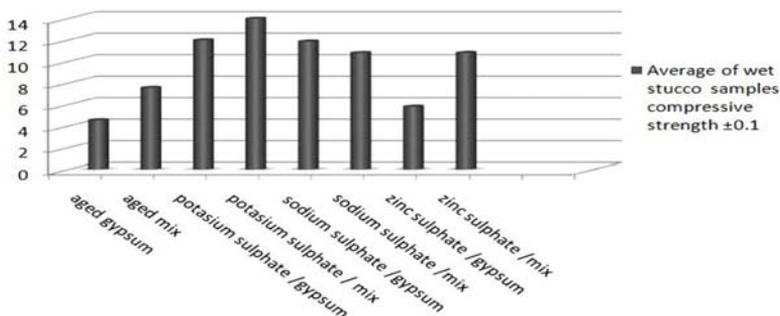
Fig. 15. All stucco samples achieved average of compressive strength of wet stucco samples more than the aged stucco samples, especially K_2SO_4 and Na_2SO_4 , which may be a result of retransformation of anhydrite to gypsum. The increasing ratio in $ZnSO_4 \cdot 7H_2O$ gypsum stucco samples was very low, and may relate to the non-interlocked gypsum crystals.

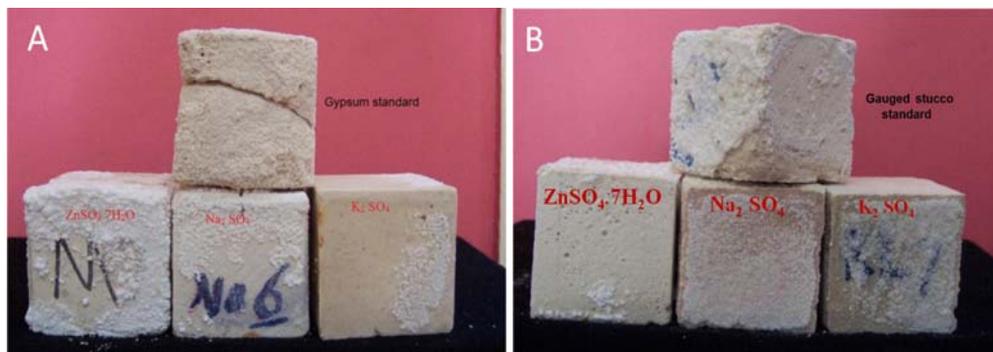
Fig. 16. Photographs show the effect of sodium chloride aging cycles on gypsum and gypsum lime stucco treated samples with the selected sulphate activators in comparison with the aged standard samples.

The effect of sodium chloride aging cycles on gypsum and gypsum lime treated stucco samples with the selected sulphate activators in comparison with the aged standard samples showed an improvement in the appearance of the treated samples, especially, samples that were

treated with K_2SO_4 , but without preventing salt efflorescence; this means that sulphate activators don't close the pores of the samples but decrease them (Fig. 16).
