## THE EFFECTIVENESS OF *SANSEVIERIA TRIFASCIATA* CUTICLE ISOLATION TO PROTECT THE MATERIALS OF CULTURAL HERITAGE OBJECT AGAINST WEATHERING CAUSED BY RAINWATER

### **Abstract**

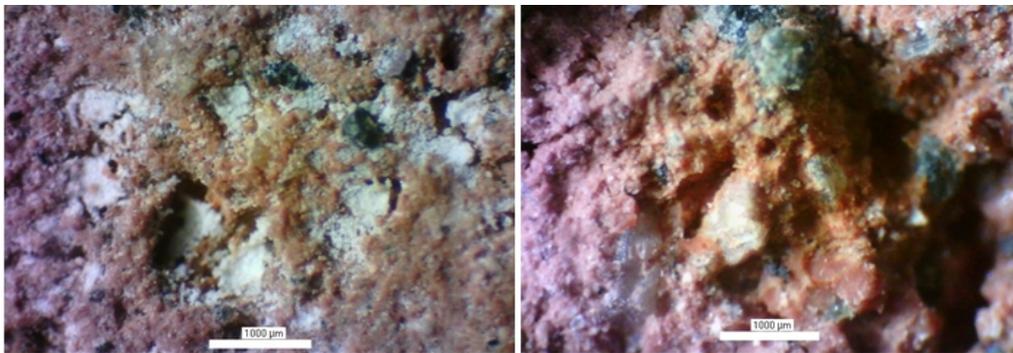
**Fig. 7.** Comparison of Coated and Uncoated Brick

The display of binocular microscope shows that andesite and brick pores after Aging Test and coated by cuticle isolation have different surface of pores which uncoated. Display of uncoated andesite and brick surfaces by cuticle isolation show many pores whereas the display of coated andesite and brick surface by cuticle isolation show that most of surface has been covered by cuticle isolation and there are still some pores that have not been covered (Fig. 6-9).

- From the Stereoscope display can be seen that on the material andesite and brick that coated by cuticle isolation there are some pores that have not been covered by cuticle powder. This case shows that the method of coating is less precise, requiring a careful coating method.
